## **EXHIBIT B – Housing Survey, Hamilton-161 CRA**

The City of Columbus Department of Development conducted a housing survey in the area proposed to be designated as the Hamilton-161 Community Reinvestment Area (CRA) on October 23, 2015. This proposed area is approximately 1,416 acres in size and will be comprised of approximately 1,615 parcels.

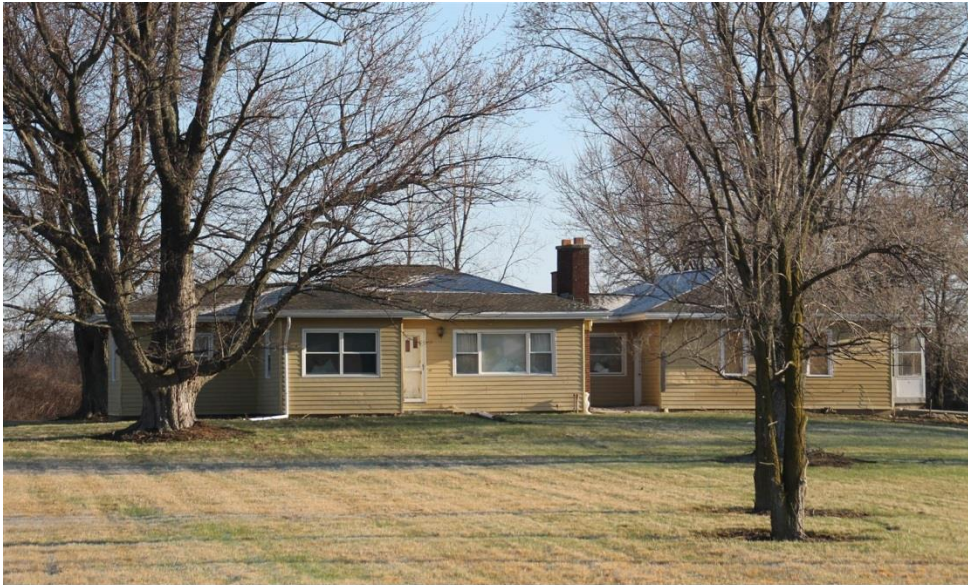
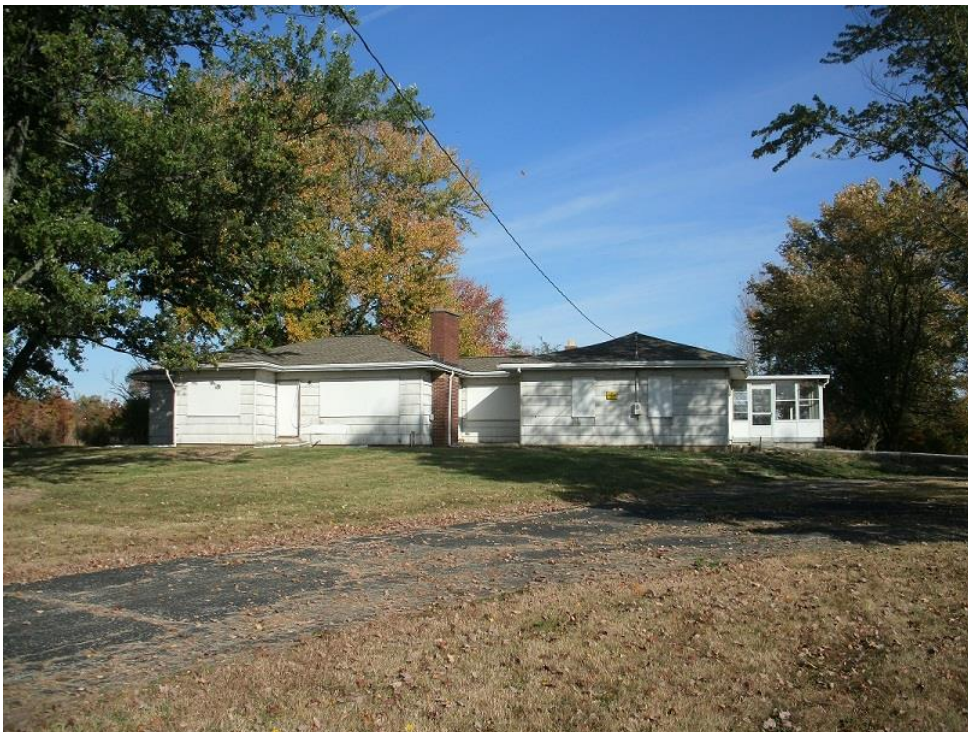
Slide  
A

This unit is showing signs of disinvestment by boarded over doorways and window openings, damaged siding and an outbuilding/garage in general disrepair. Year built: 1951.

Note the disinvestment that has occurred between April 2014 and October 2015. The photograph at the top was taken by the Franklin County Auditor in April 2014; the photograph at the bottom was taken by the City in October 2015.

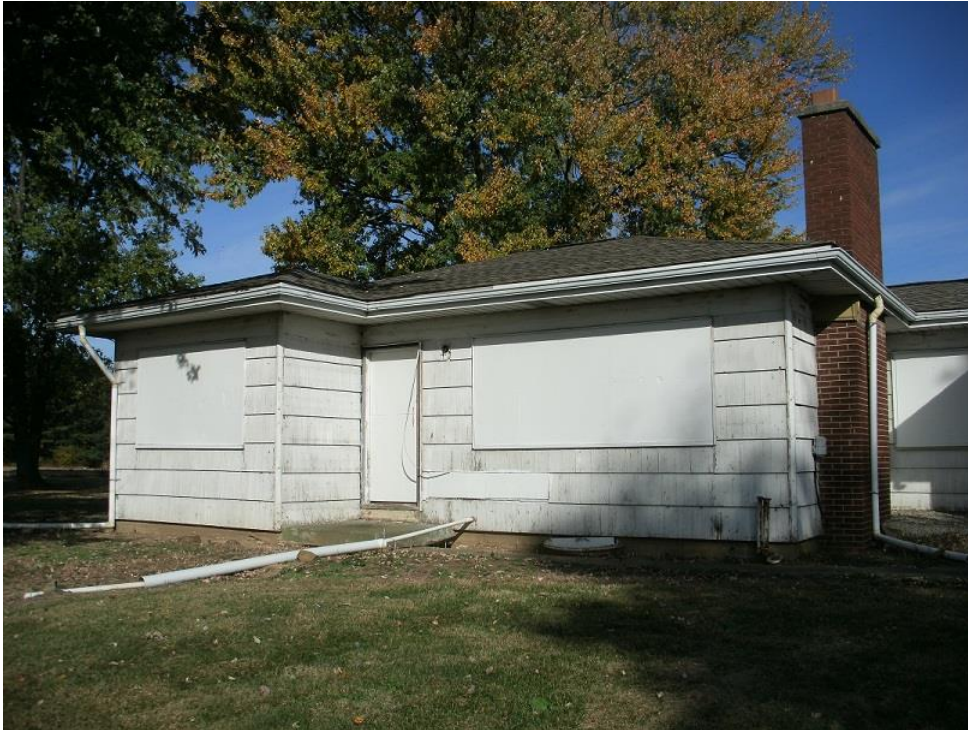
Slide  
C

This view of the front entry way of the structures shows the worn condition of the shingle siding and front door trim hanging loose.

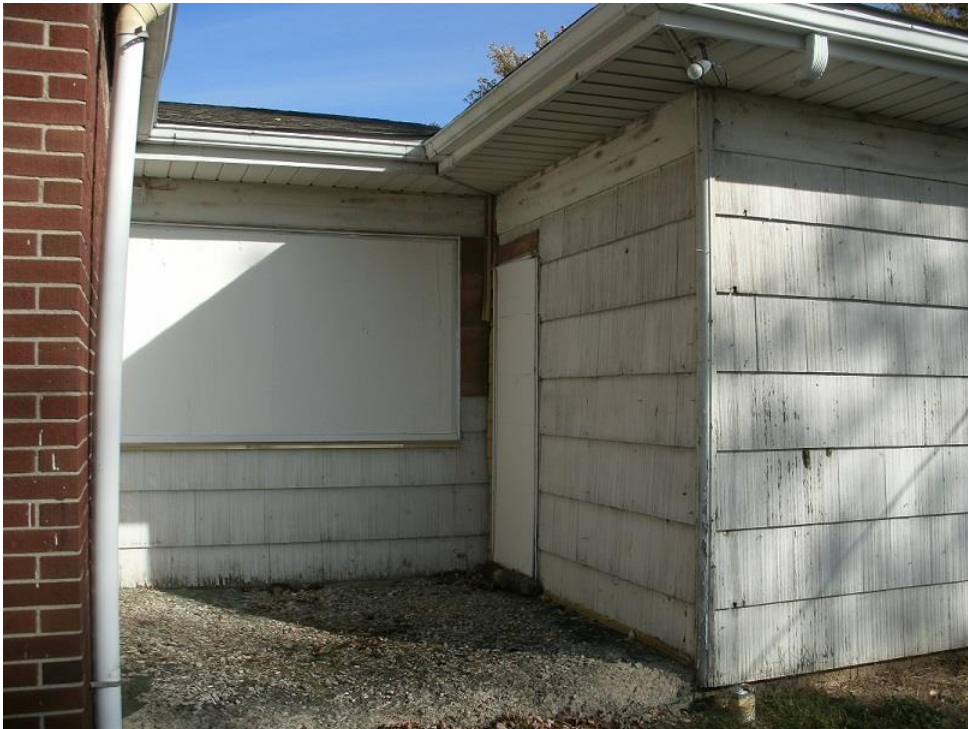
Slide  
D

This view just to the right of the Slide C image shows the poor condition of the paint along with damaged and missing shingles from the siding.

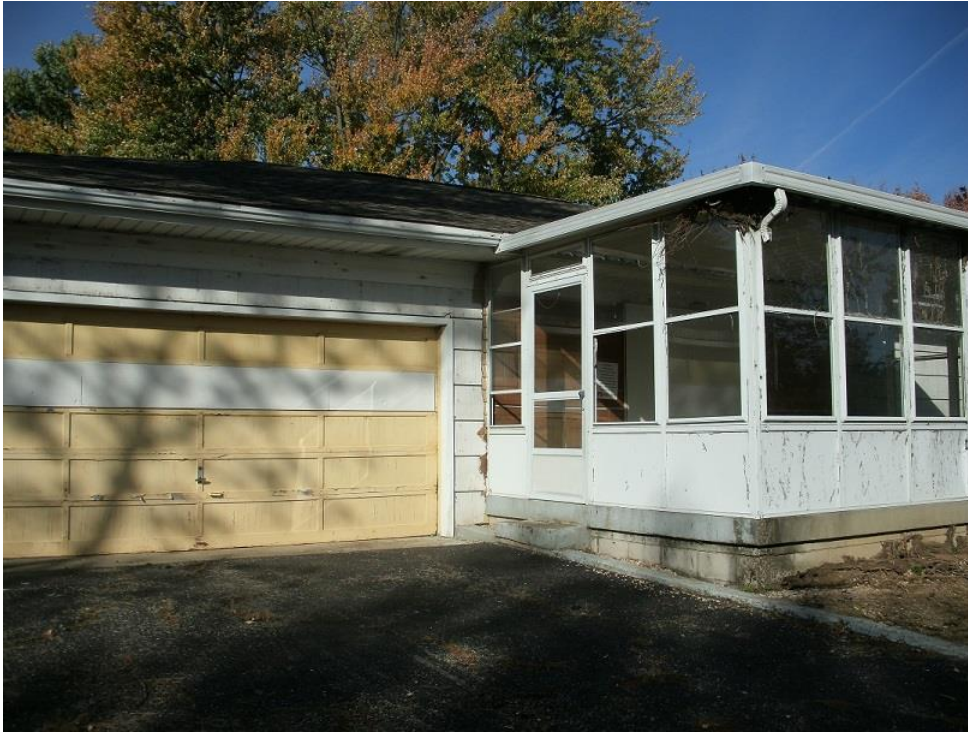
Slide  
E

This view shows the garage and sun porch area and the associated continued poor condition of the shingle siding along with peeling paint.

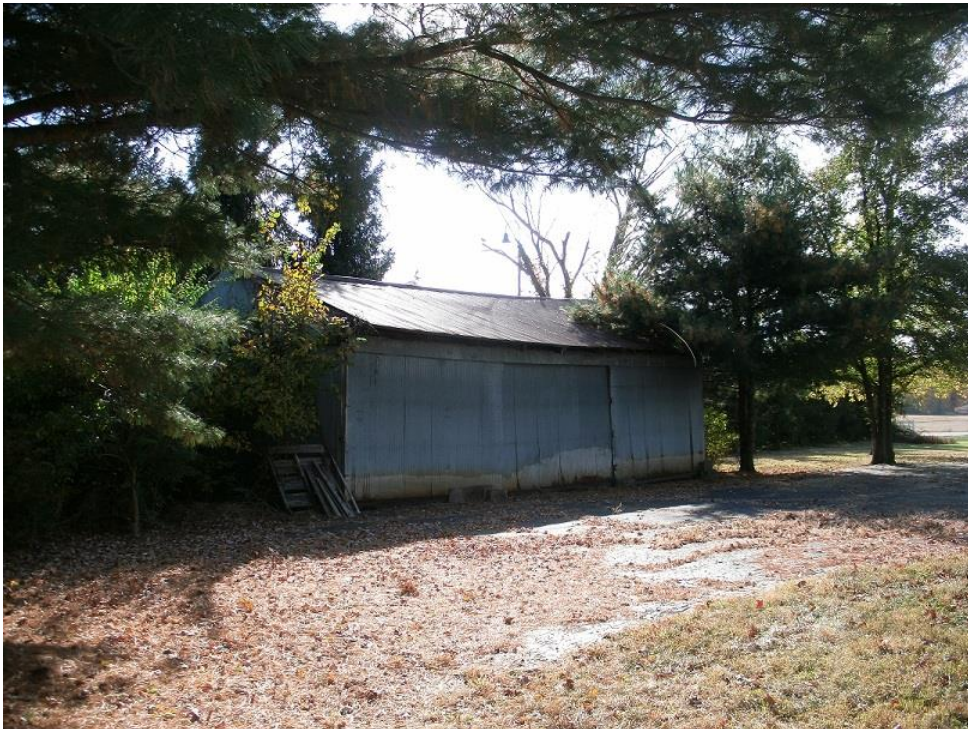
Slide  
F

This view shows the general poor condition of the out building along the eastern edge of the property.

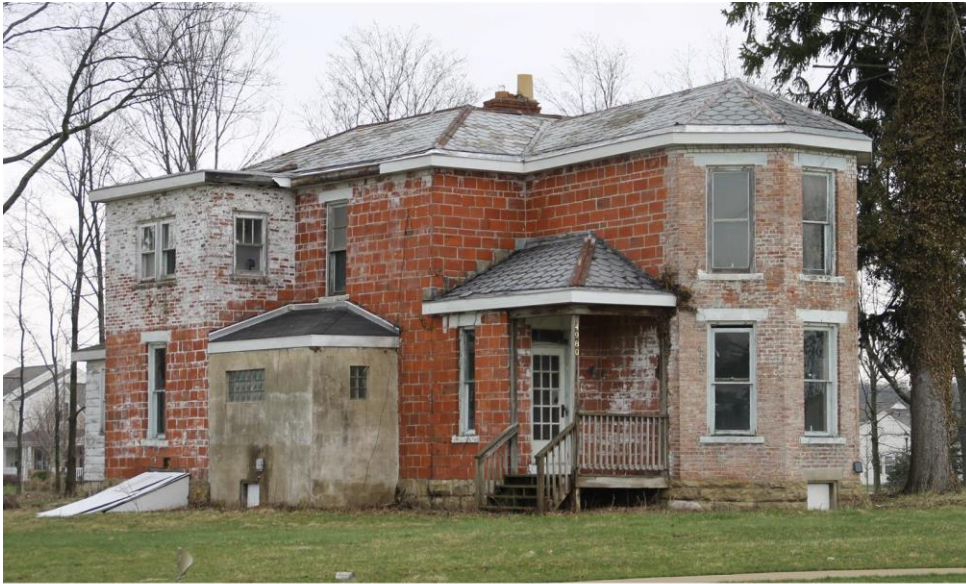
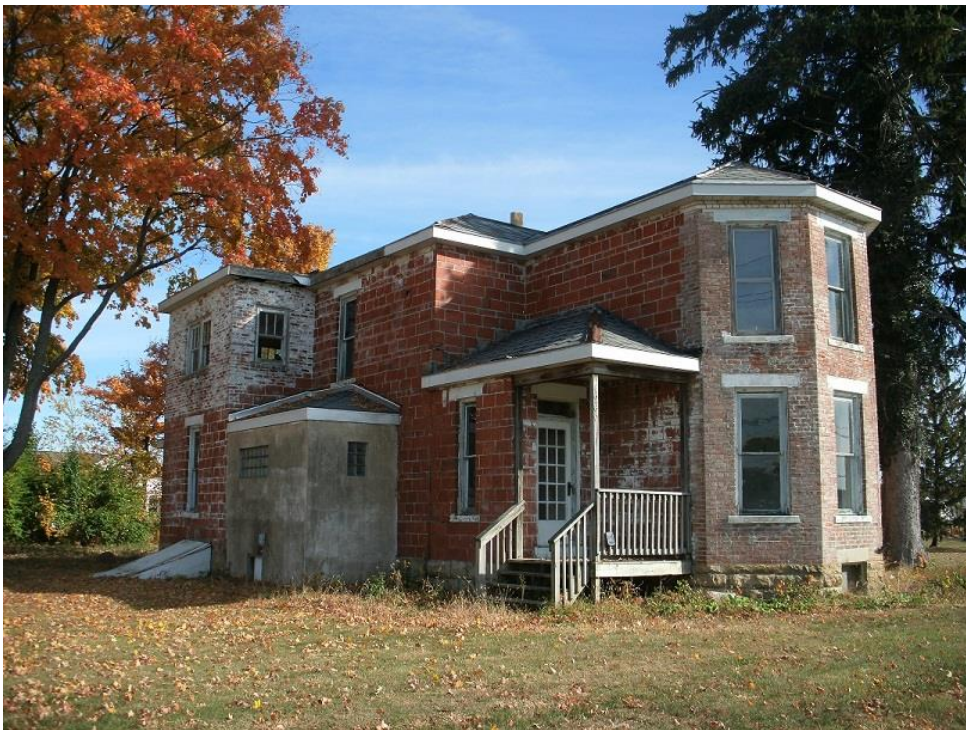
Slide  
A

This unit is showing signs of disinvestment by the poor condition of the gutters, peeling paint and an overall state of general disrepair. Year built: 1850.

Note the continued disinvestment that continues to have occurred between April 2014 and October 2015. The photograph at the top was taken by the Franklin County Auditor in April 2014; the photograph at the bottom was taken by the City in October 2015.

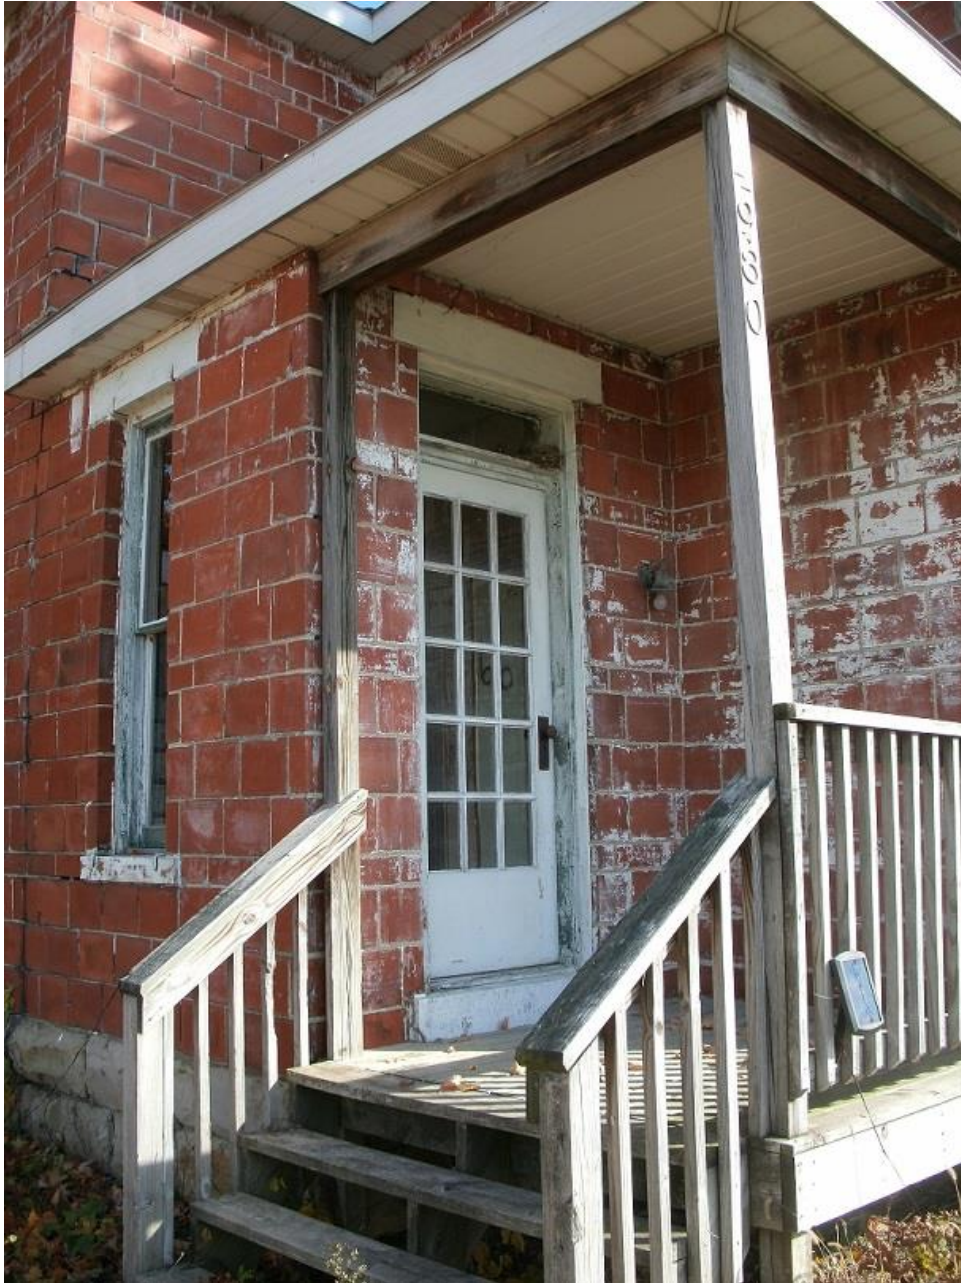
Slide  
C

Note the overall poor condition of the front steps, railing, door frame and window frame. Also note the bird nest in the transom window.

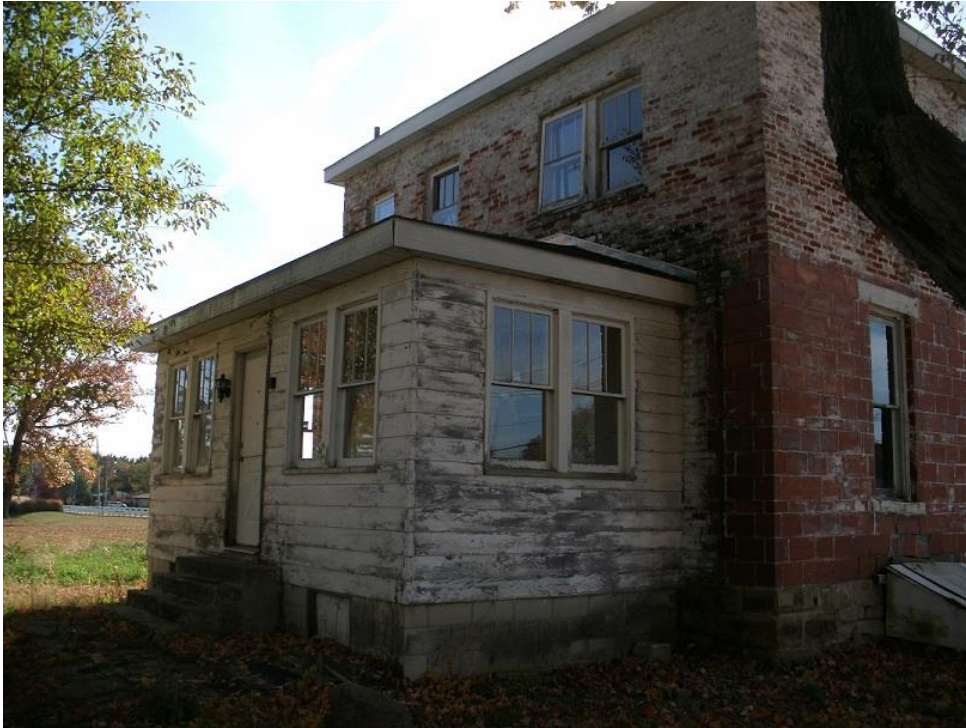
Slide  
D

This view shows the general poor condition of the rear of the structure. Note the poor condition of the paint and broken light fixture to the right of the door.

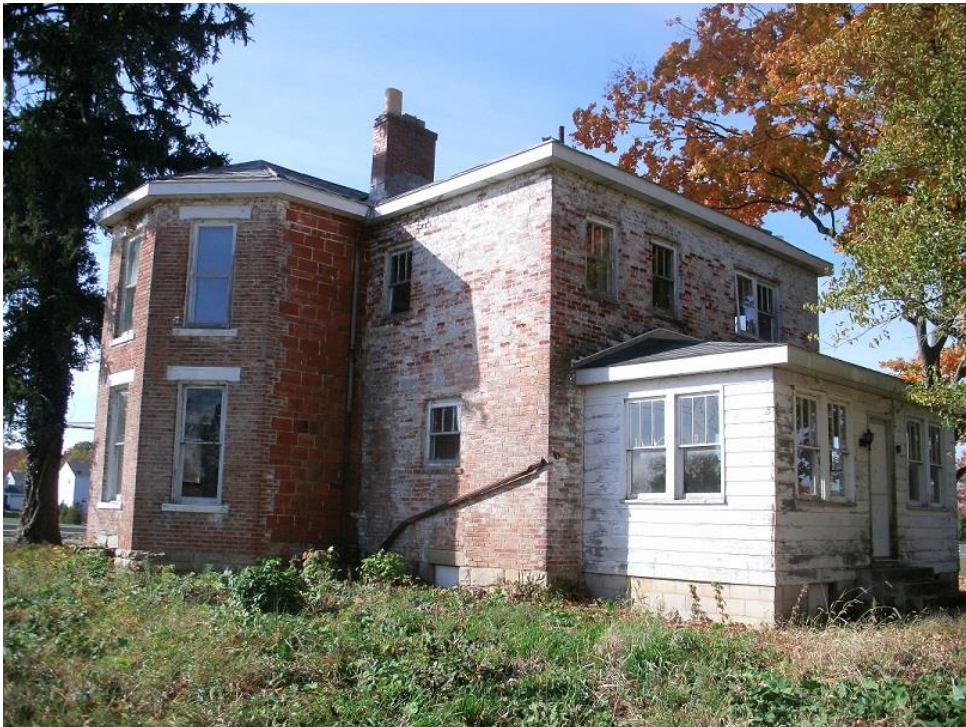
Slide  
E

This view again shows the rear of the structure. Note the loose, hanging downspout and overgrown landscaping.

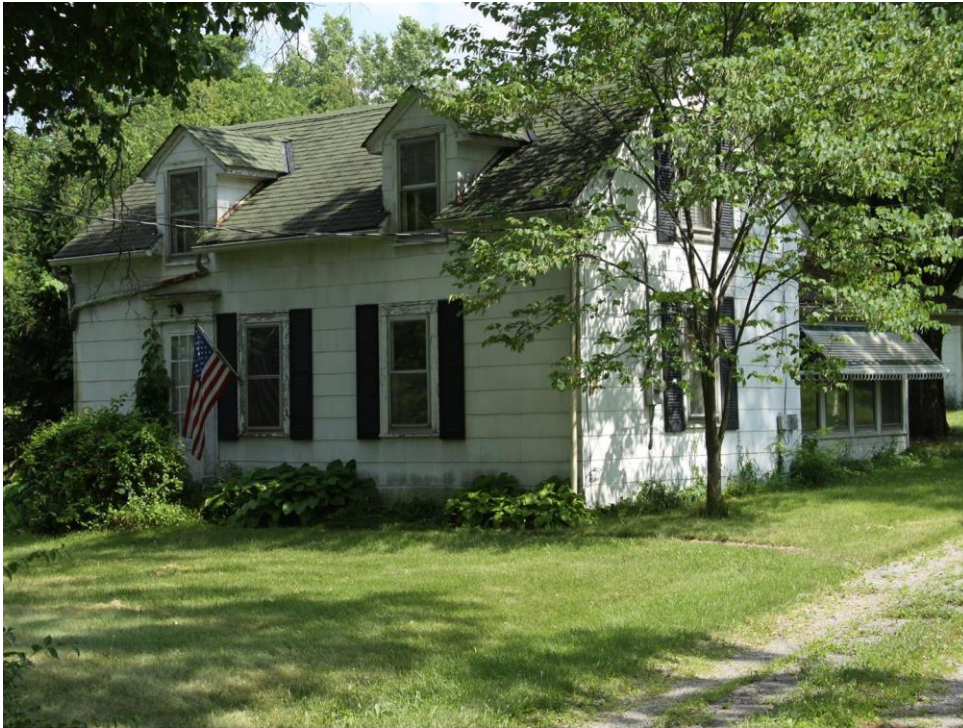
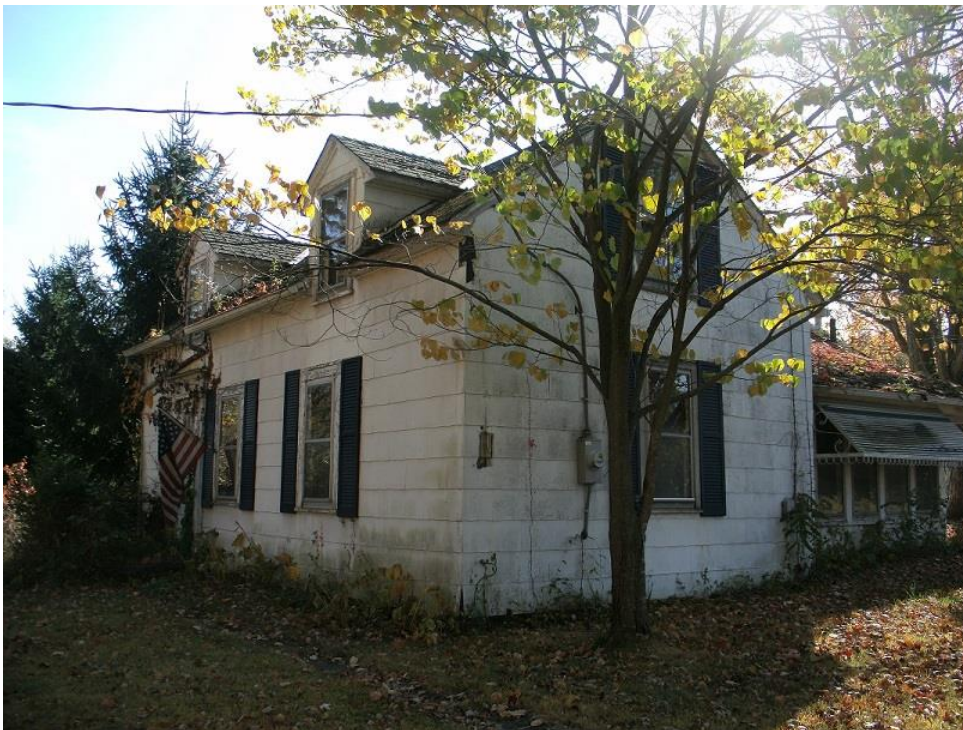
Slide  
A

This unit is showing signs of disinvestment by the poor condition of the roof, mildewed siding, overgrown/unkempt vegetation and peeling paint. Year built: 1930.

Note the disinvestment that has occurred between June 2010 and October 2015. The photograph at the top was taken by the Franklin County Auditor in June 2010; the photograph at the bottom was taken by the City in October 2015.

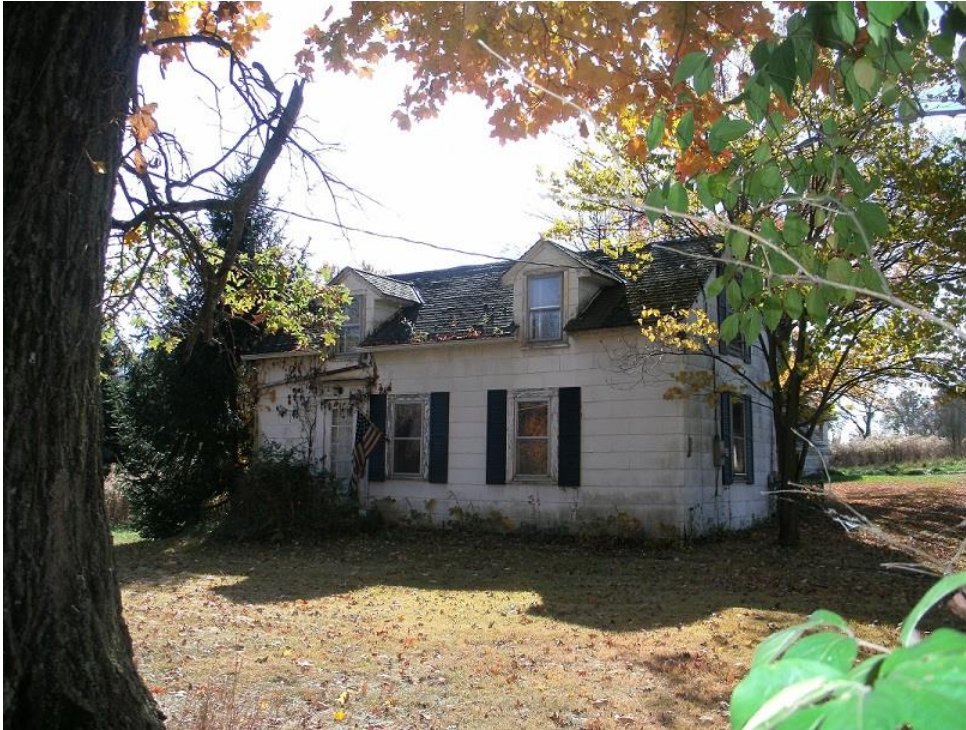
Slide  
C

This view of the front of the structure shows mildewed siding along the lower front right corner continuing to the side. Also note the overgrown vegetation at the front door.

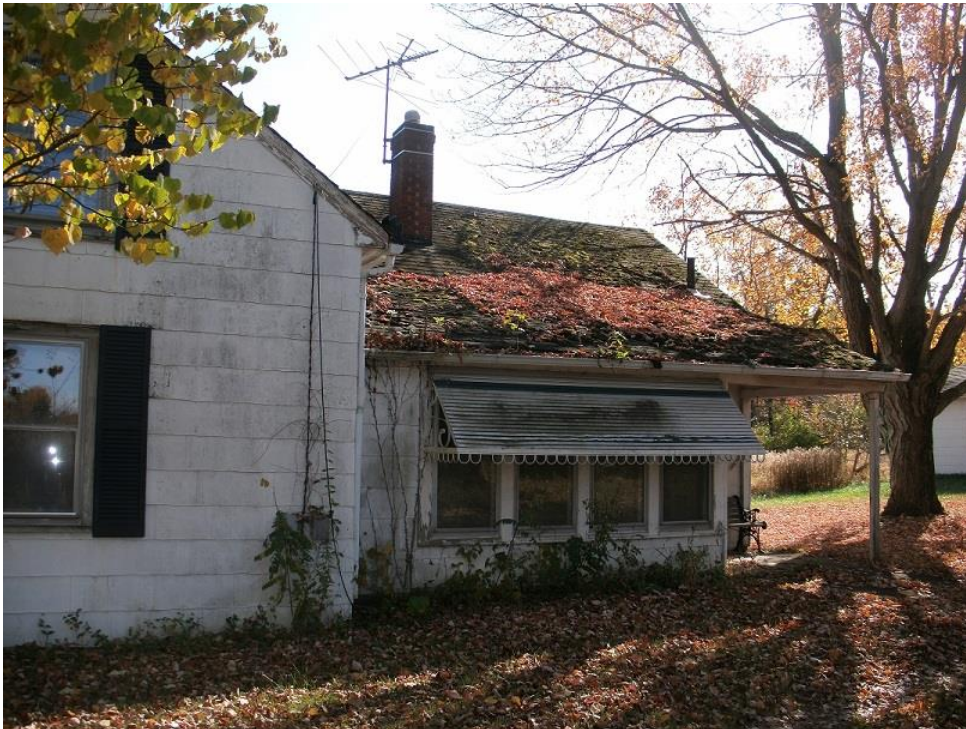
Slide  
D

This view shows the poor condition of the siding, roof and window awning. Also note the overgrown vegetation.

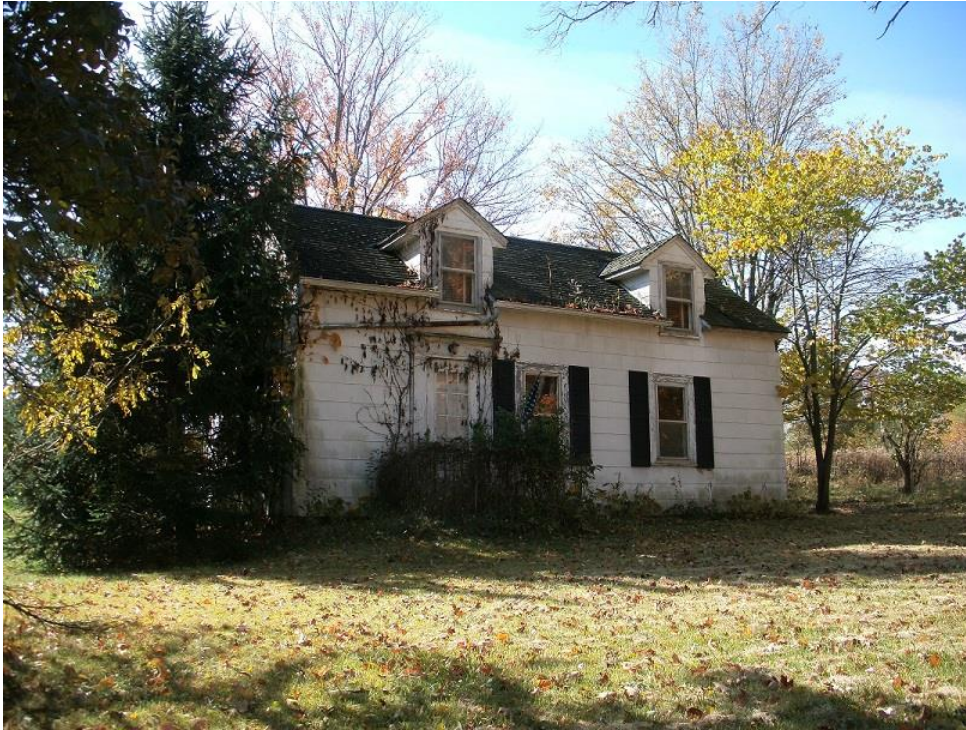
Slide  
E

This view again shows the front of the structure but from the opposite angle which provides additional evidence of disinvestment.

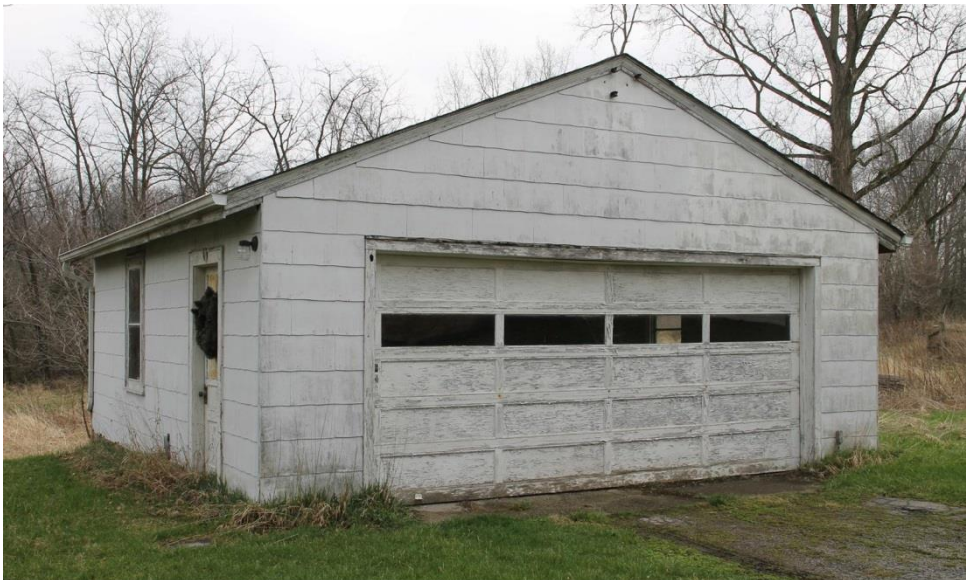
Slide  
F

This view shows the general poor condition of the garage highlighted by the deteriorated paint on the door, the door frame and the siding.

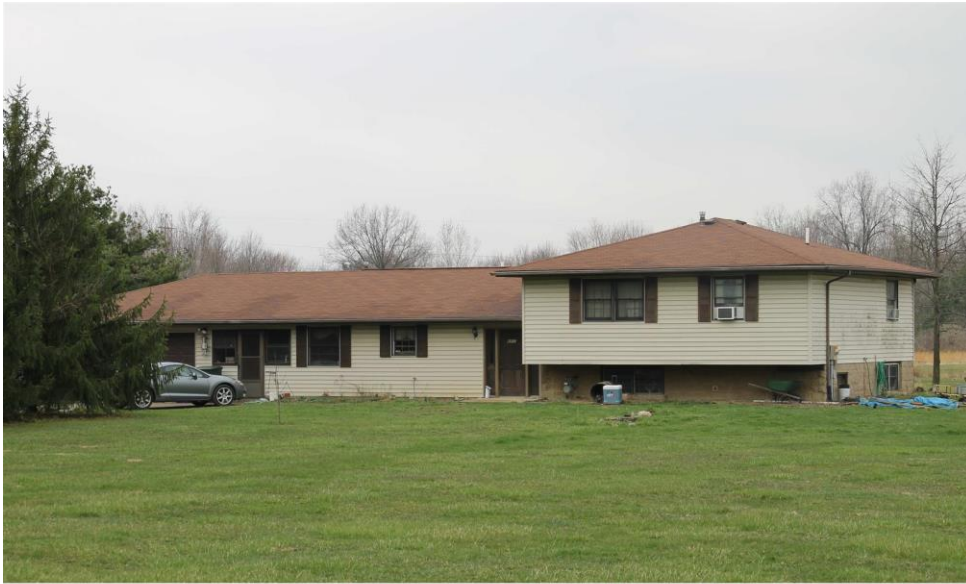
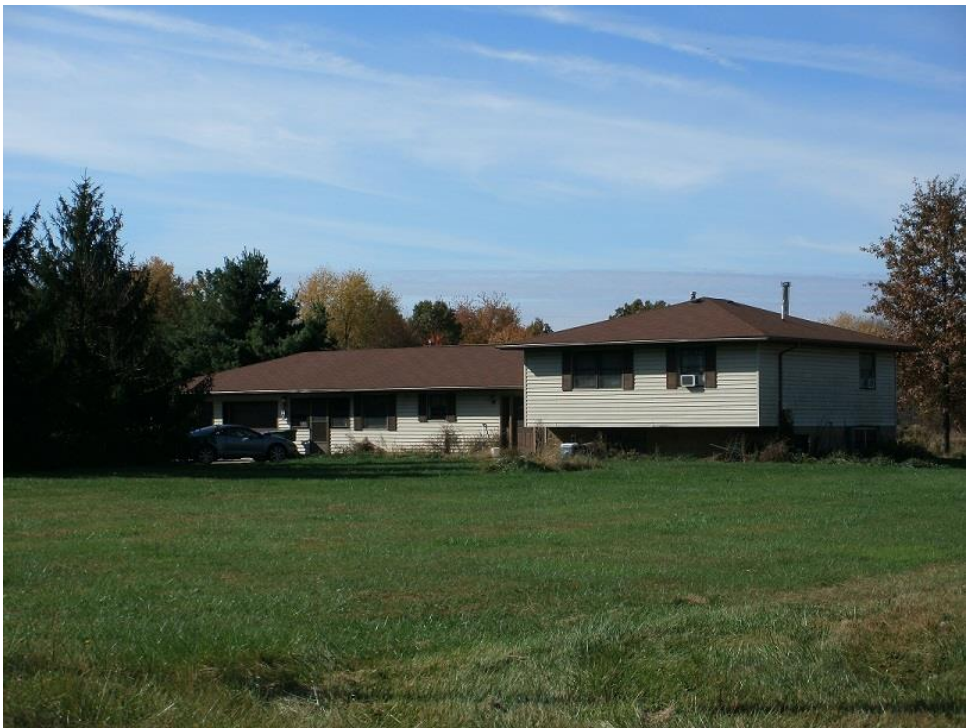
Slide  
A

This unit is showing signs of disinvestment by the general unkempt appearance, overgrown/unkempt vegetation and poor condition of the painted surfaces. Year built: 1984.

Note the disinvestment that has occurred between April 2014 and October 2015. The photograph at the top was taken by the Franklin County Auditor in April 2014; the photograph at the bottom was taken by the City in October 2015.

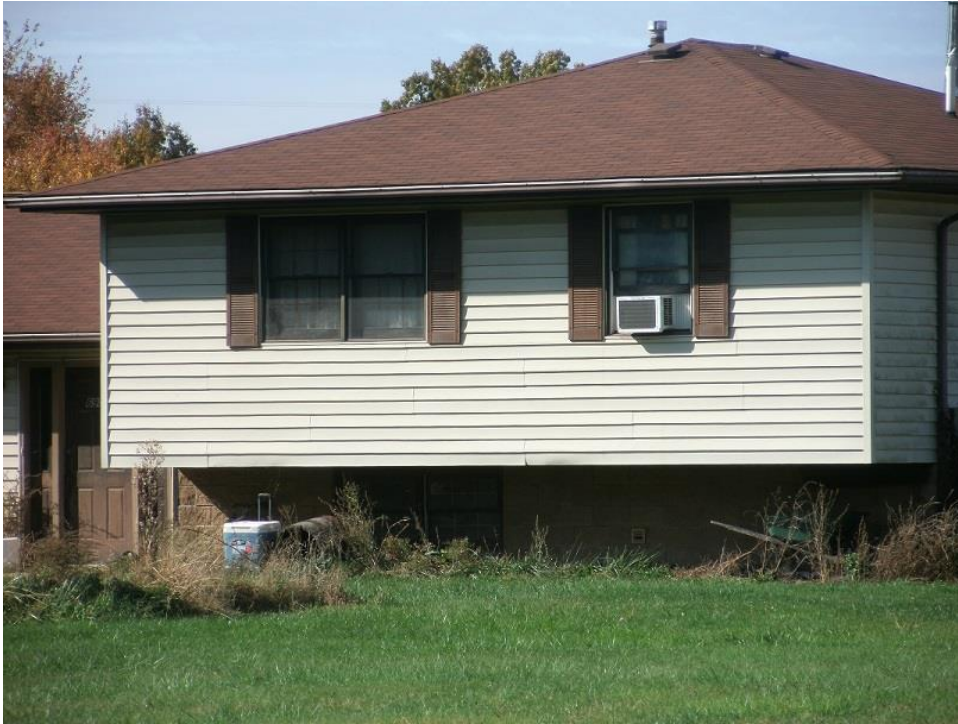
Slide  
C

Of particular note in this view is the overgrowth of vegetation up close to the foundation of the structure.

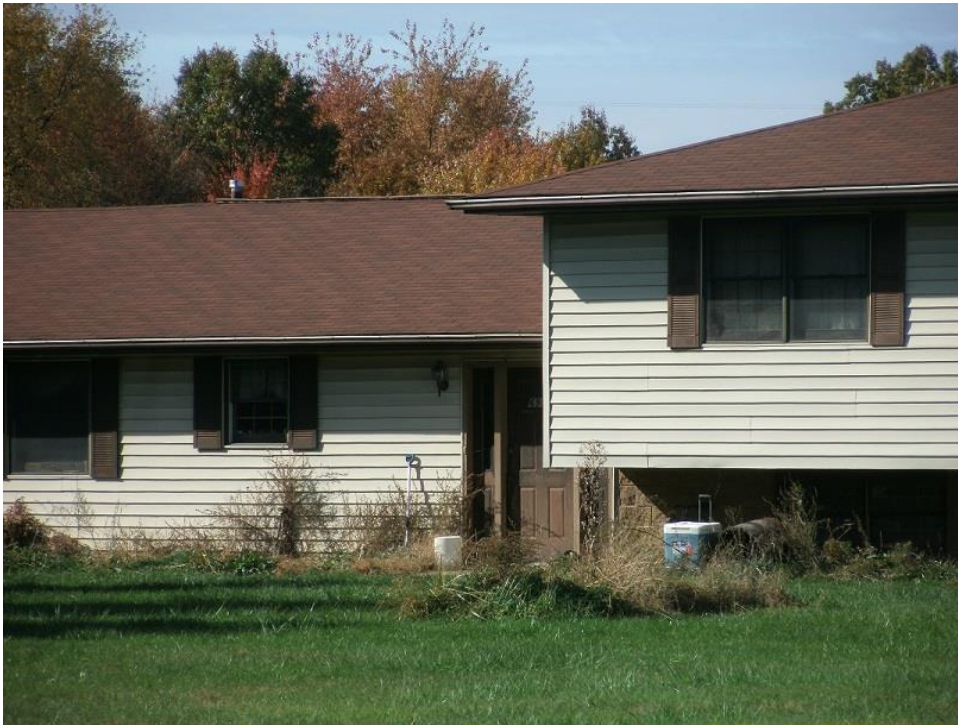
Slide  
D

This view shows the poor condition of the landscaping and general clutter surrounding the structure.

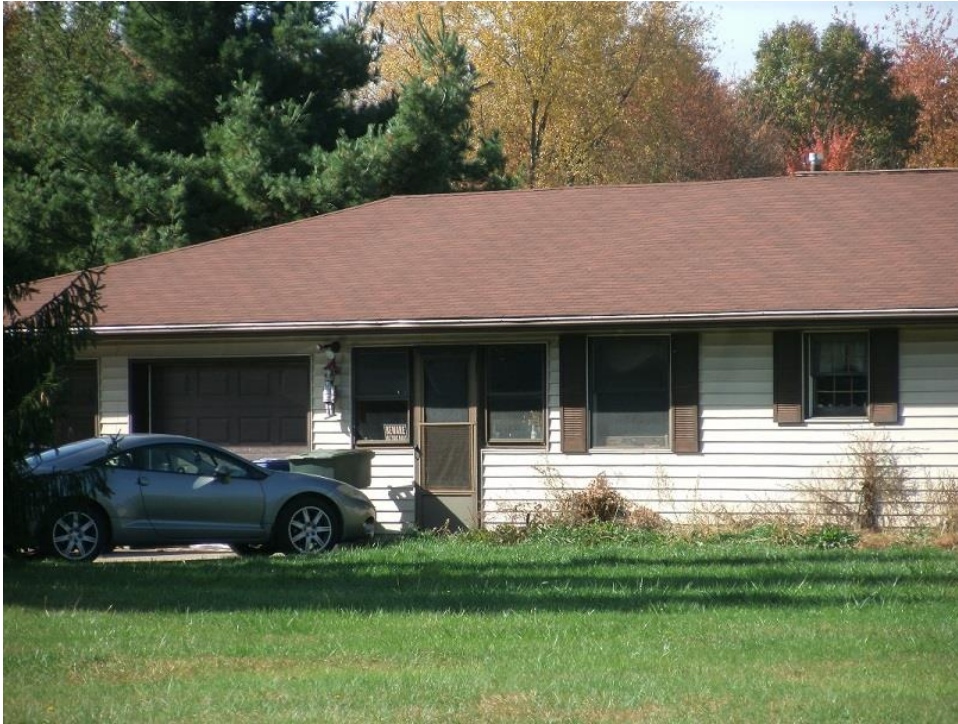
Slide  
E

This view continues to illustrate disinvestment of the property through general clutter and overgrown vegetation.

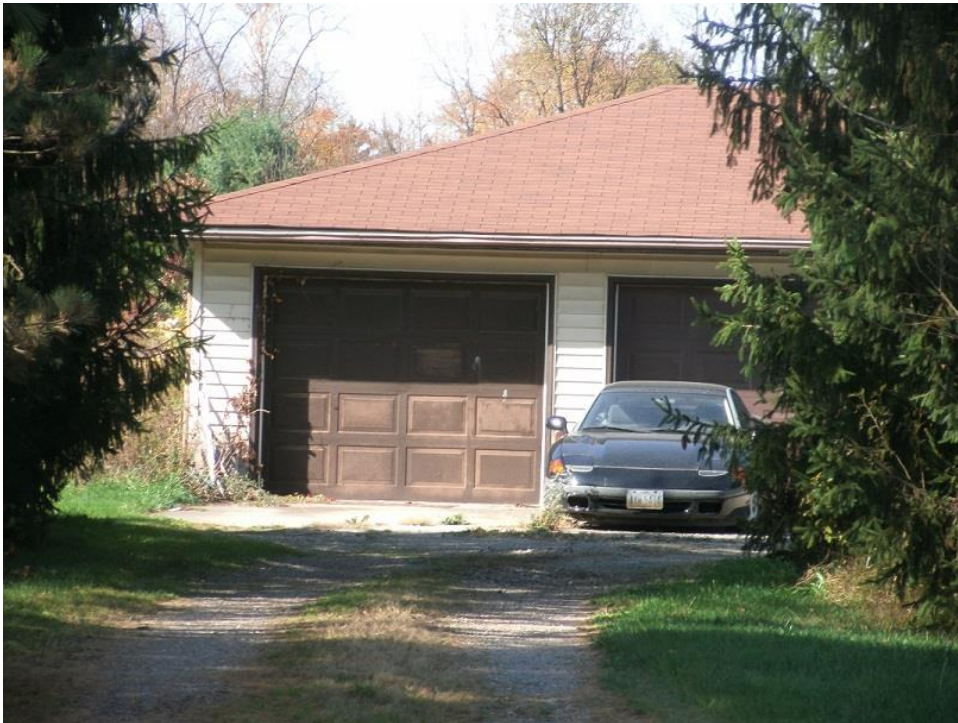
Slide  
F

This view of the garage portion of the structure shows the poor condition of the garage doors, unkempt vegetation and an apparent abandoned automobile.
