EXHIBIT B: HOUSING SURVEY, OLD STATE ROAD C.R.A.

Parcel 31834301069000, 142 Lazelle Road

Parcels 31834301066000/318343065000, 10209 Arnold Place (Lots 48 and 51)

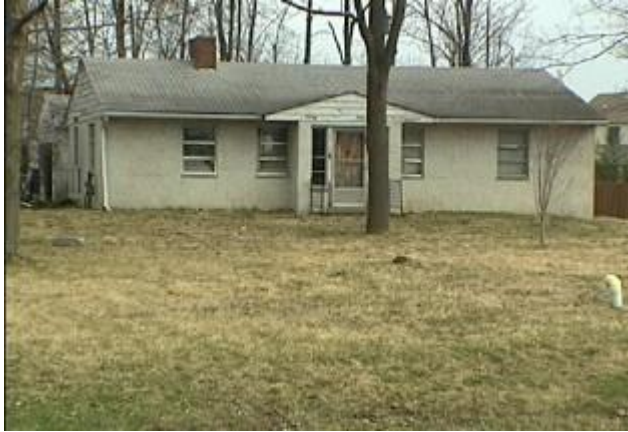
Slide A

This angle provides a good overall view of the front of the structure.

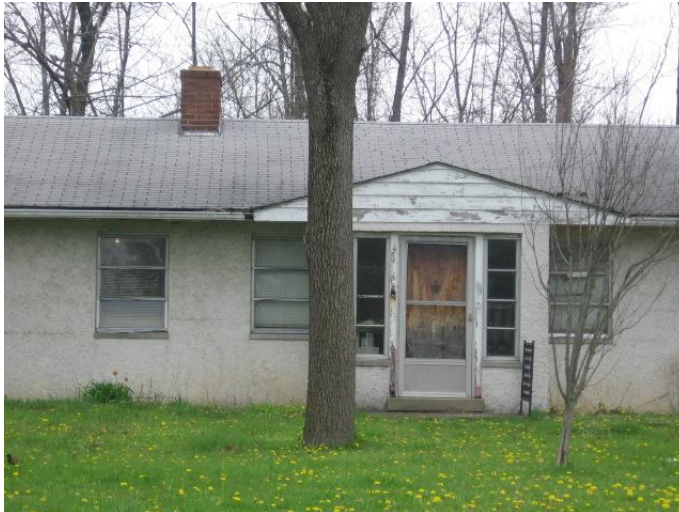
Slide B

This close-up view of the front entry. Note the peeling paint over the doorway and the apparent worn and weathered condition of the front door.

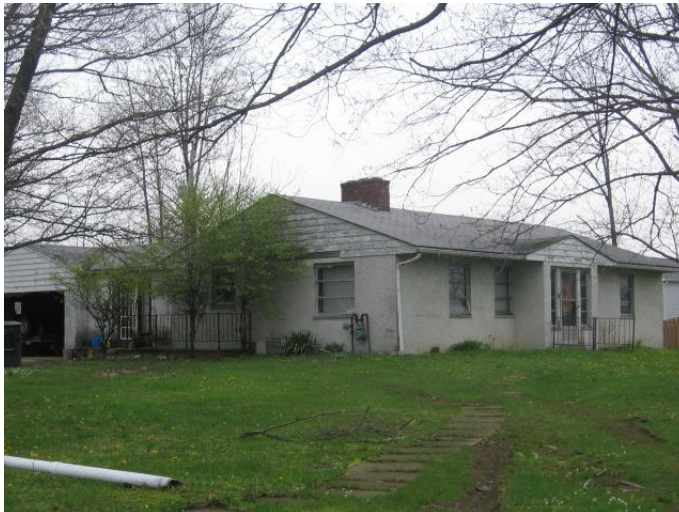
Slide C

This view from a left front angle provides an overview of the condition of the dwelling. Note the missing section of wood lathing over the window at the end of the structure.

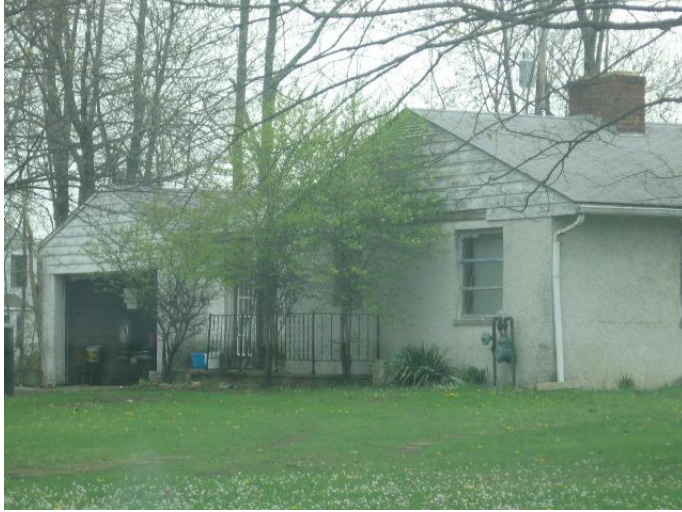
Slide D

This angle is a close-up view of the end of the structure showing in greater detail the condition of the wood lathing. Also note the tree growing very near to the structure.

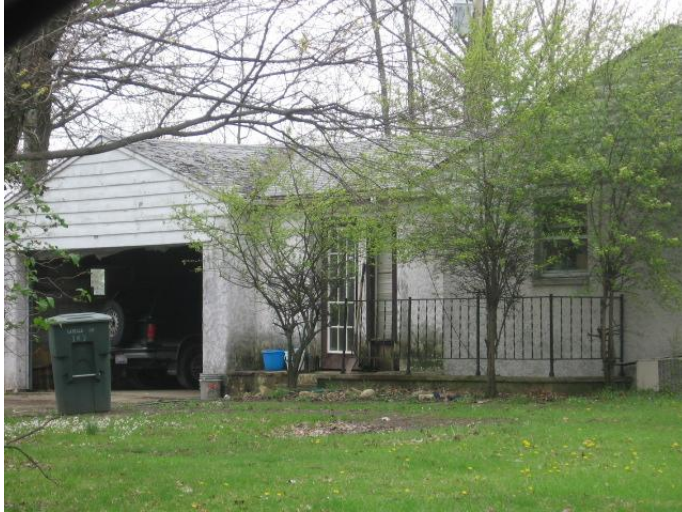
Slide E

This close up shot shows what appears to be mildewed concrete or stucco at a side porch entry way. Also note the debris in the yard.

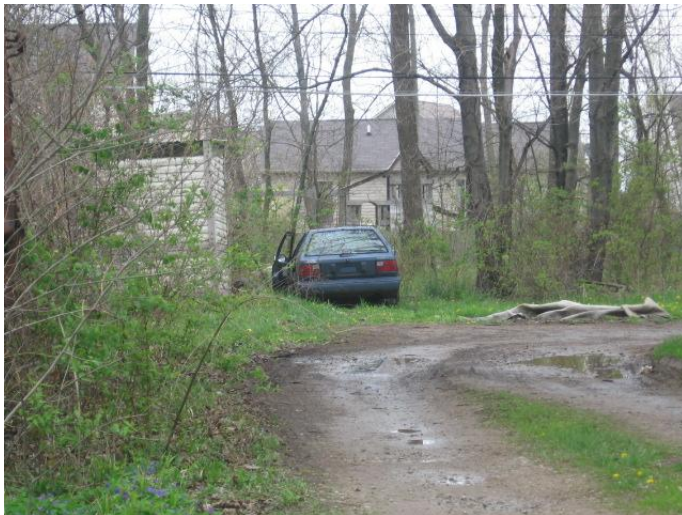
Slide F

This shot provides a close-up view of the side yard. The vehicle in the photograph appears to be dilapidated and inoperable. Note the poor condition of the driveway.

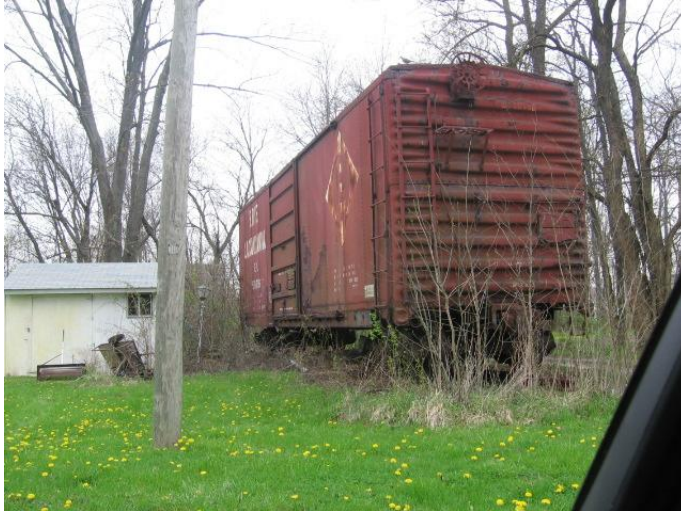
Slide G

There is an old railroad boxcar along the western edge of the property

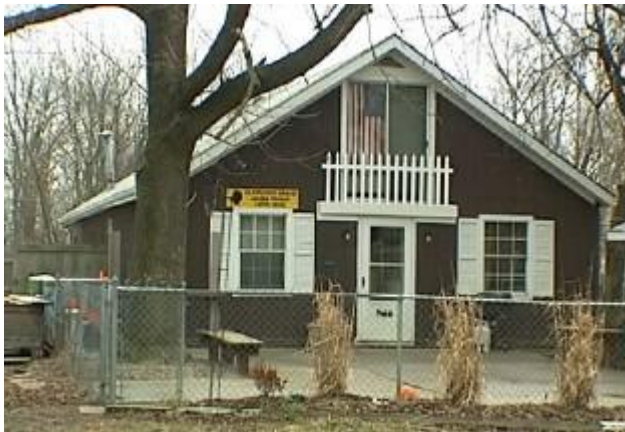
Slide A

This angle provides a good overall view of the front of the structure. Note the general unkempt condition of the front yard area.

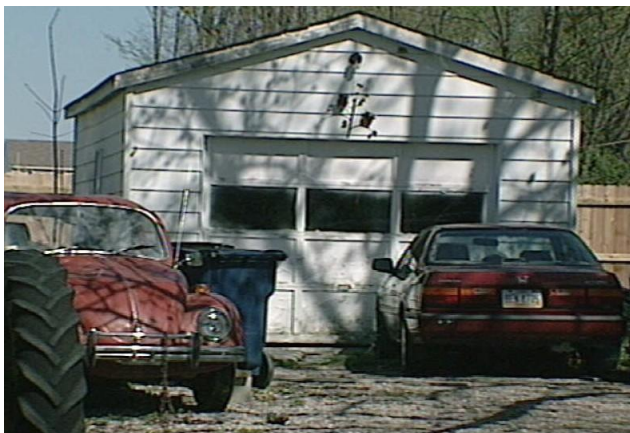
Slide B

This photograph provides a close view of the garage area of the dwelling. Note the peeling and poor condition of the paint on the garage door and the various vehicles cluttering an area between the garage and the street.
