## **EXHIBIT B: HOUSING SURVEY, RICKENBACKER C.R.A.**

On May 4, 2007, a housing survey was conducted by the City of Columbus Department of Development/Economic Division in the area to be designated as the Rickenbacker CRA. The residential structures surveyed in this area were constructed primarily between the 1960s to the early 1970s except for those housing structures related that could be described as farm houses and were all likely constructed prior to 1950. Due to the age of the housing, and some neglect, many properties are showing visible signs of deterioration or disrepair in one or more of the following areas: roofs, siding, doorways, windows, garage doors, gutters, trees/landscape.

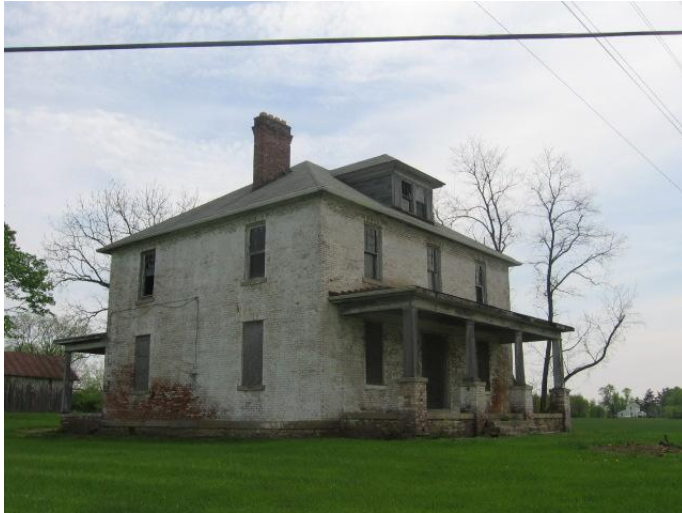
Slide B

This unit is showing signs of disinvestment by broken window panes, loose brick work with missing mortar, worn and peeling paint, boarded-up windows, and broken up concrete steps.

This view from a left front angle provides an overview of the condition of the dwelling. Note the broken window pane in the dormer and the loose brick on the side of the structure.

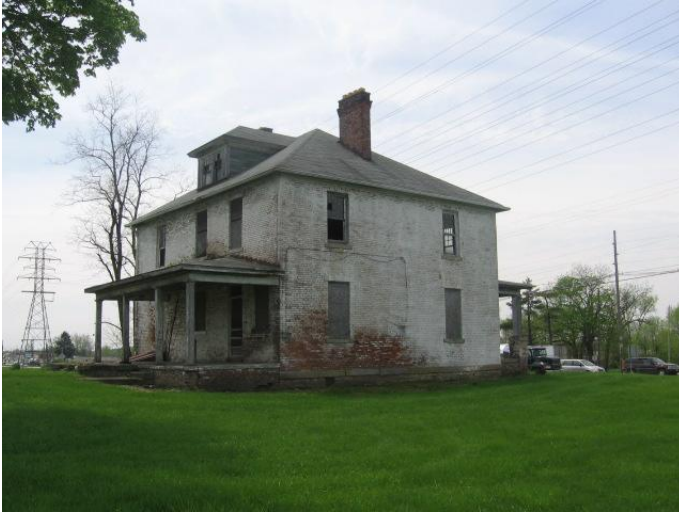
Slide C

This view of the structure shows the same side of the dwelling from the rear.

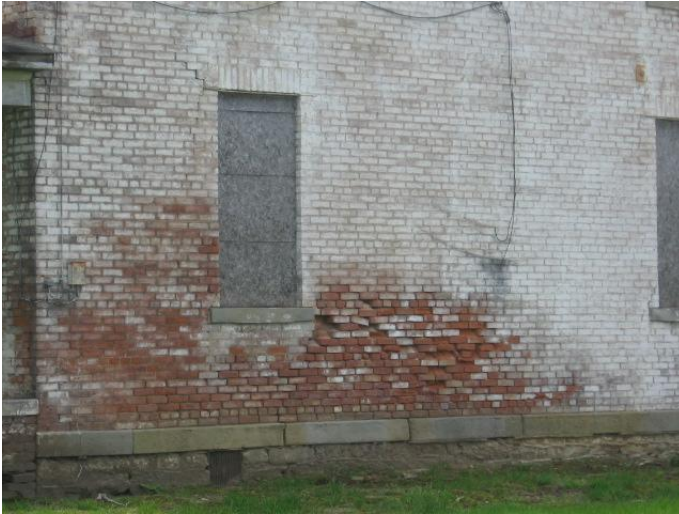
Slide D

This close up shot shows loose brickwork – note the lack of mortar, the worn paint, and the boarded-up window.

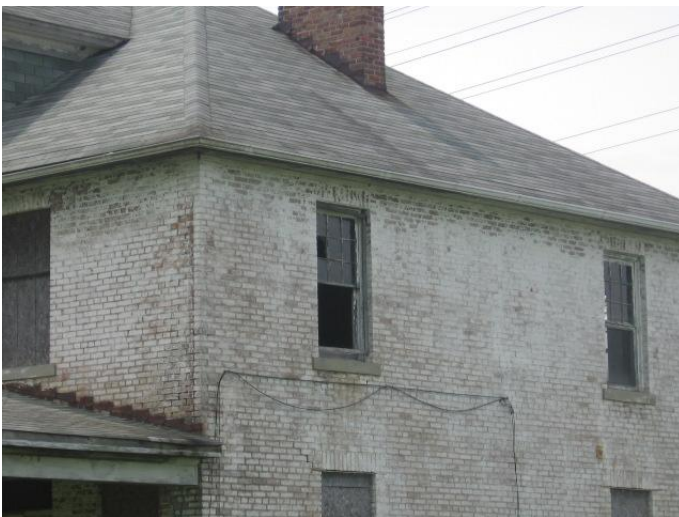
Slide E

This shot provides a closer view of the side of the structure just above from where the previous photograph was taken. Note the worn paint and the broken window pane.

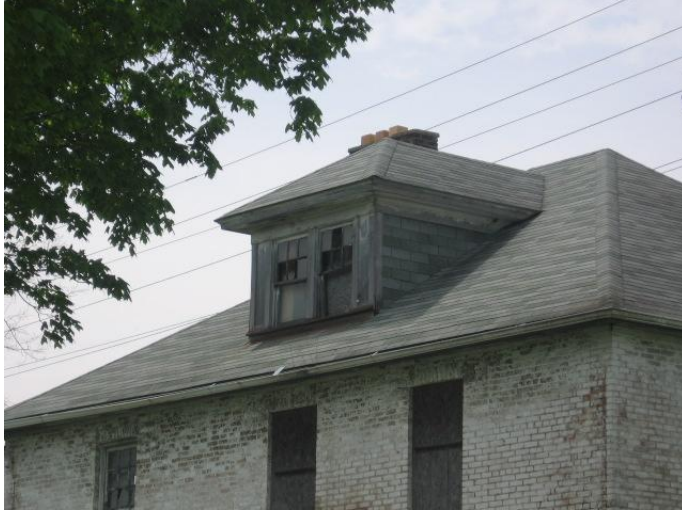
Slide F

This angle shows the dormer on the rear facing slope of the roof. Note the broken window panes in the dormer.

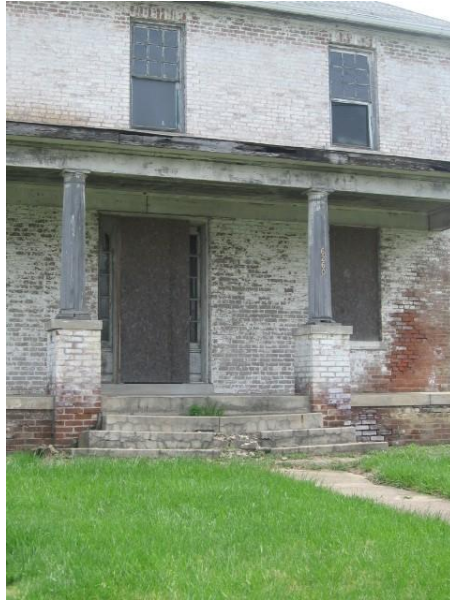
Slide G

This photograph shows the front porch area of the structure. Note the worn paint and the broken up concrete steps.

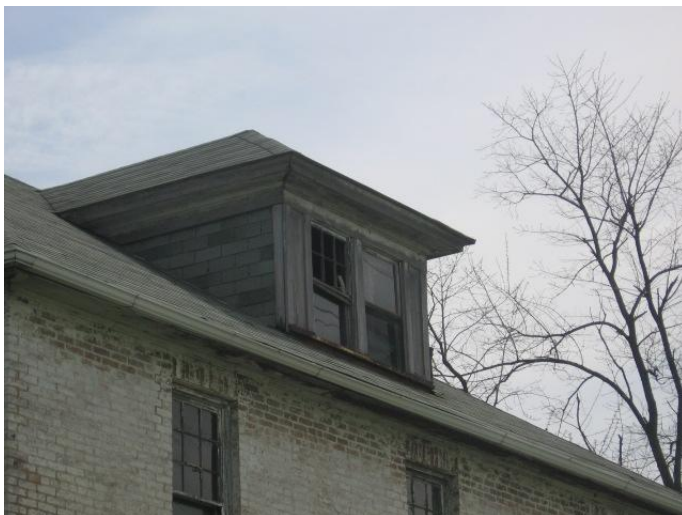
Slide H

This angle shows the dormer on the front facing slope of the roof. Note the broken window panes in the dormer.

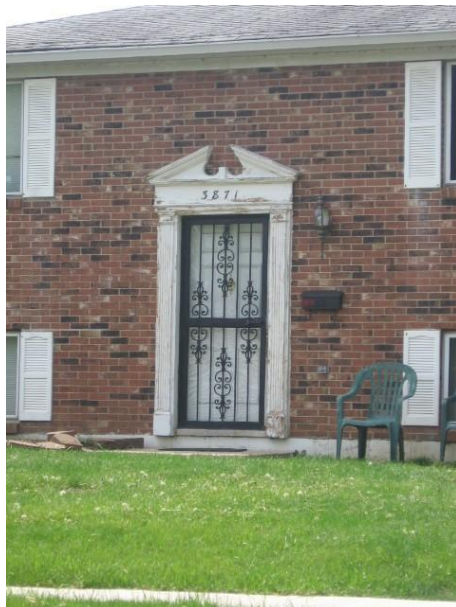
Slide B

This unit is showing signs of disinvestment by peeling paint and the apparent poor condition of the roof.

This photograph highlights the front entrance to the structure. Note the peeled paint on the woodwork surrounding the front door.

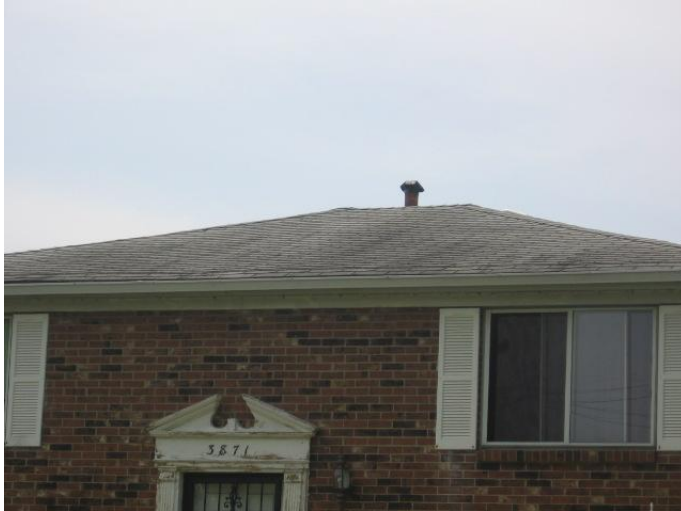
Slide C

This angle highlights the front-facing slope of the roof. Note the apparent poor condition of the roof as well as again the peeled paint on the woodwork surrounding the front door.

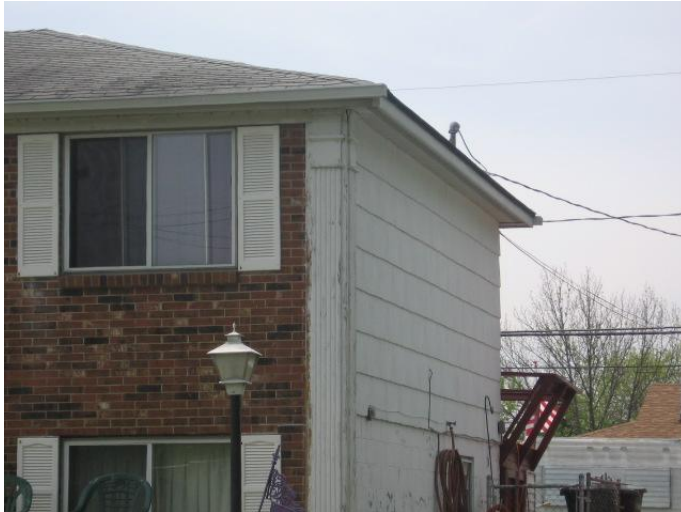
Slide D

This angle of the structure highlights the right front corner section. Note the peeling paint.

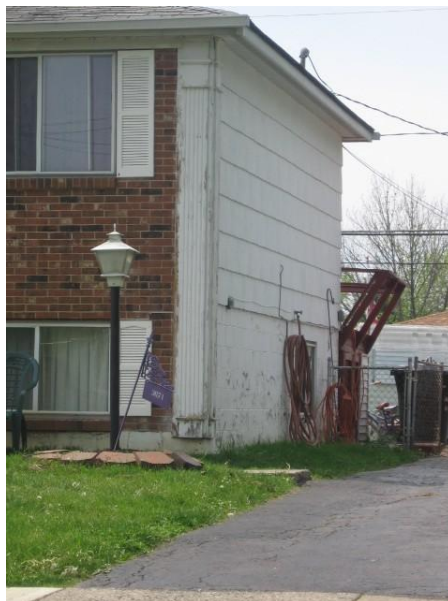
Slide E

This photograph is similar to the one above but offers a view from a slightly further distance. In addition to the peeling paint on the corner of the structure, note the peeling paint on the brickwork on the lower half of the side wall.

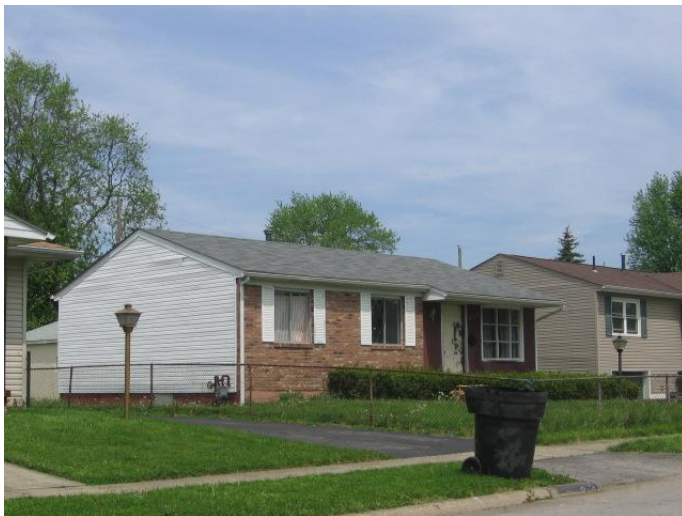
Slide B

This unit is showing signs of disinvestment by warped siding on the side of the structure, peeling paint, crookedly hanging mailbox, poor condition of the driveway, cracked sidewalk, and the general unkempt length of the grass as compared to the neighboring units.

This view from a left front angle provides an overview of the condition of the dwelling. Note the warping of the siding on the side of the structure and the length of the grass as compared to the neighbor to the left.

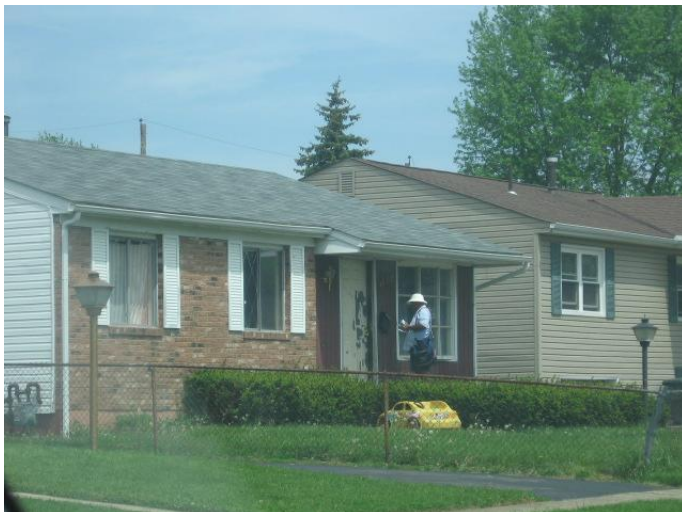
Slide C

This photograph provides a closer view from a similar angle.

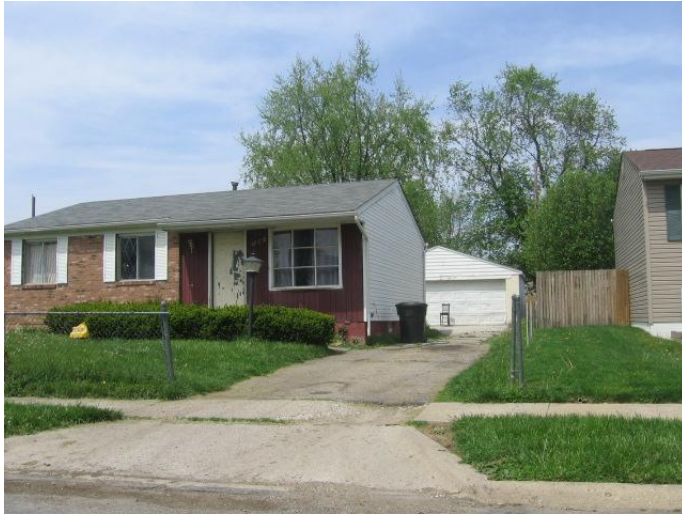
Slide D

This is view of the structure from a left-front angle. Note that the driveway appears to be in poor condition and the sidewalk to be cracked.

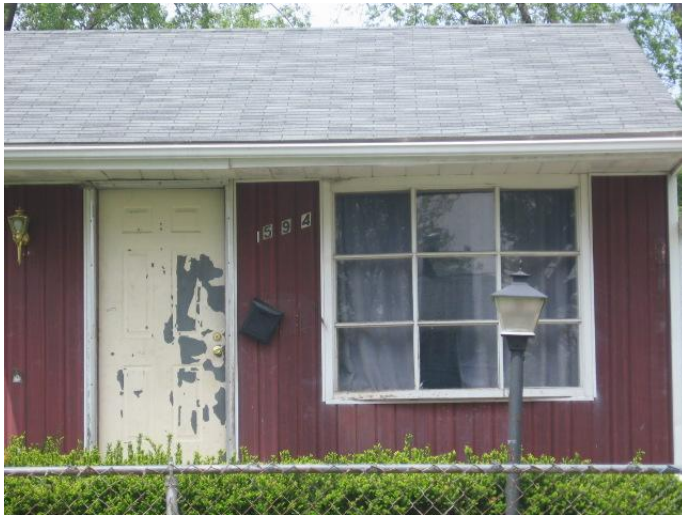
Slide E

This is a close-up view of the front of the dwelling. Note the peeling paint on the front door and the mailbox hanging crookedly at an angle.

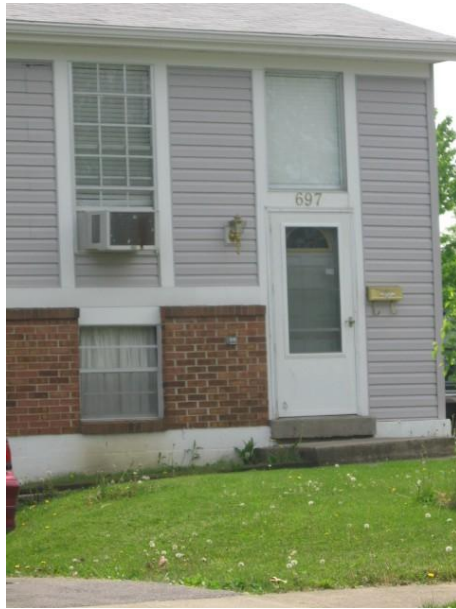
Slide B

This unit is showing signs of disinvestment by visible staining on the foundation, rusted garage door and peeling paint.

This photograph provides a closer view of the right front of the dwelling. Note the stains on the foundation underneath the lower level window.

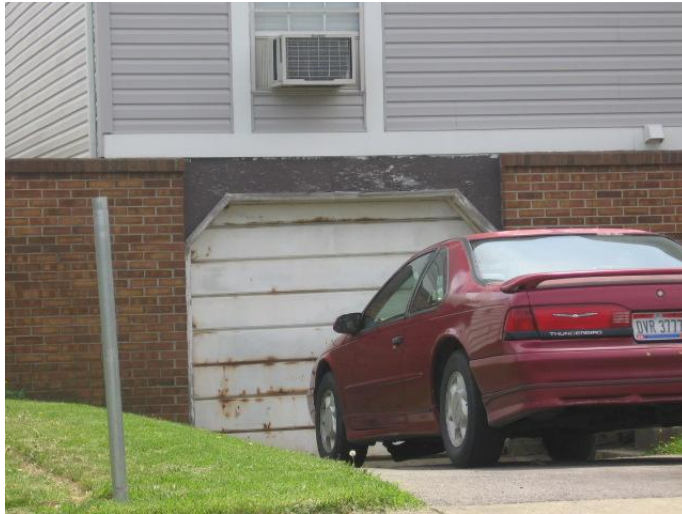
Slide C

This photograph provides a closer view of the garage area of the dwelling. Note the rusted garage door and the peeling paint on the top of the door frame.

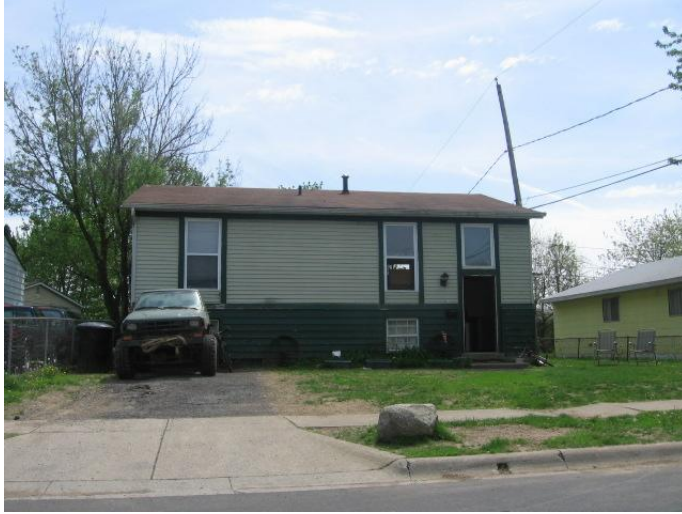
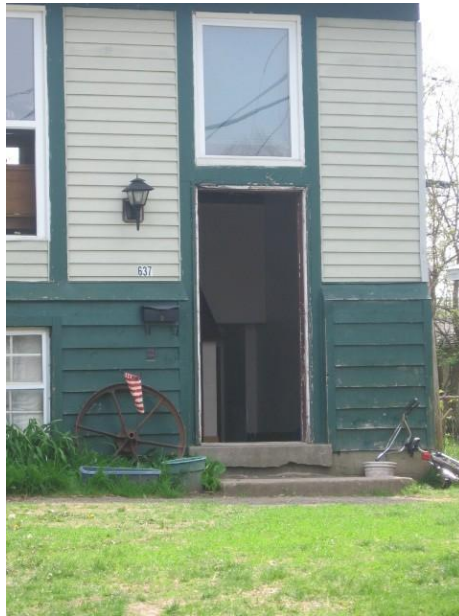
This unit is showing signs of disinvestment by visibly peeling paint, the absence of a front storm door, a chipped front concrete step, the poor condition of the driveway, and a vehicle in the driveway that appears to be dilapidated and inoperable.

The photograph above provides an overview of the condition of the dwelling. The vehicle in the driveway appears to be dilapidated and inoperable. Note the poor condition of the driveway. This photograph to the left provides a closer view of the entryway to the house. Note the absence of storm door, the peeling paint, and the chipped front step.
