Columbus Housing Community Reinvestment Area (CHCRA): Housing Survey

Between August and October 2023, a surveillance survey was conducted in the area to be known as the Columbus Housing Community Reinvestment Area (CHCRA). The purpose of the survey was to determine the location of housing units that appeared to be in need of repair or upgrading, vacant lots in need of redevelopment and the severity of structures that appeared to be in need of repair, and/or needing to be removed.

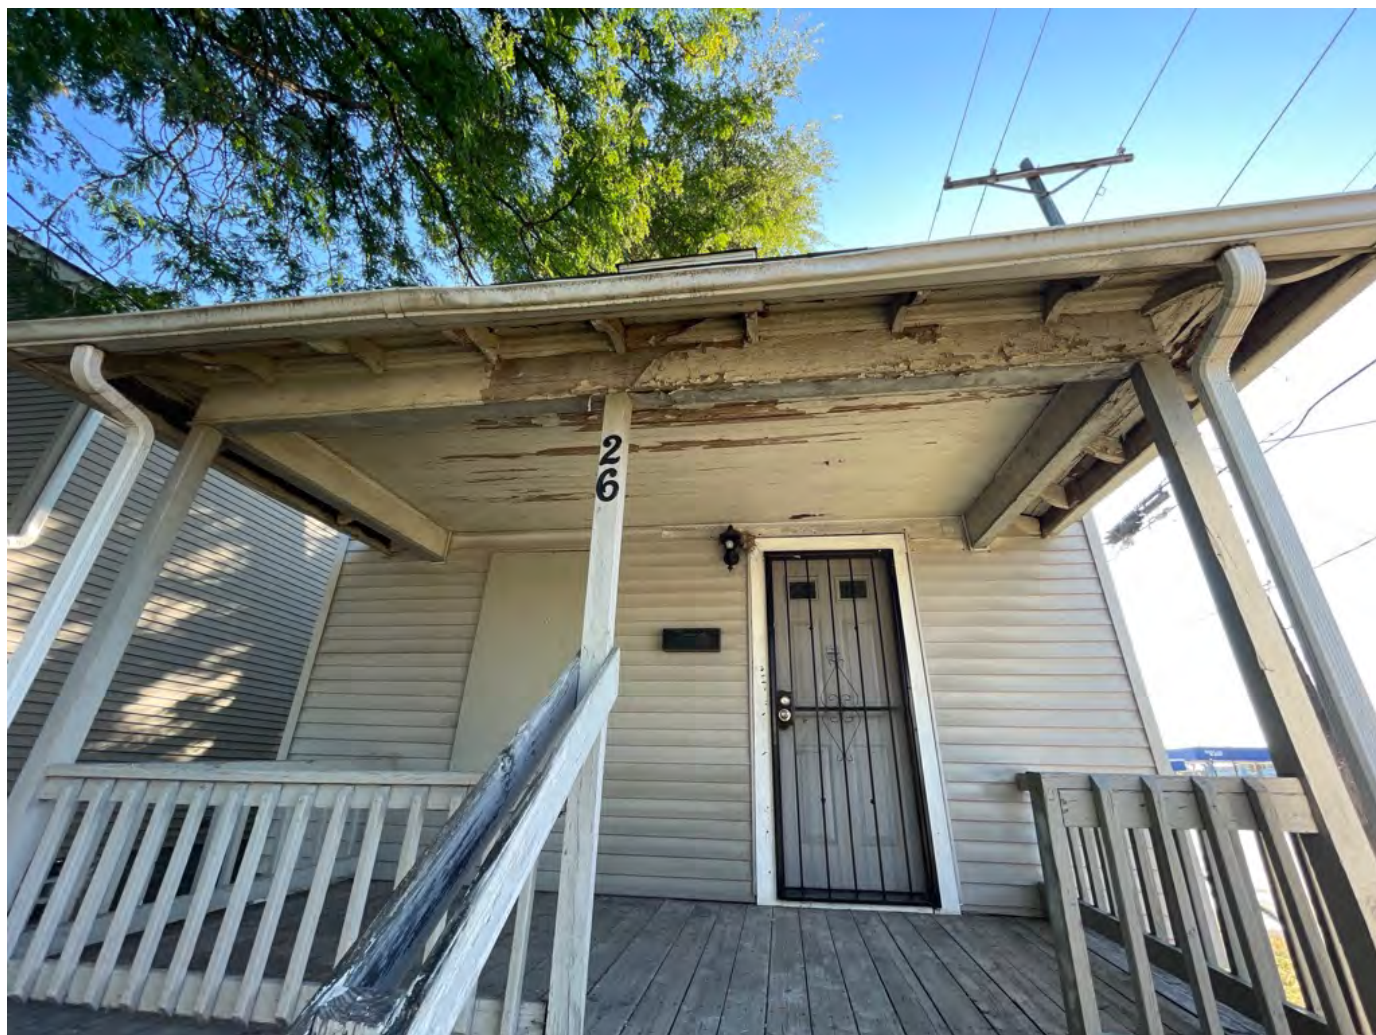
(3)

Vacant structure not boarded to code. Soffits detaching, damaged and/or otherwise in a state of disrepair. Bare, exposed wood surfaces.

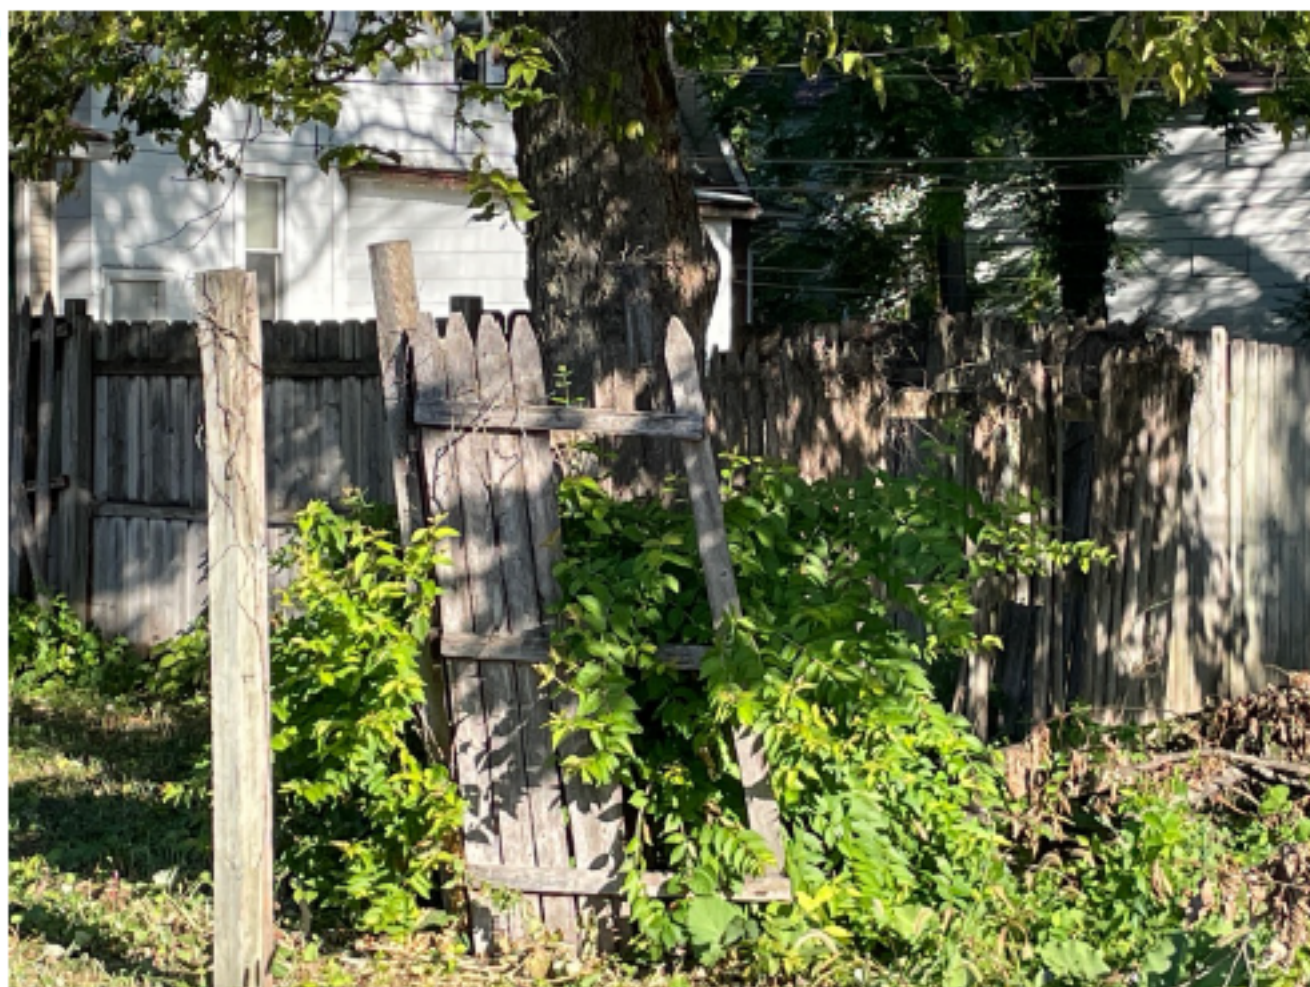
(6)

Fence in disrepair.

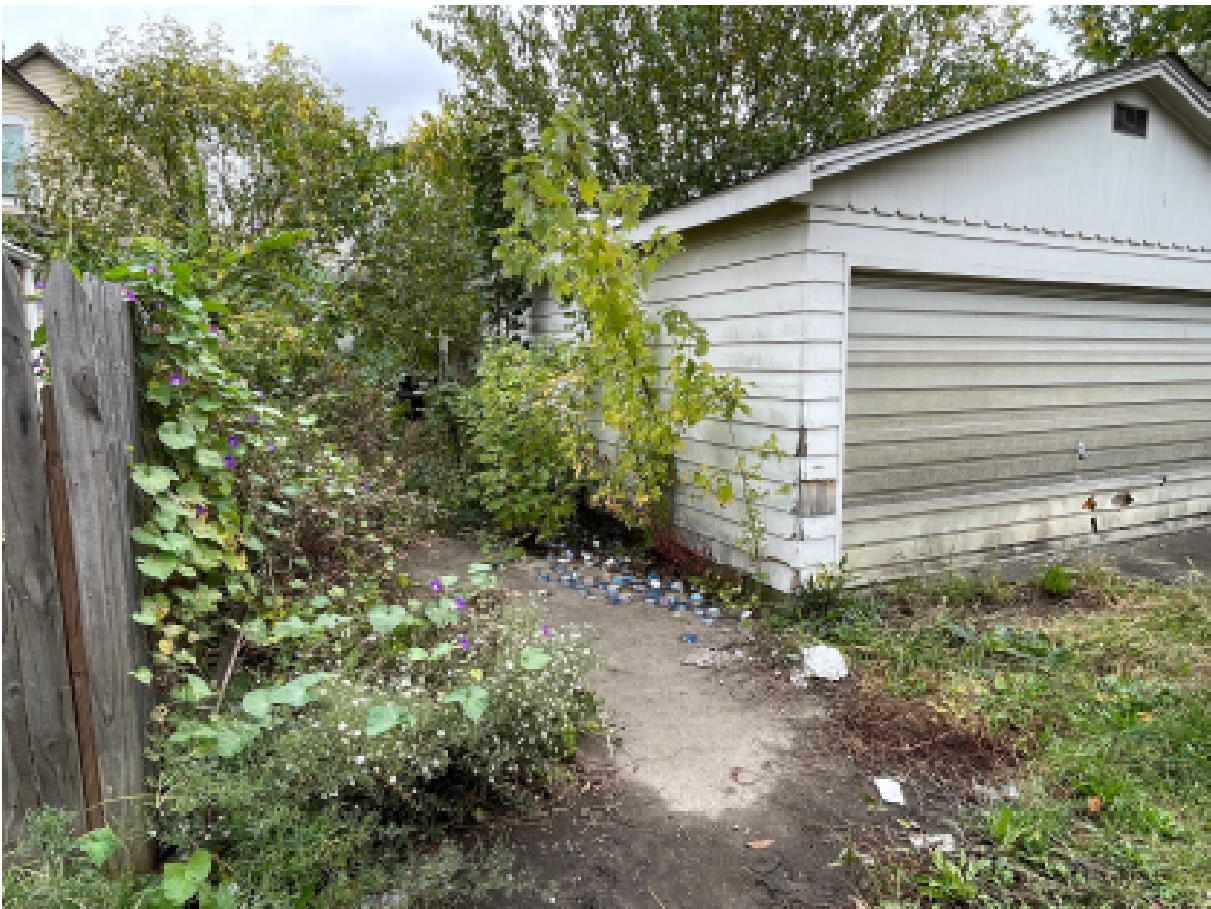
(6)

- High grass and weeds.
- Solid waste.
- Damaged garage door on the accessory structure.
- Bare and exposed wood surfaces on the accessory structure.

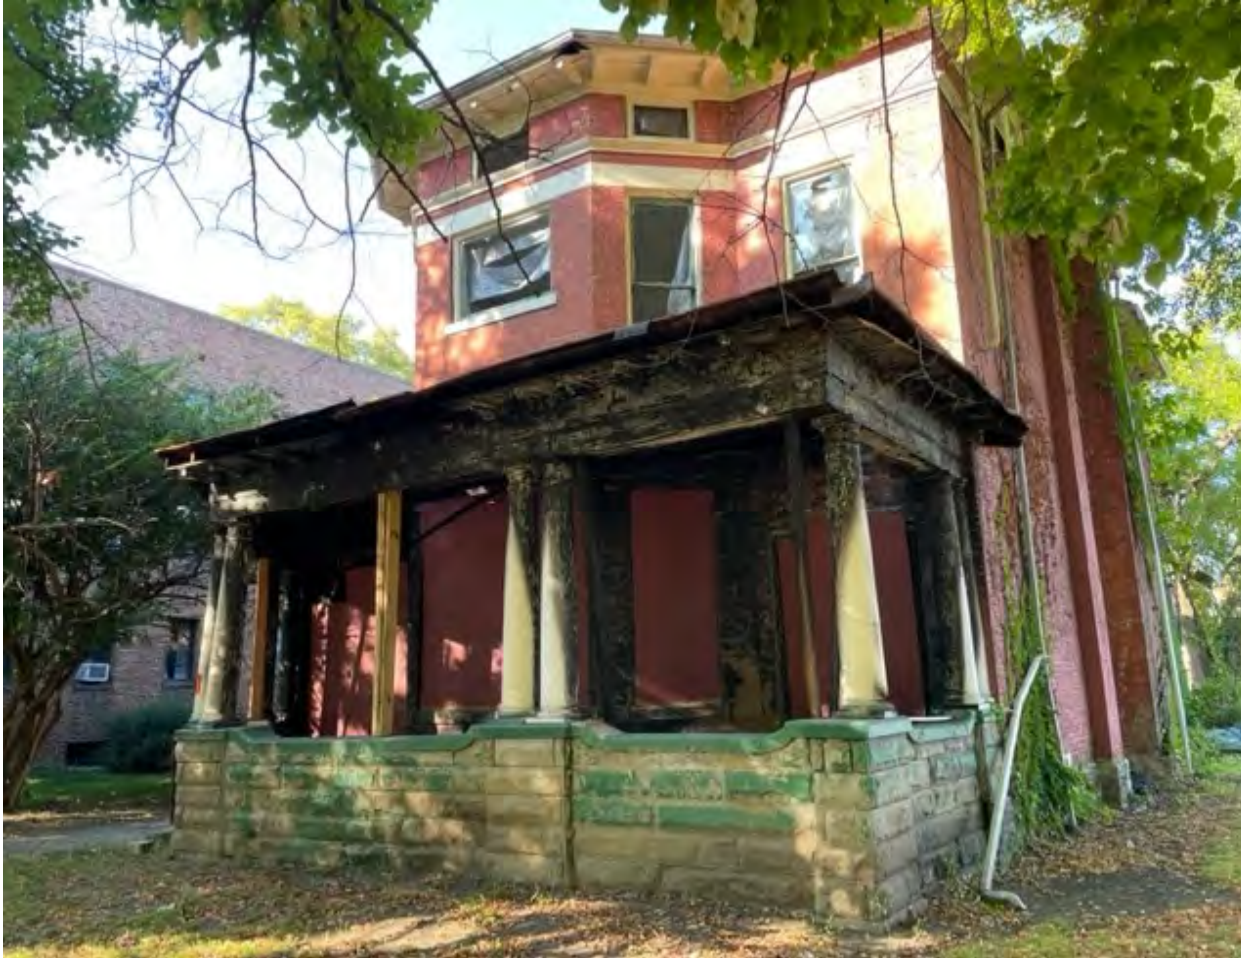
- Vacant structure is not boarded/secured to code
- Fire damaged porch/1st floor
- Structure exhibits rotted and damaged wood on the soffit
- Mortar voids in the block and brick
- Damaged/broken windows
- Bare wood on the window coverings, window trim, and porch supports
- Rain carriers are missing from the first floor and downspouts are disconnected on the north side.

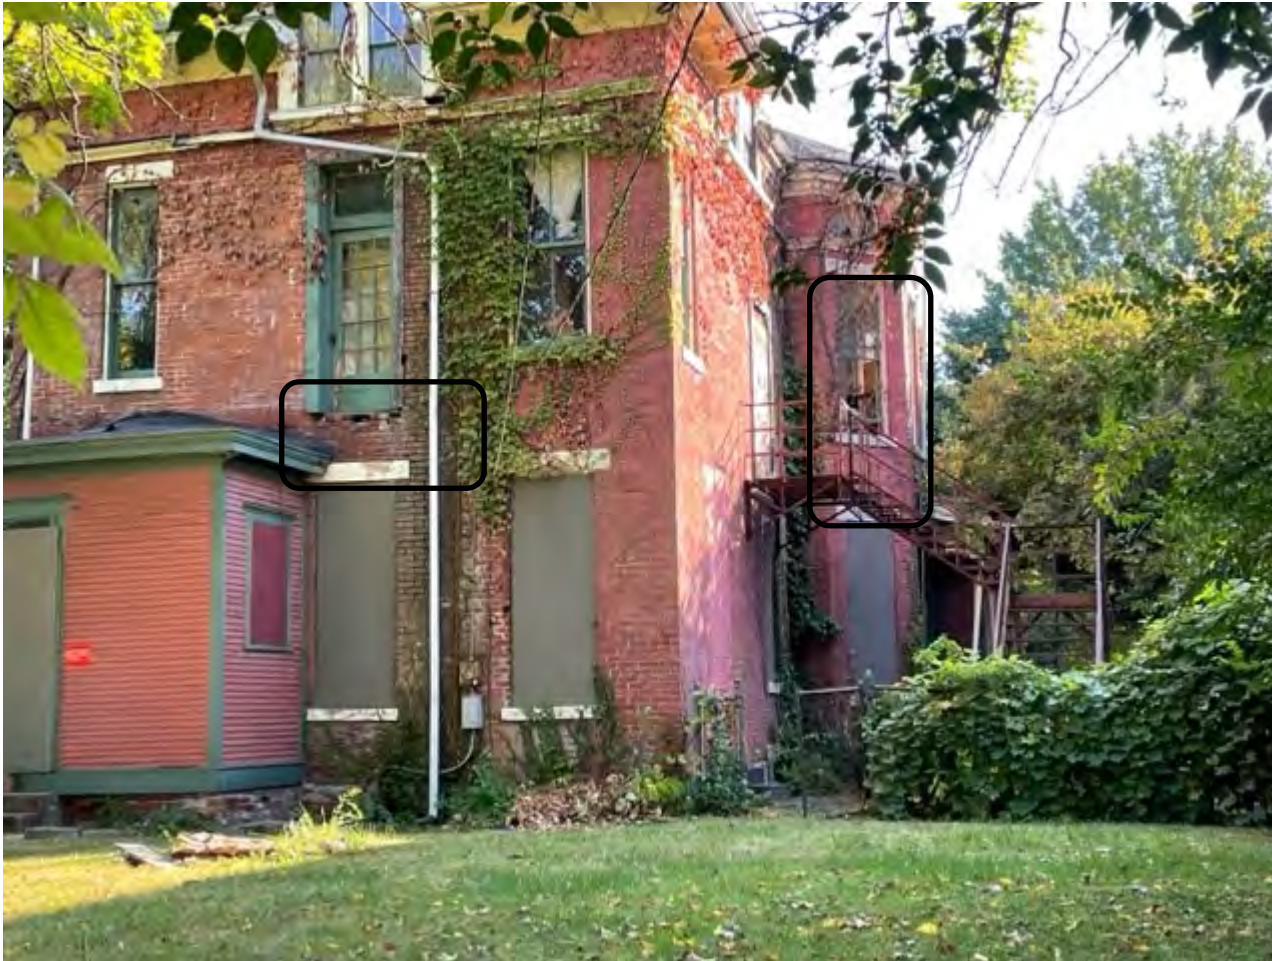
- Missing brick and mortar voids
- Damaged/missing window
- Areas of bare and exposed wood on the trim and windows
- Structure is not boarded to code

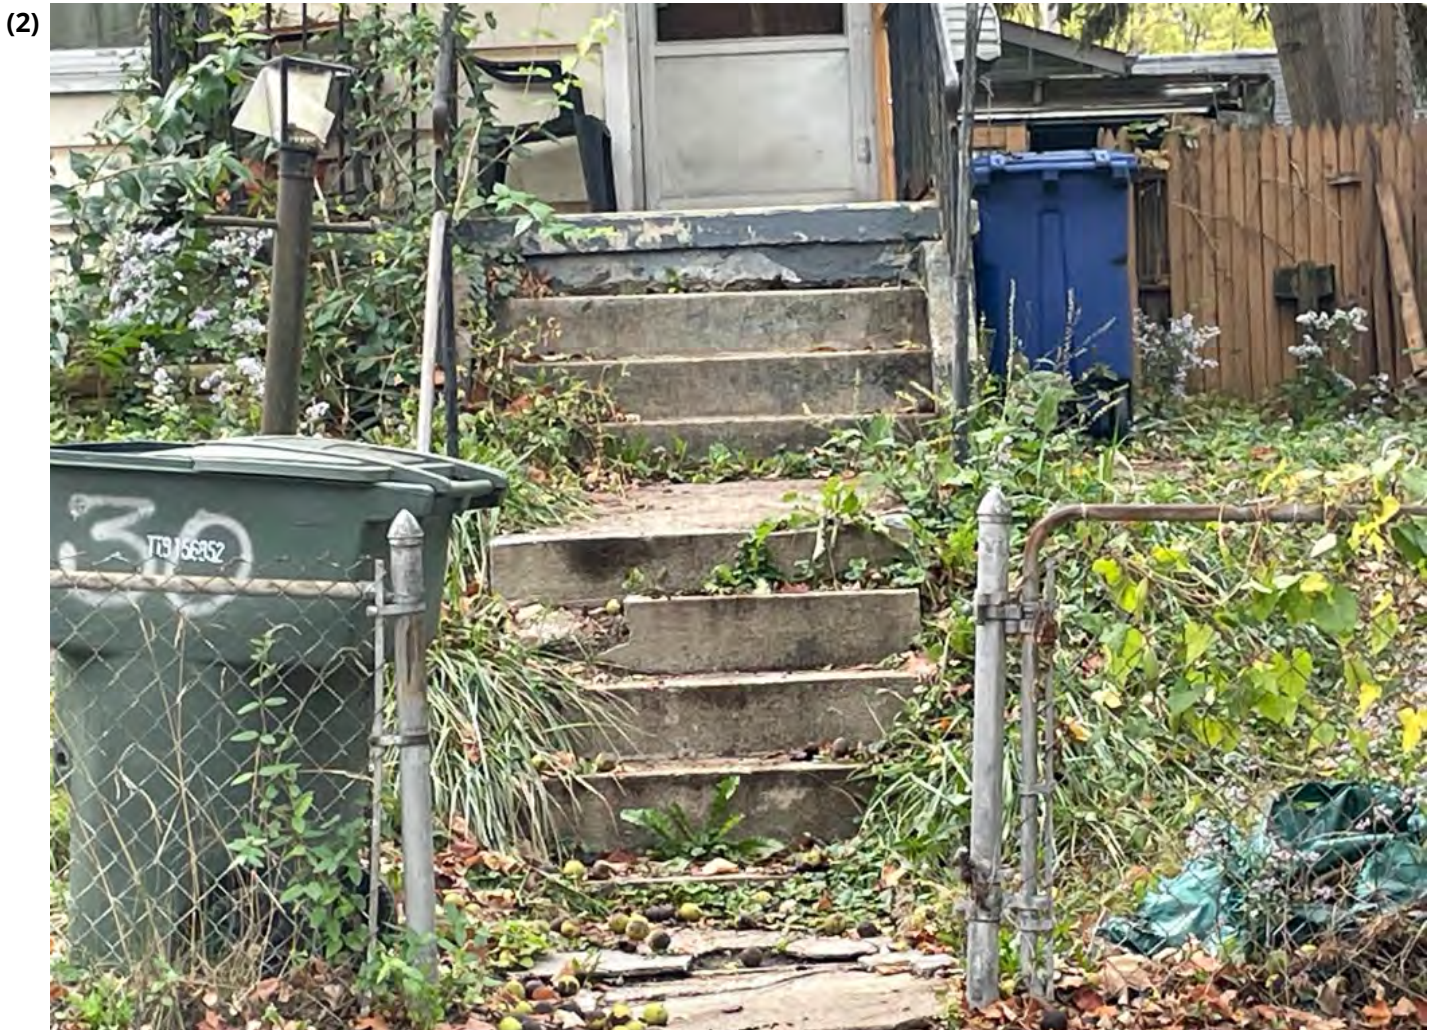
Front concrete service steps and walkway in disrepair and deteriorating.

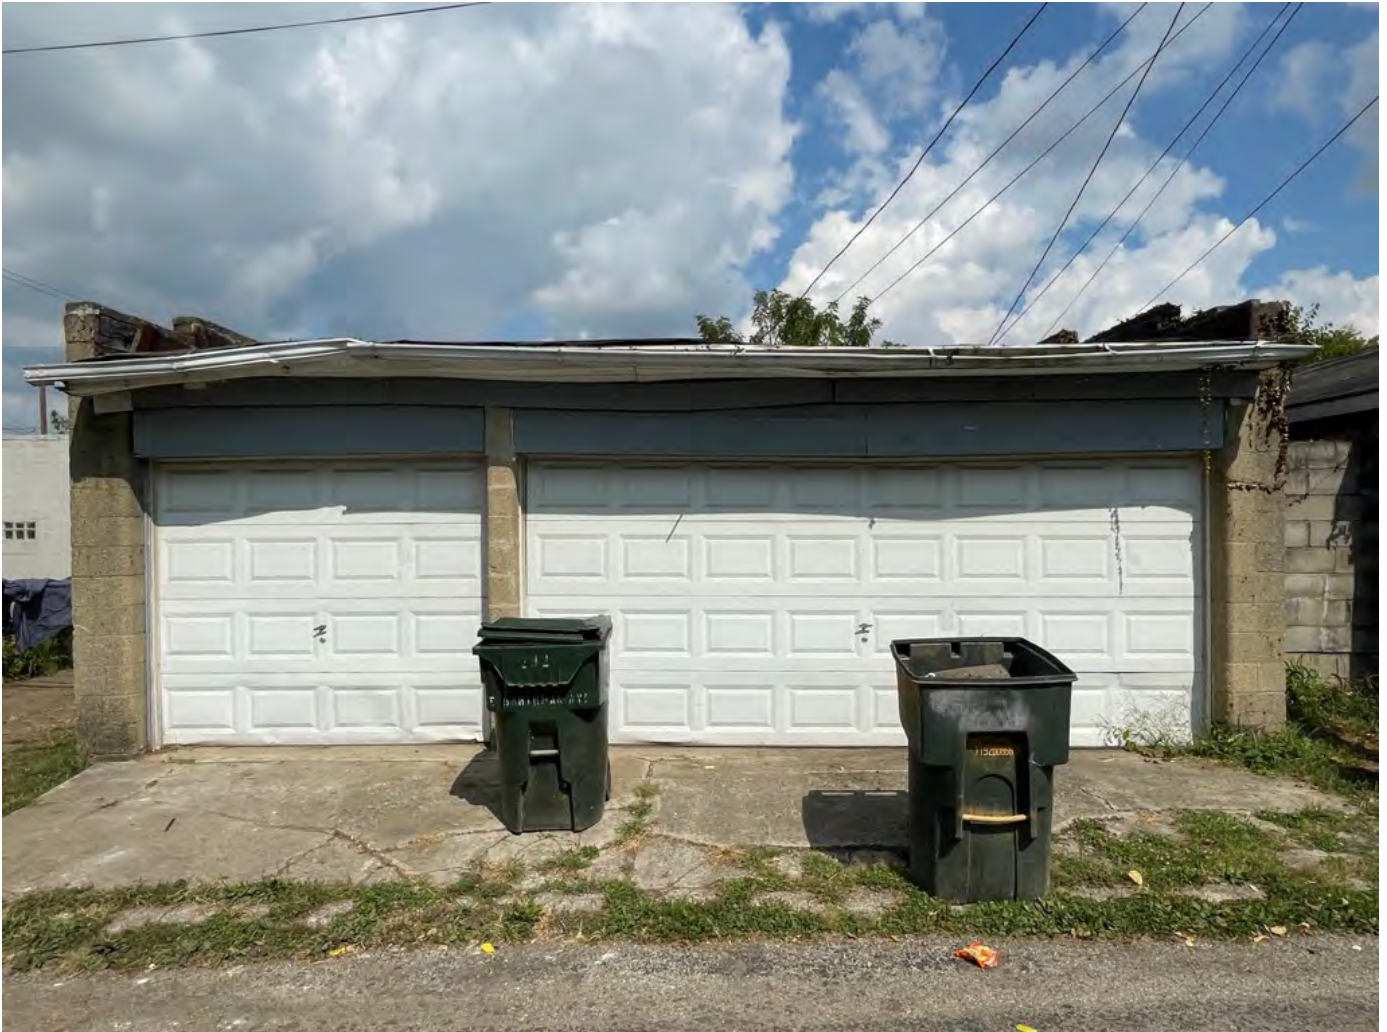
(7)

Damaged rain carrier. Missing downspouts.

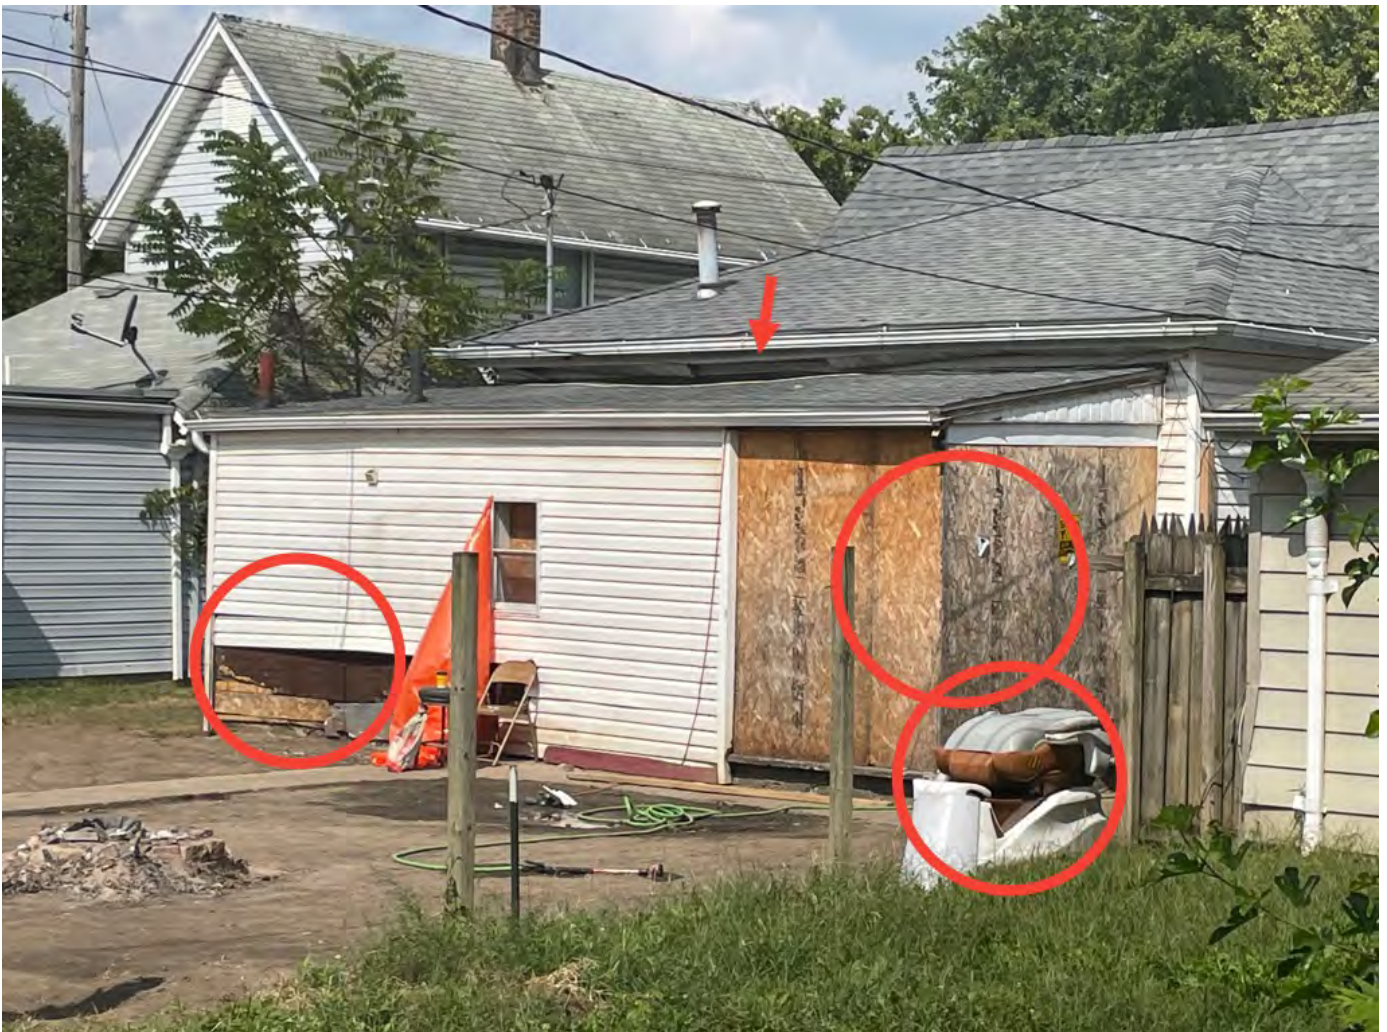
(8)

Damaged and missing siding. Missing soffit sections. Bare, exposed wood. Improper exterior storage.

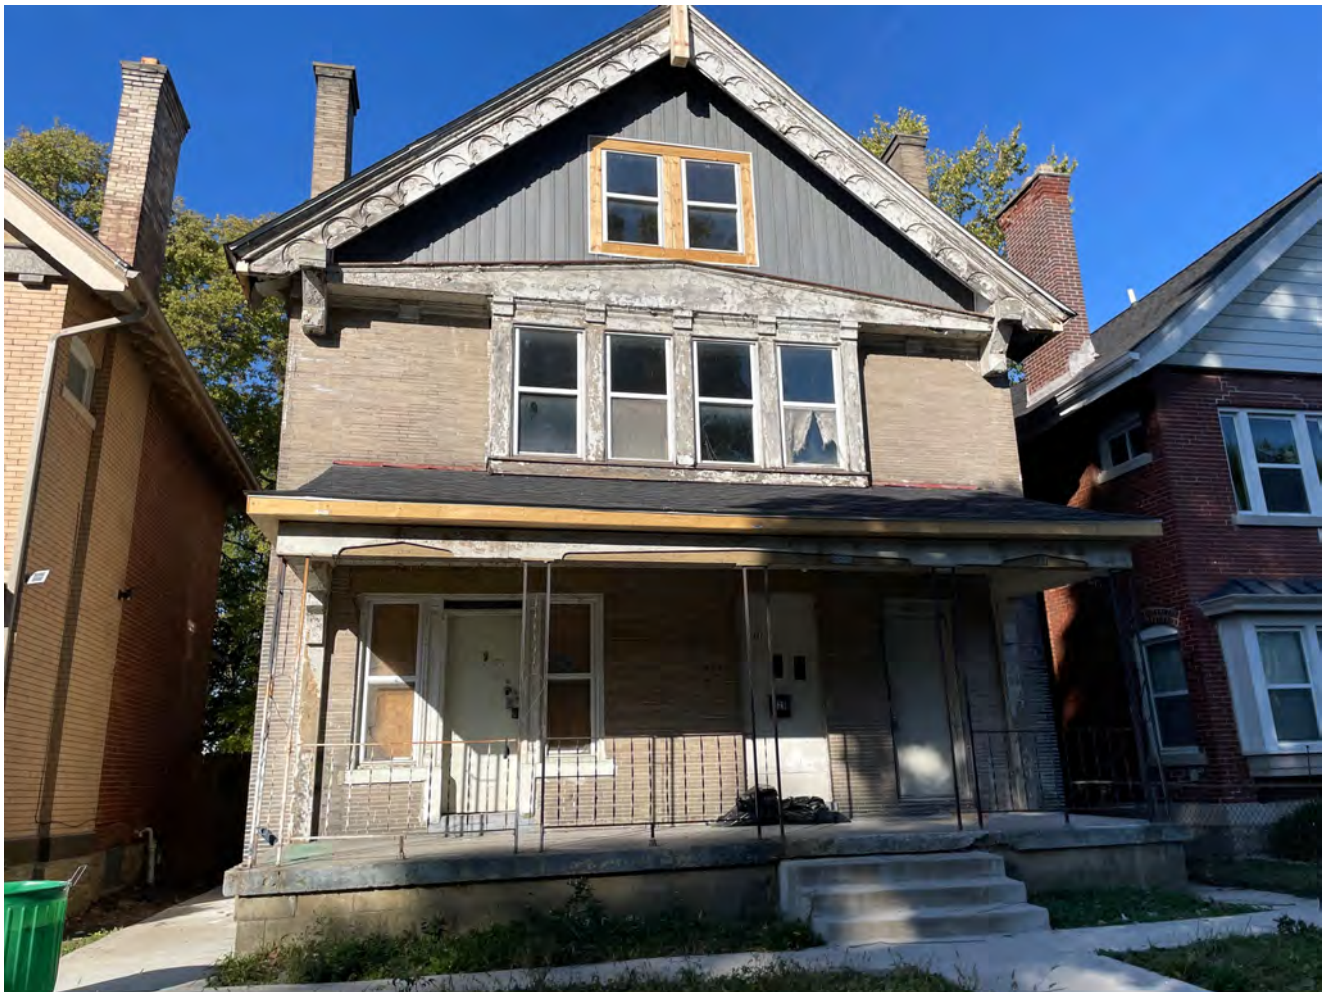
(1)

- Vacant structure is not boarded to code
- Bare and/or rotting wood surfaces throughout the exterior
- Damaged masonry at front porch decking/foundation and throughout exterior walls
- Damaged window screens
- Front steps missing handrail
- Missing raincarriers

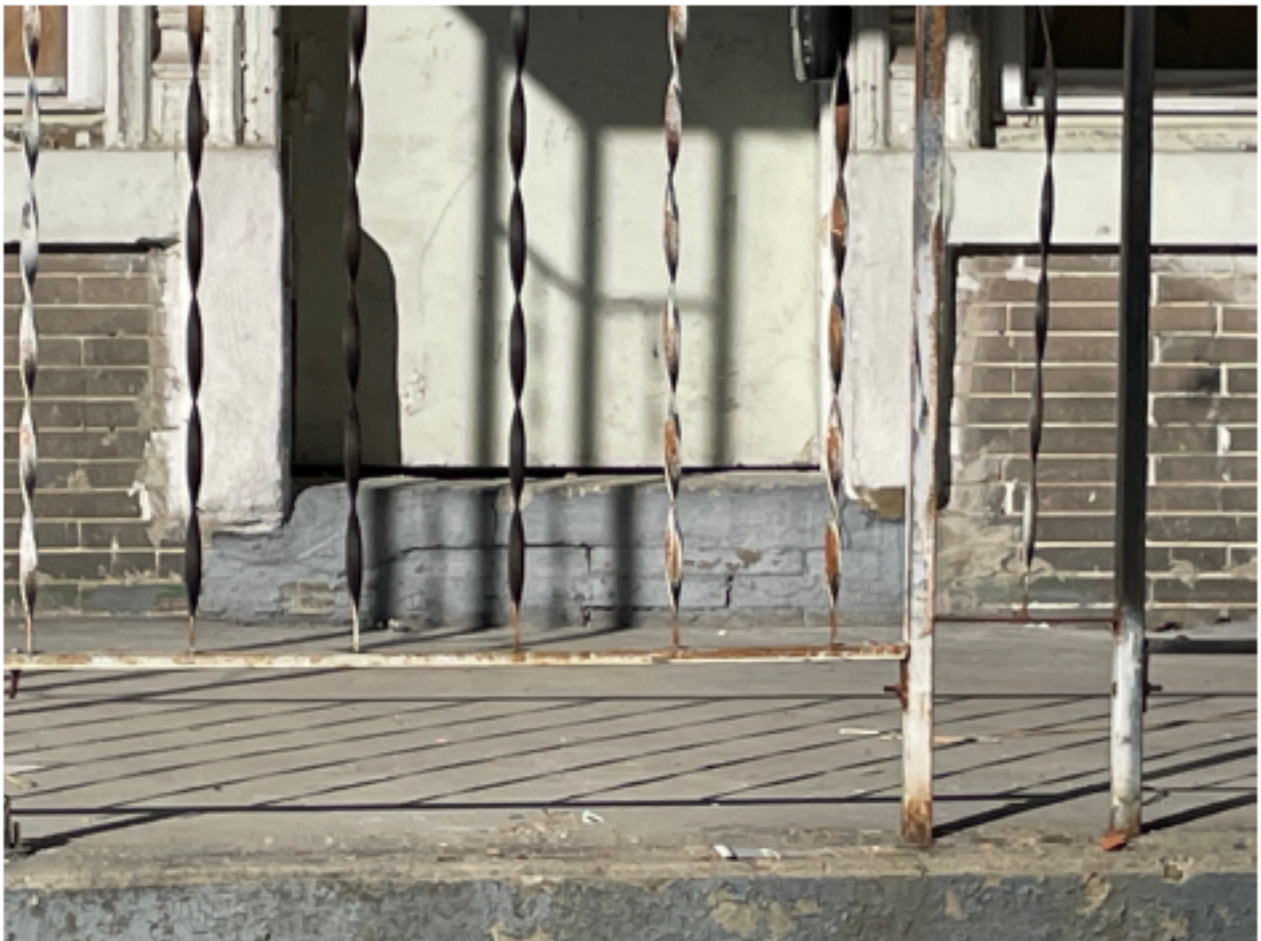
(5)

Missing threshold components with gapping under front entry door

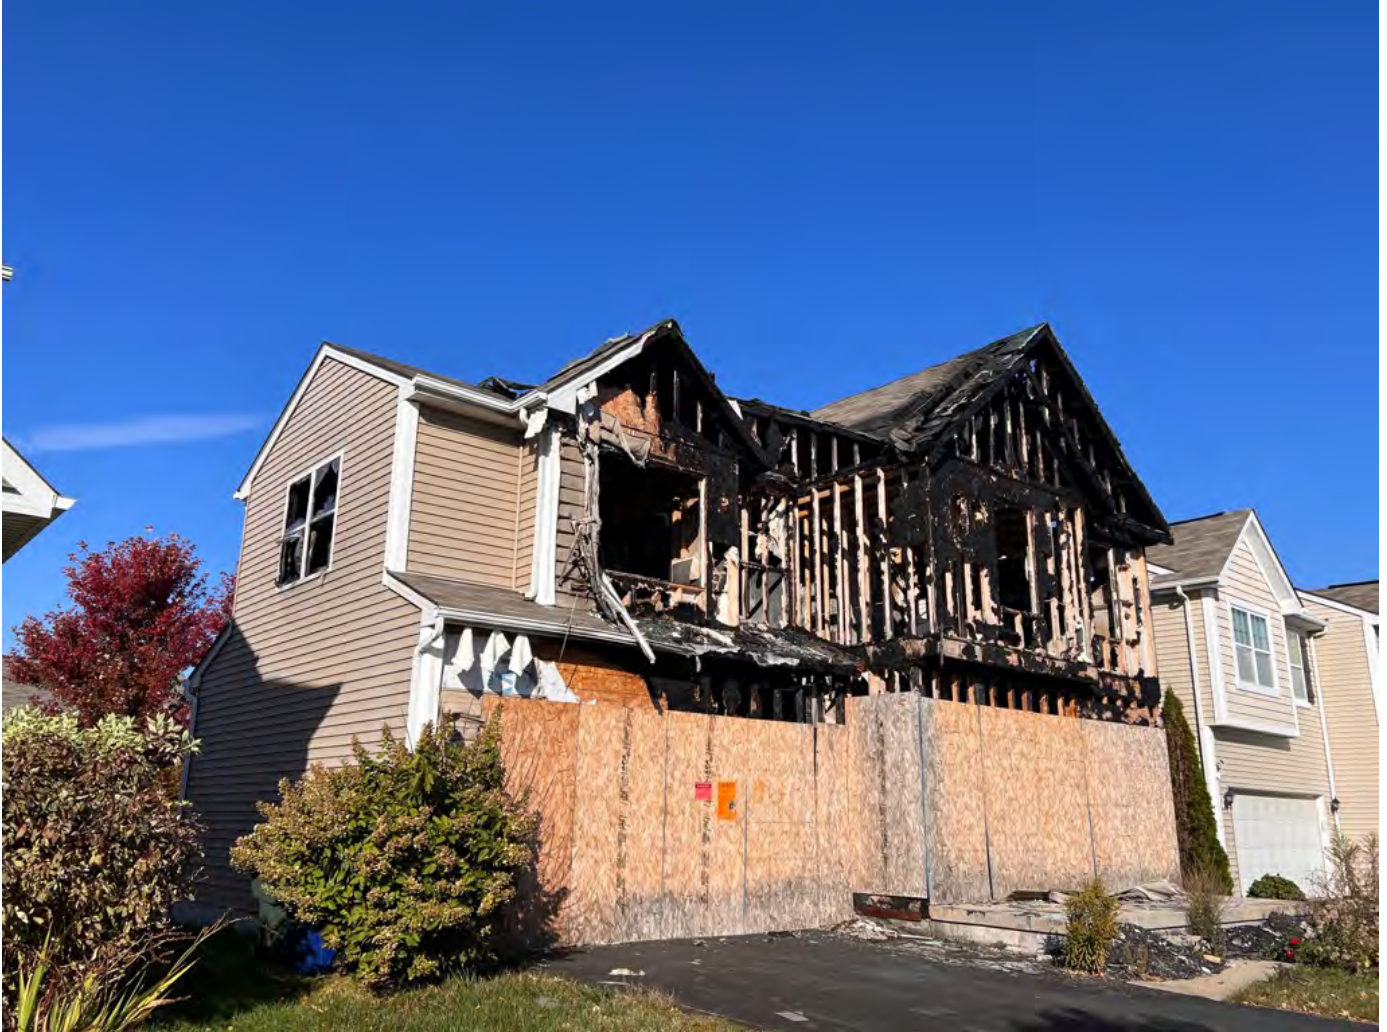
(1)

Vacant structure not boarded and secured to code. Severe fire damage throughout the structure including roofing, siding, soffit, fascia, trim boards, rain carriers, and broken windows. Boards covering the openings not painted. Address not clearly posted. Solid waste including debris created by the fire.

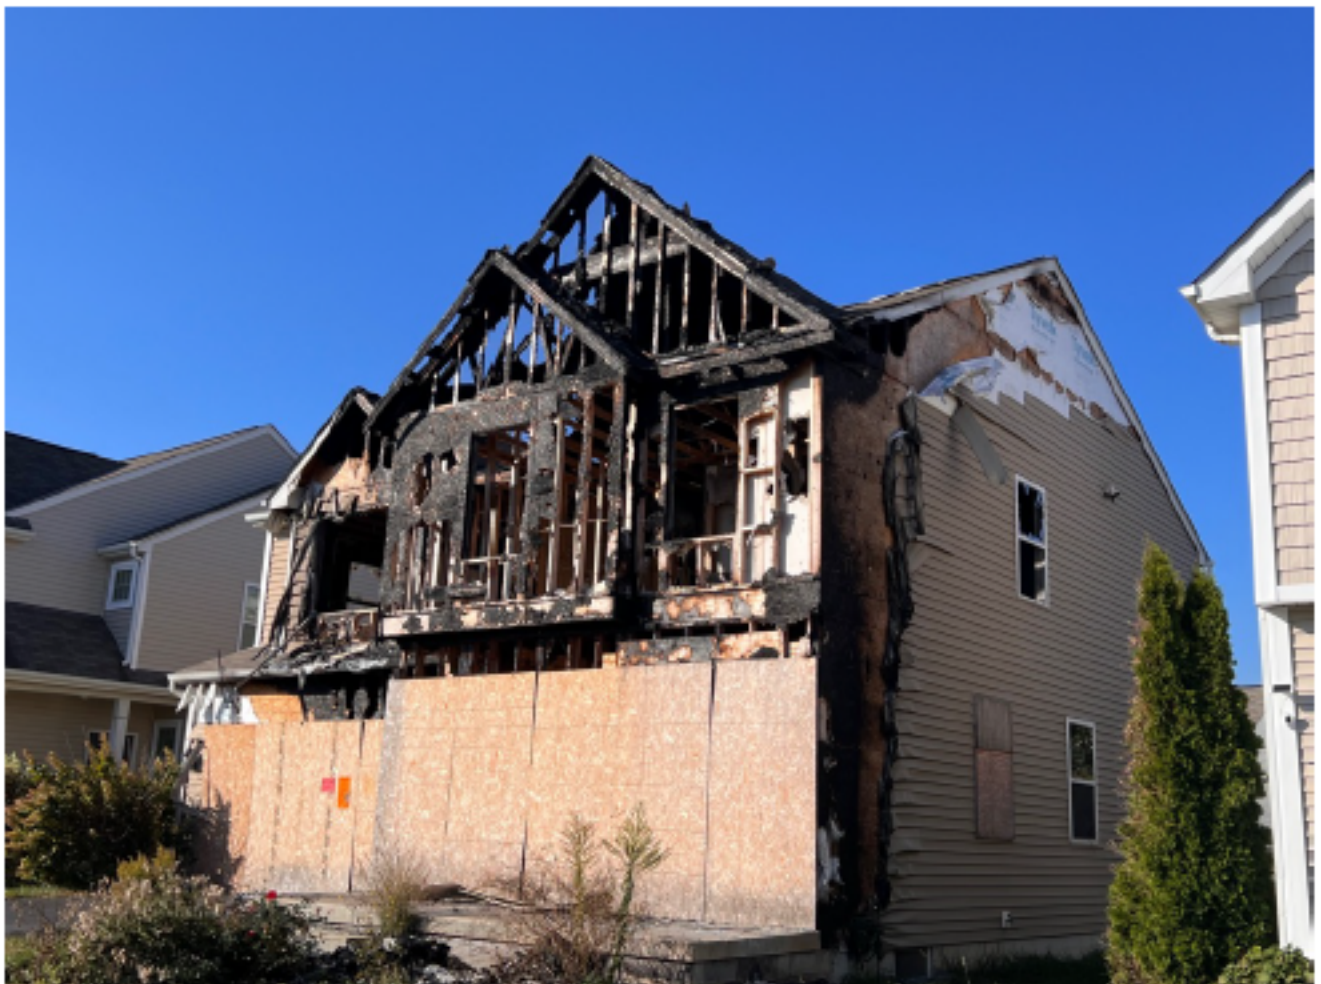
(2)

Vacant structure not boarded and secured to code. Severe fire damage throughout the structure including roofing, siding, soffit, fascia, trim boards, rain carriers, and broken windows. Boards covering the openings not painted. Address not clearly posted. Solid waste including debris created by the fire.

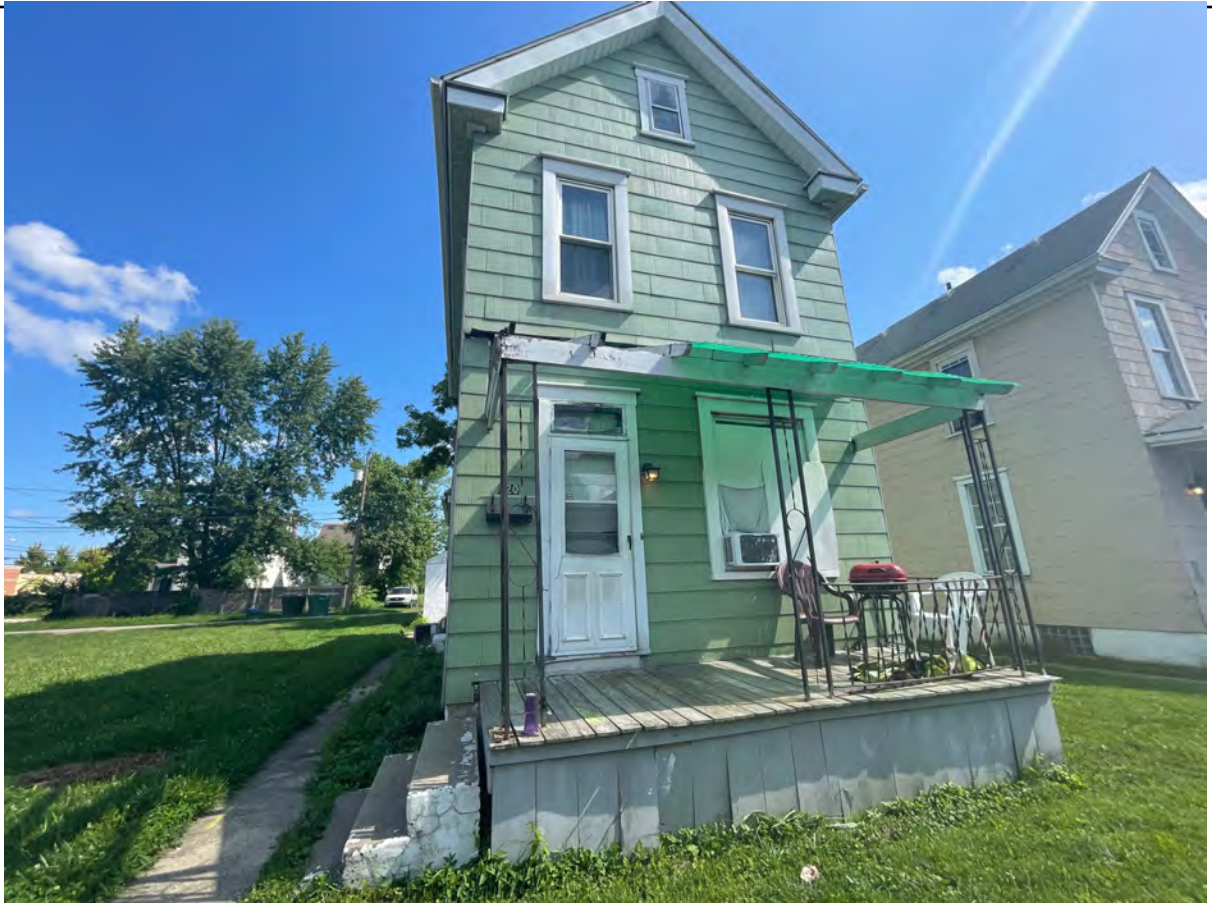
(1)

- porch overhang is damaged and in disrepair
- porch steps missing handrail

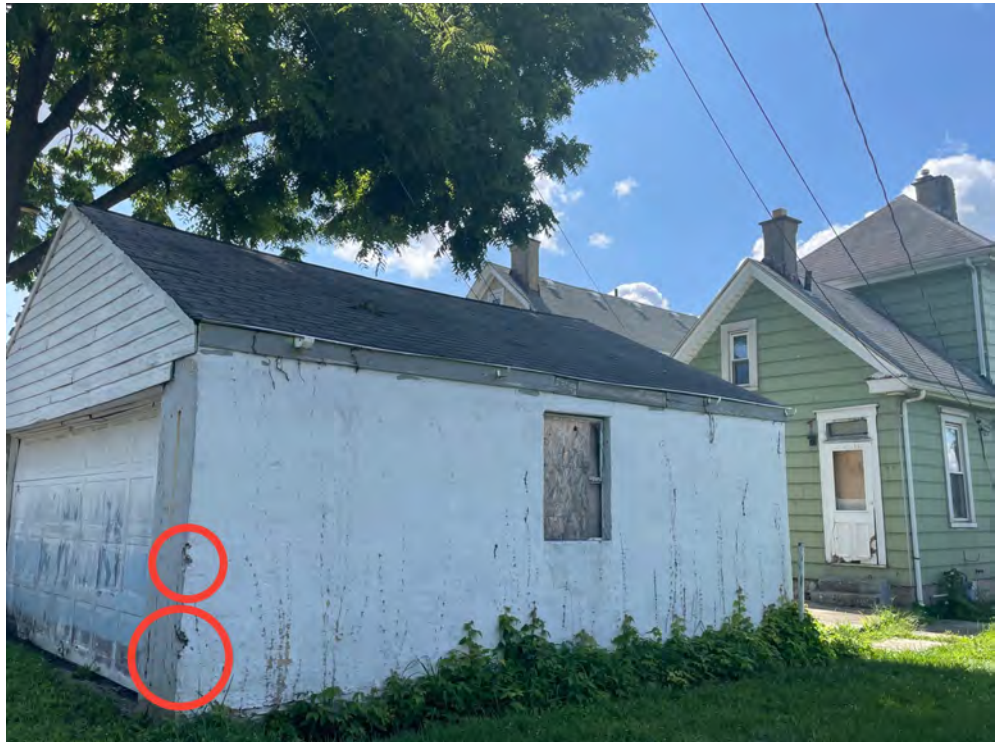
- accessory structure is missing rain carrier system
- accessory structure has bare and exposed wood surfaces
- graffiti
- high grass, weeds, ranked growth
- sections of concrete is damaged

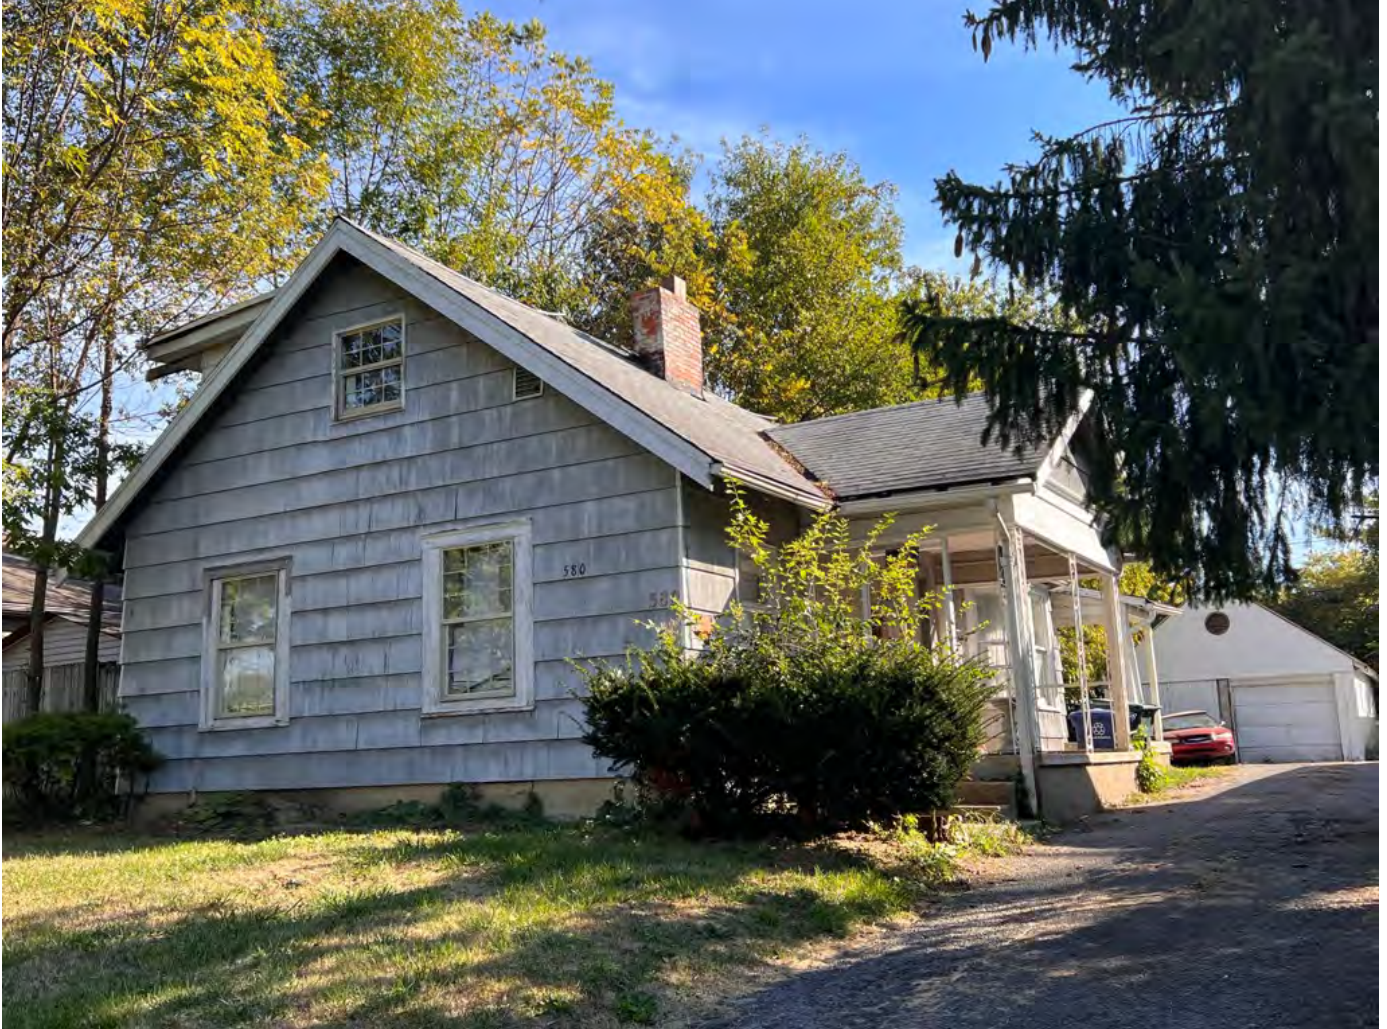
(1)

Exposed bare wood present on multiple areas of the main and accessory structures. Damaged asphalt in the driveway.

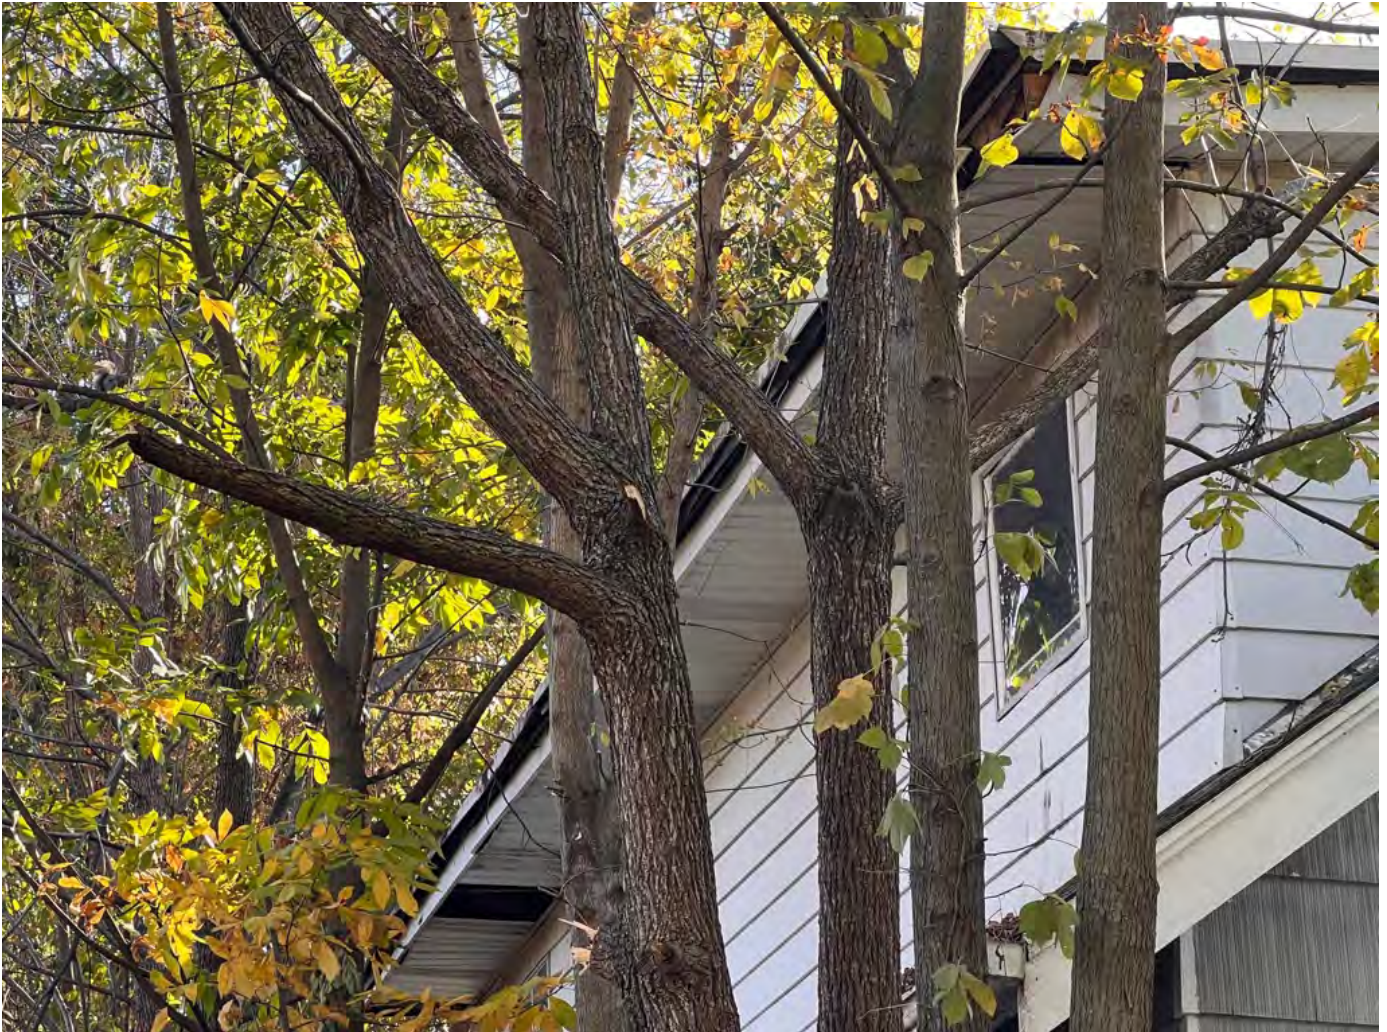
Missing and/or damaged sections of fascia and soffit on the north facing side of the main structure.

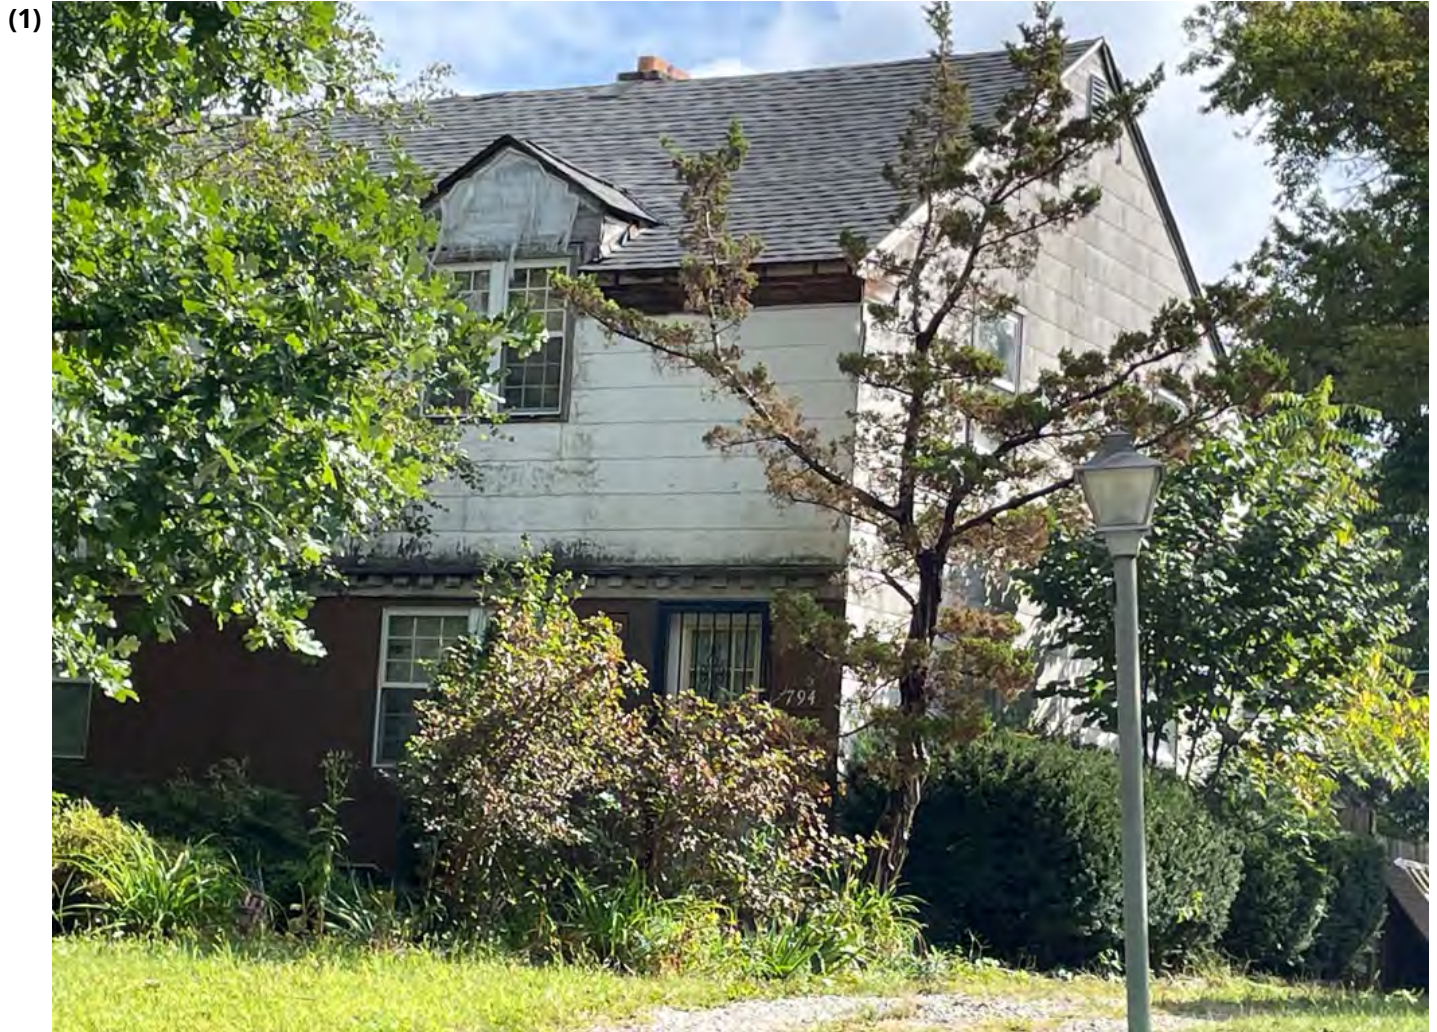
Sections of siding missing on front and south side of structure, as well as the sides of the dormers. Areas of exposed wood where siding is missing, on fascia boards, and around window trim. Rain carriers missing sections.
