Columbus Housing Community Reinvestment Area (CHCRA): Housing Survey

Between August and October 2023, a surveillance survey was conducted in the area to be known as the Columbus Housing Community Reinvestment Area (CHCRA). The purpose of the survey was to determine the location of housing units that appeared to be in need of repair or upgrading, vacant lots in need of redevelopment and the severity of structures that appeared to be in need of repair, and/or needing to be removed.

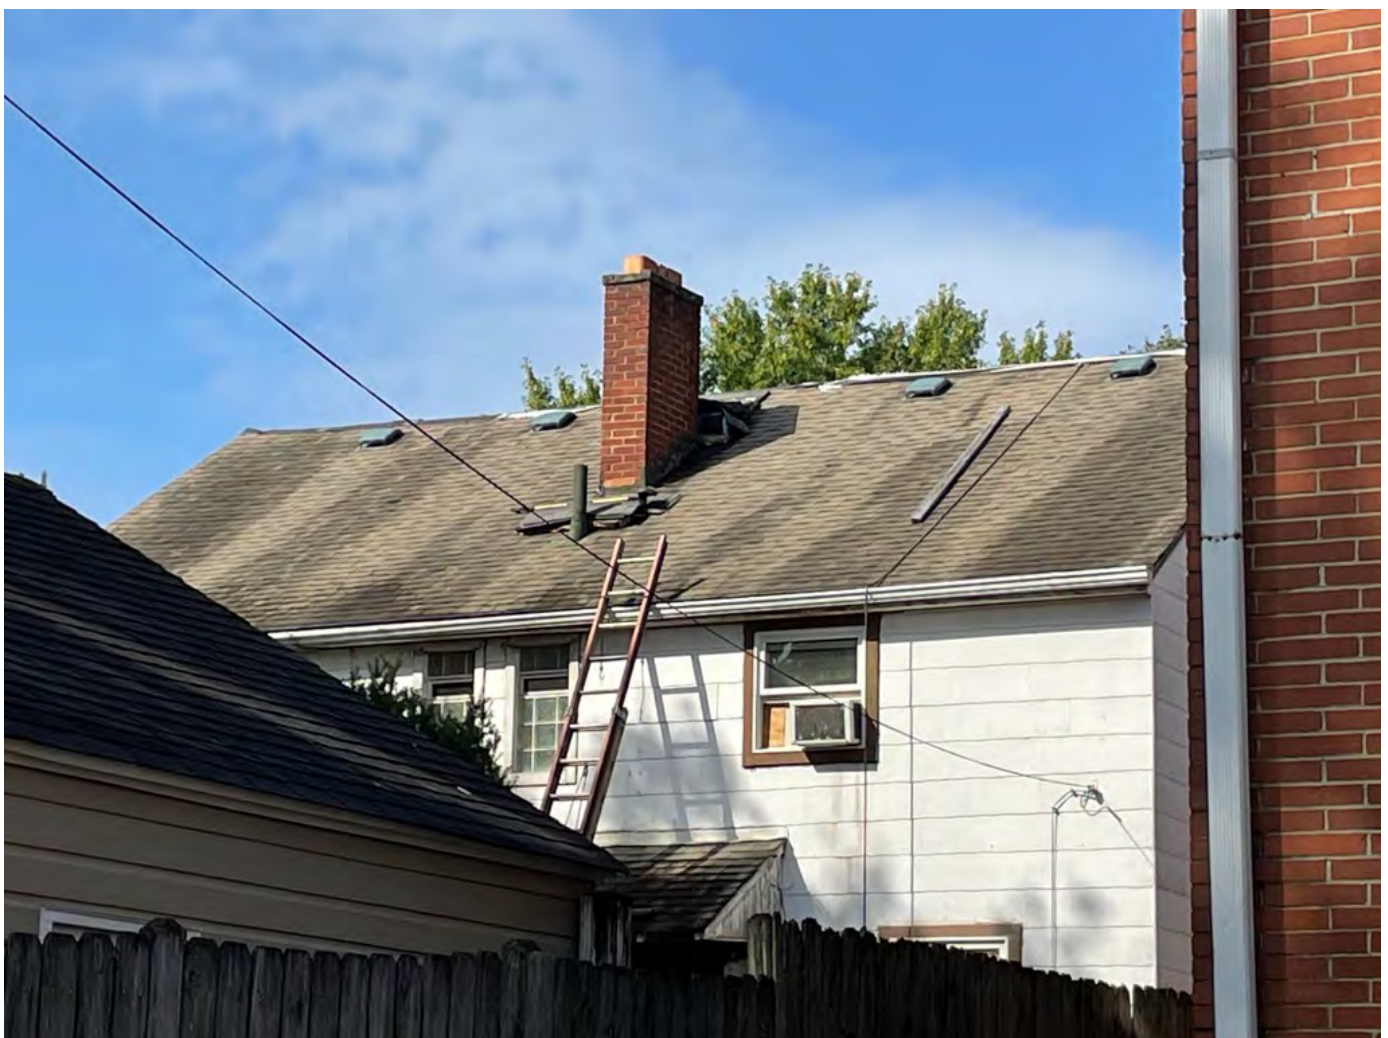
Roofing materials in disrepair. Loose materials stored on roof, and ladder stored on the exterior against the structure.

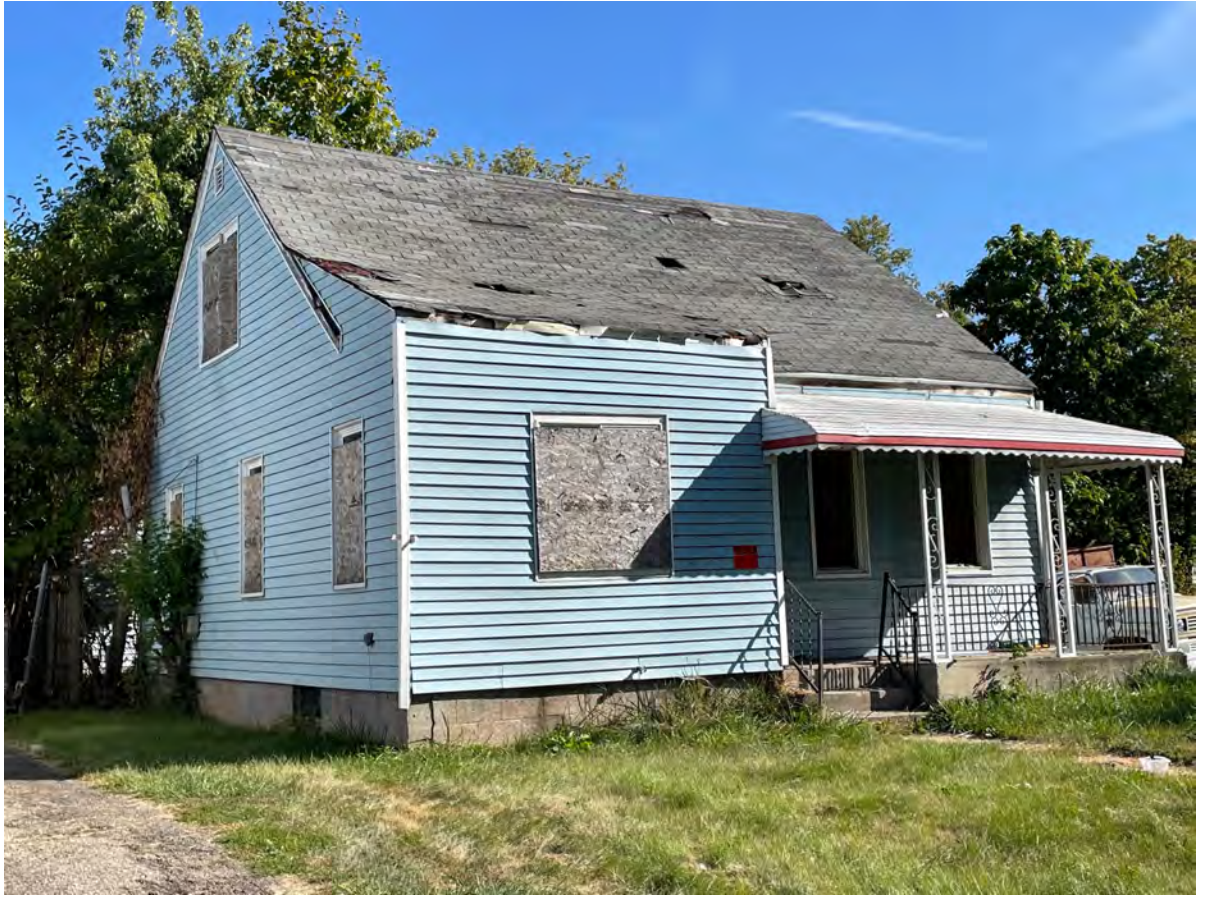
(2)

- Vacant structure is not boarded to code standards.
- Bare and exposed wood surfaces throughout the structure.
- The roof has damaged materials and holes throughout it.
- Solid waste.
- The structure is missing raincarriers.
- The structure is not weathertight, water-tight, or rodent proof.

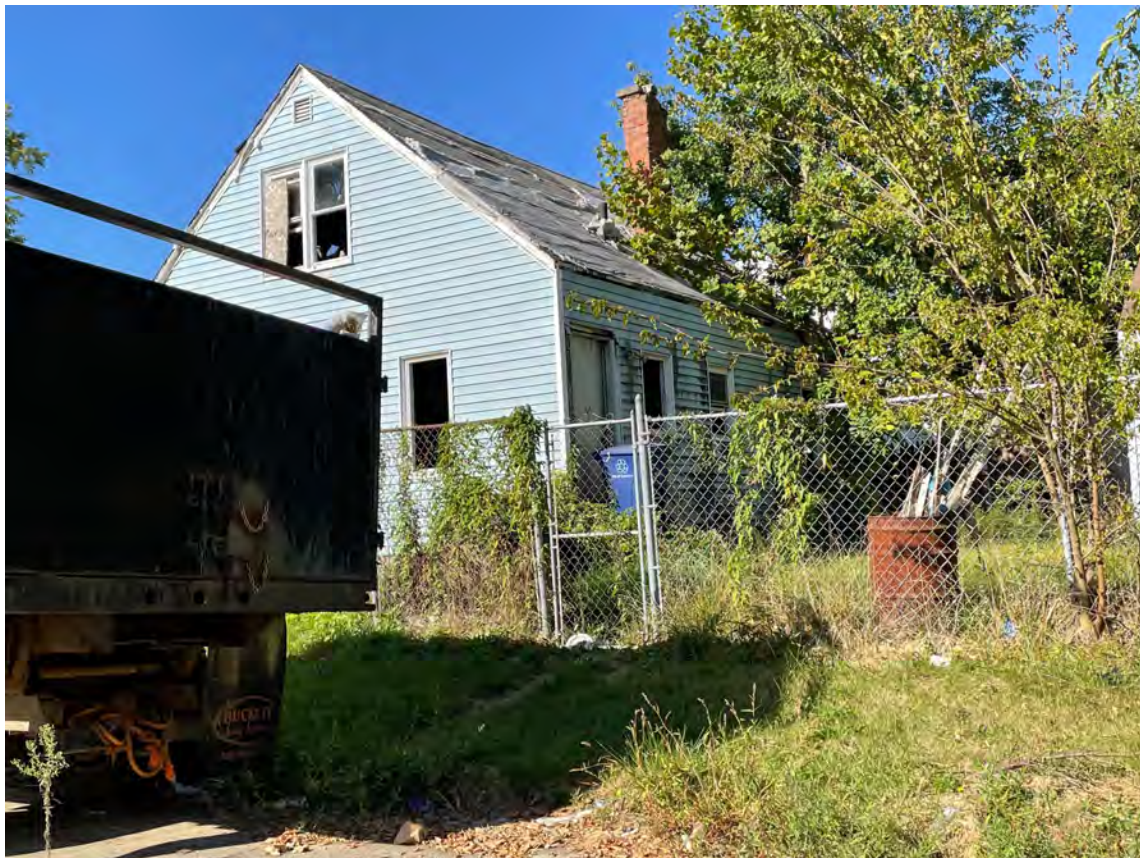
- Vacant structure is not boarded to code standards.
- High grass and weeds. Rank growth.
- Prohibited exterior storage.
- Bare and exposed wood surfaces throughout the structure.
- The roof has damaged materials and holes throughout it.
- Solid waste.
- The structure is missing raincarriers.
- The structure is not weathertight, water-tight, or rodent proof.

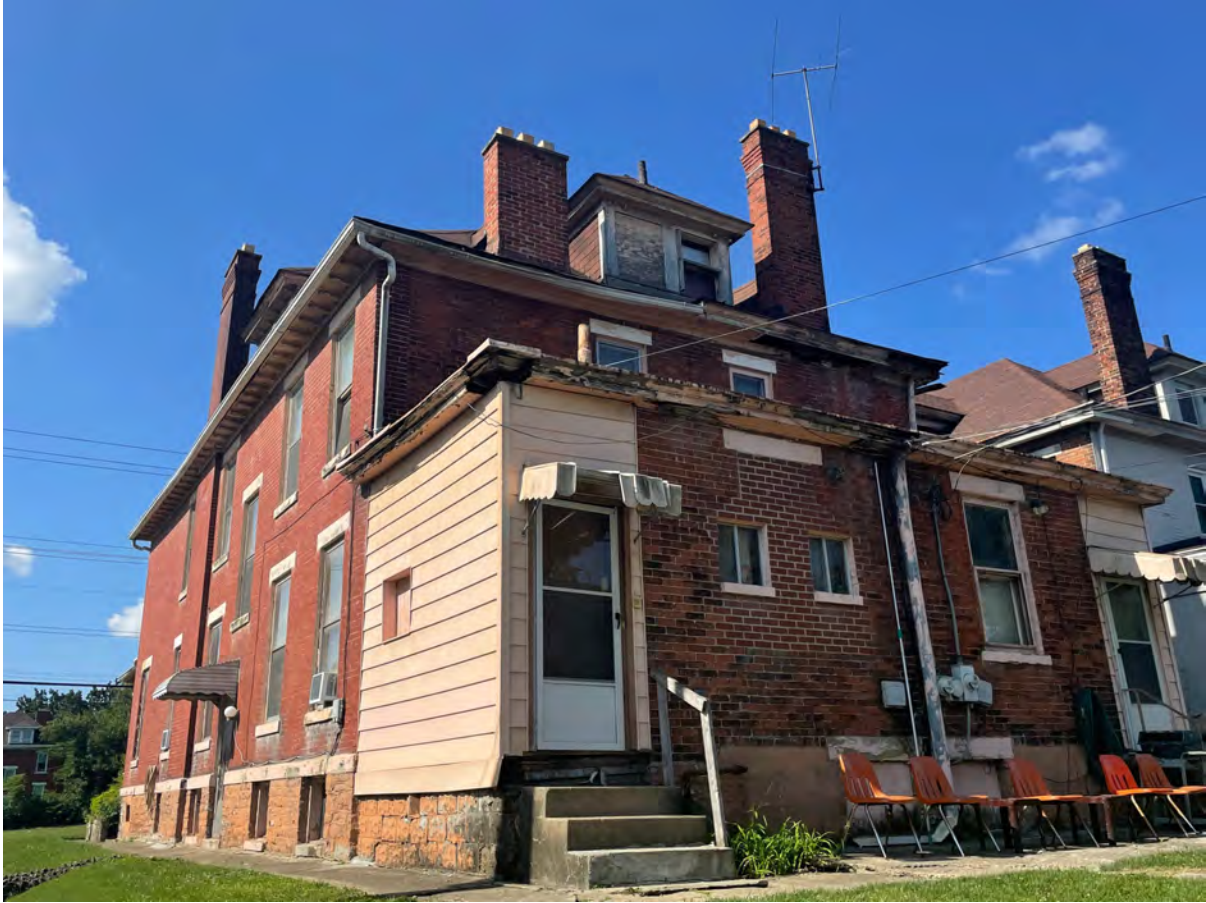
(7)

- bare, exposed and/or damaged wood surfaces present throughout exterior
- damaged/missing sections of soffits
- damaged and/or missing sections of fascia/trim
- missing sections of rain carrier system
- canopy over rear porch steps are in disrepair

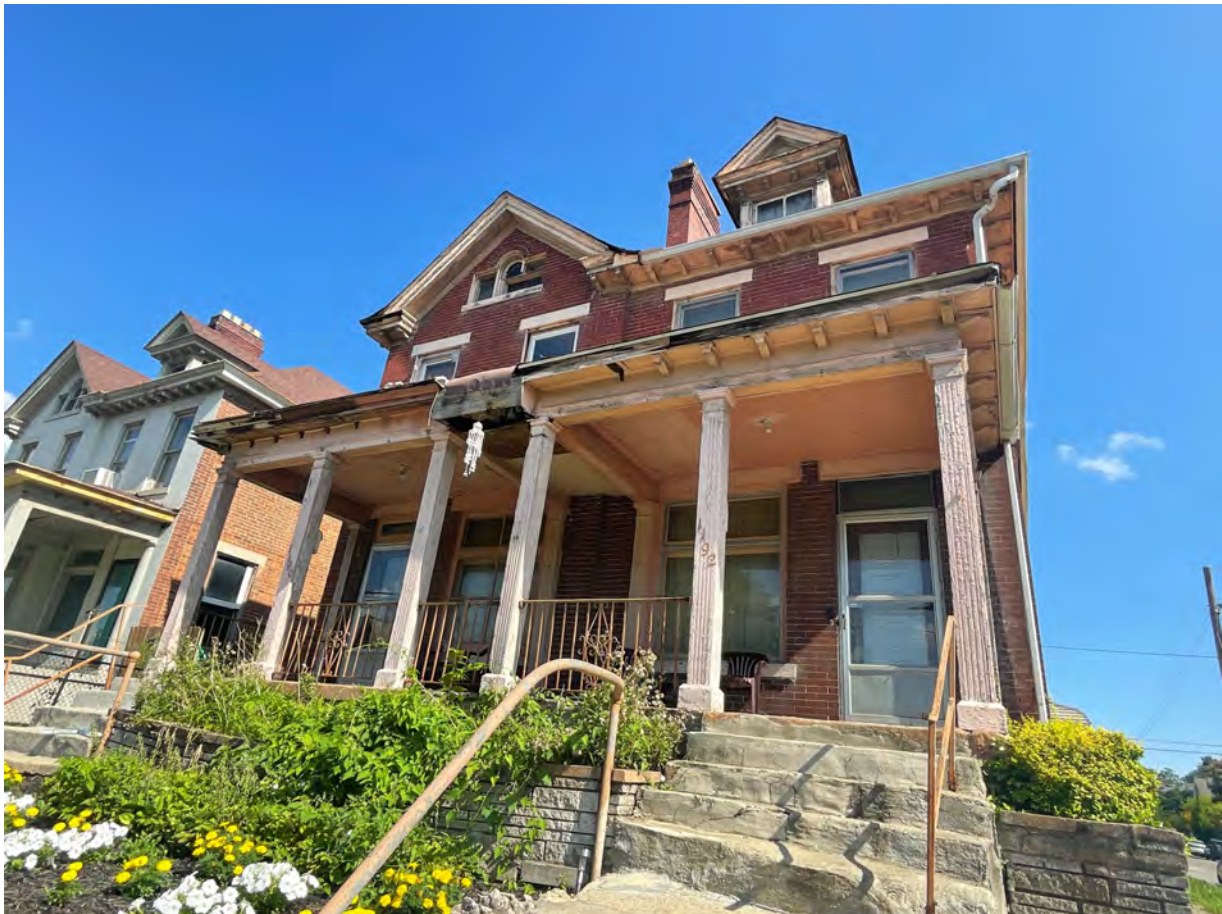
(8)

- bare, exposed and/or damaged wood surfaces present throughout exterior
- damaged/missing sections of soffits
- damaged and/or missing sections of fascia/trim
- missing sections of rain carrier system
- cracks and deteriorating concrete/masonry materials present in exterior stairs and porch floor

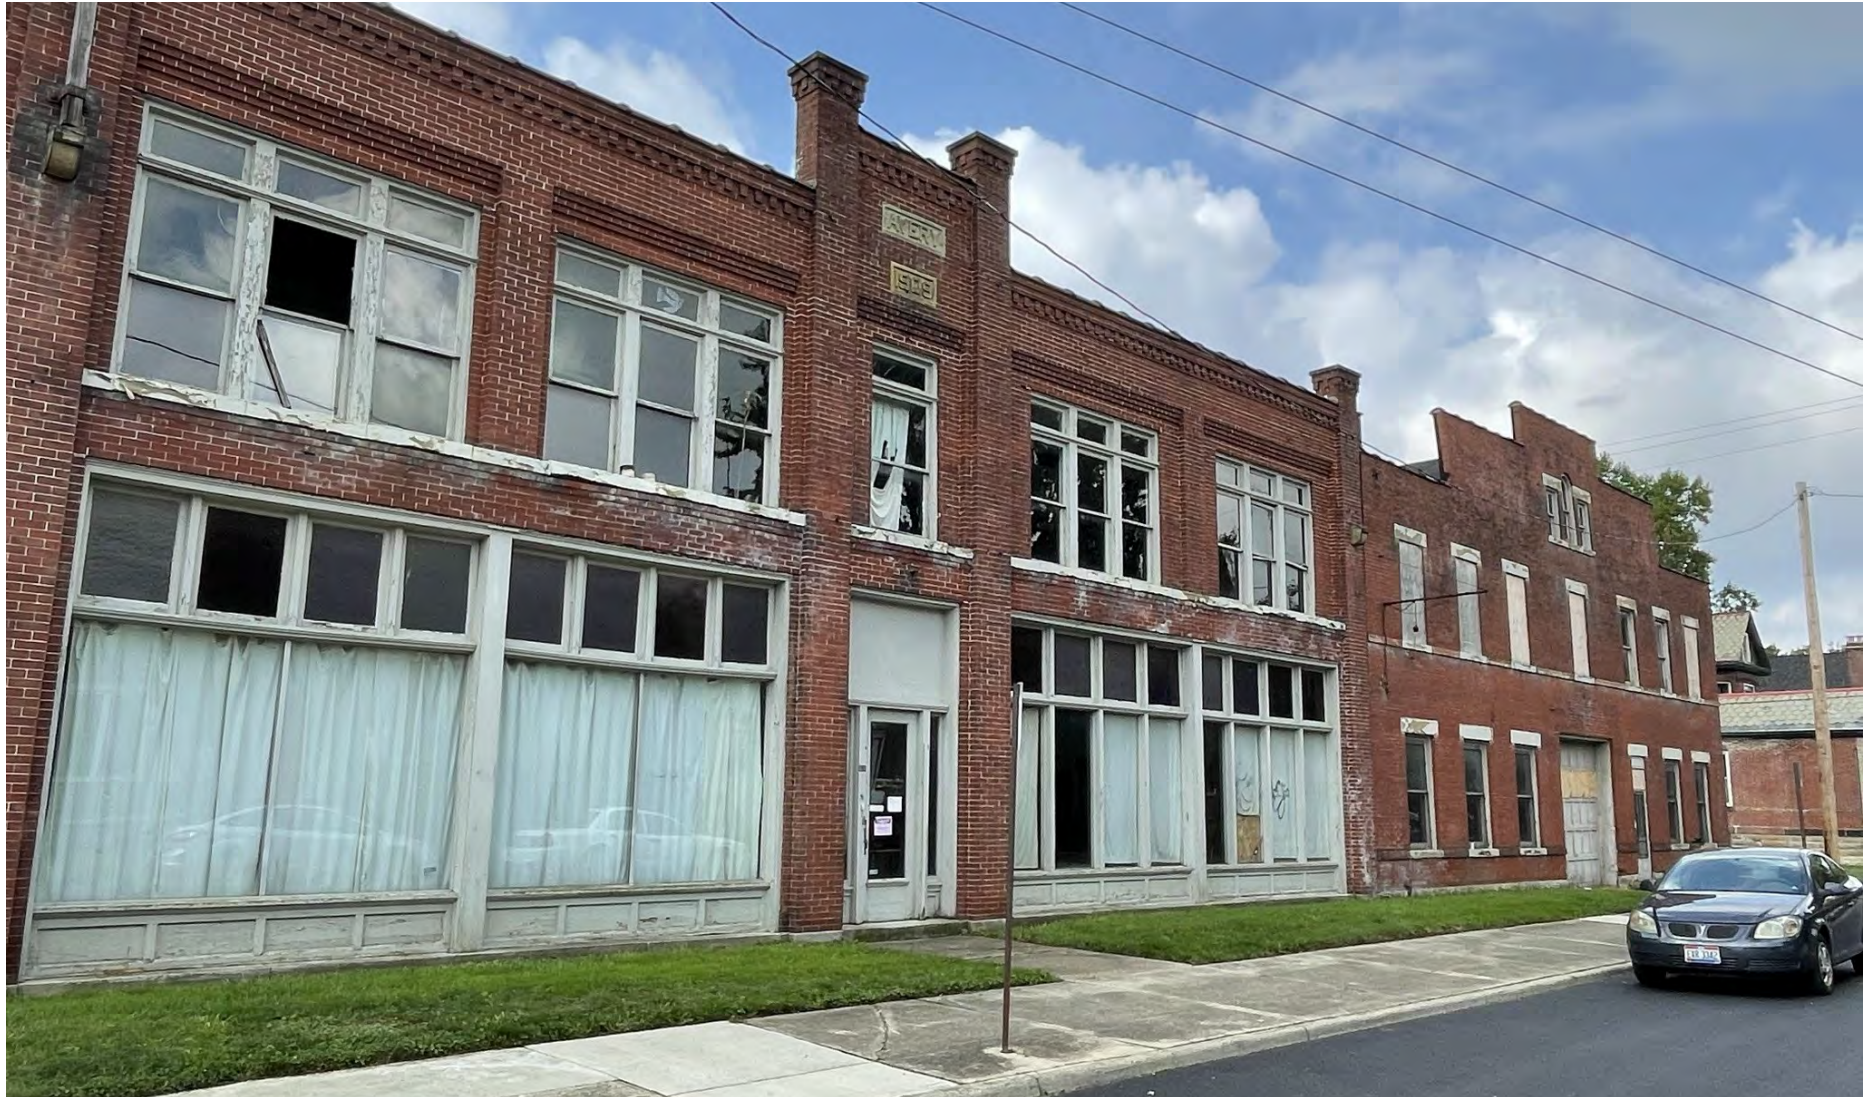
- Violations shown above: Not boarded to Code, bare and exposed wood, broken window, mortar voids throughout, graffiti.

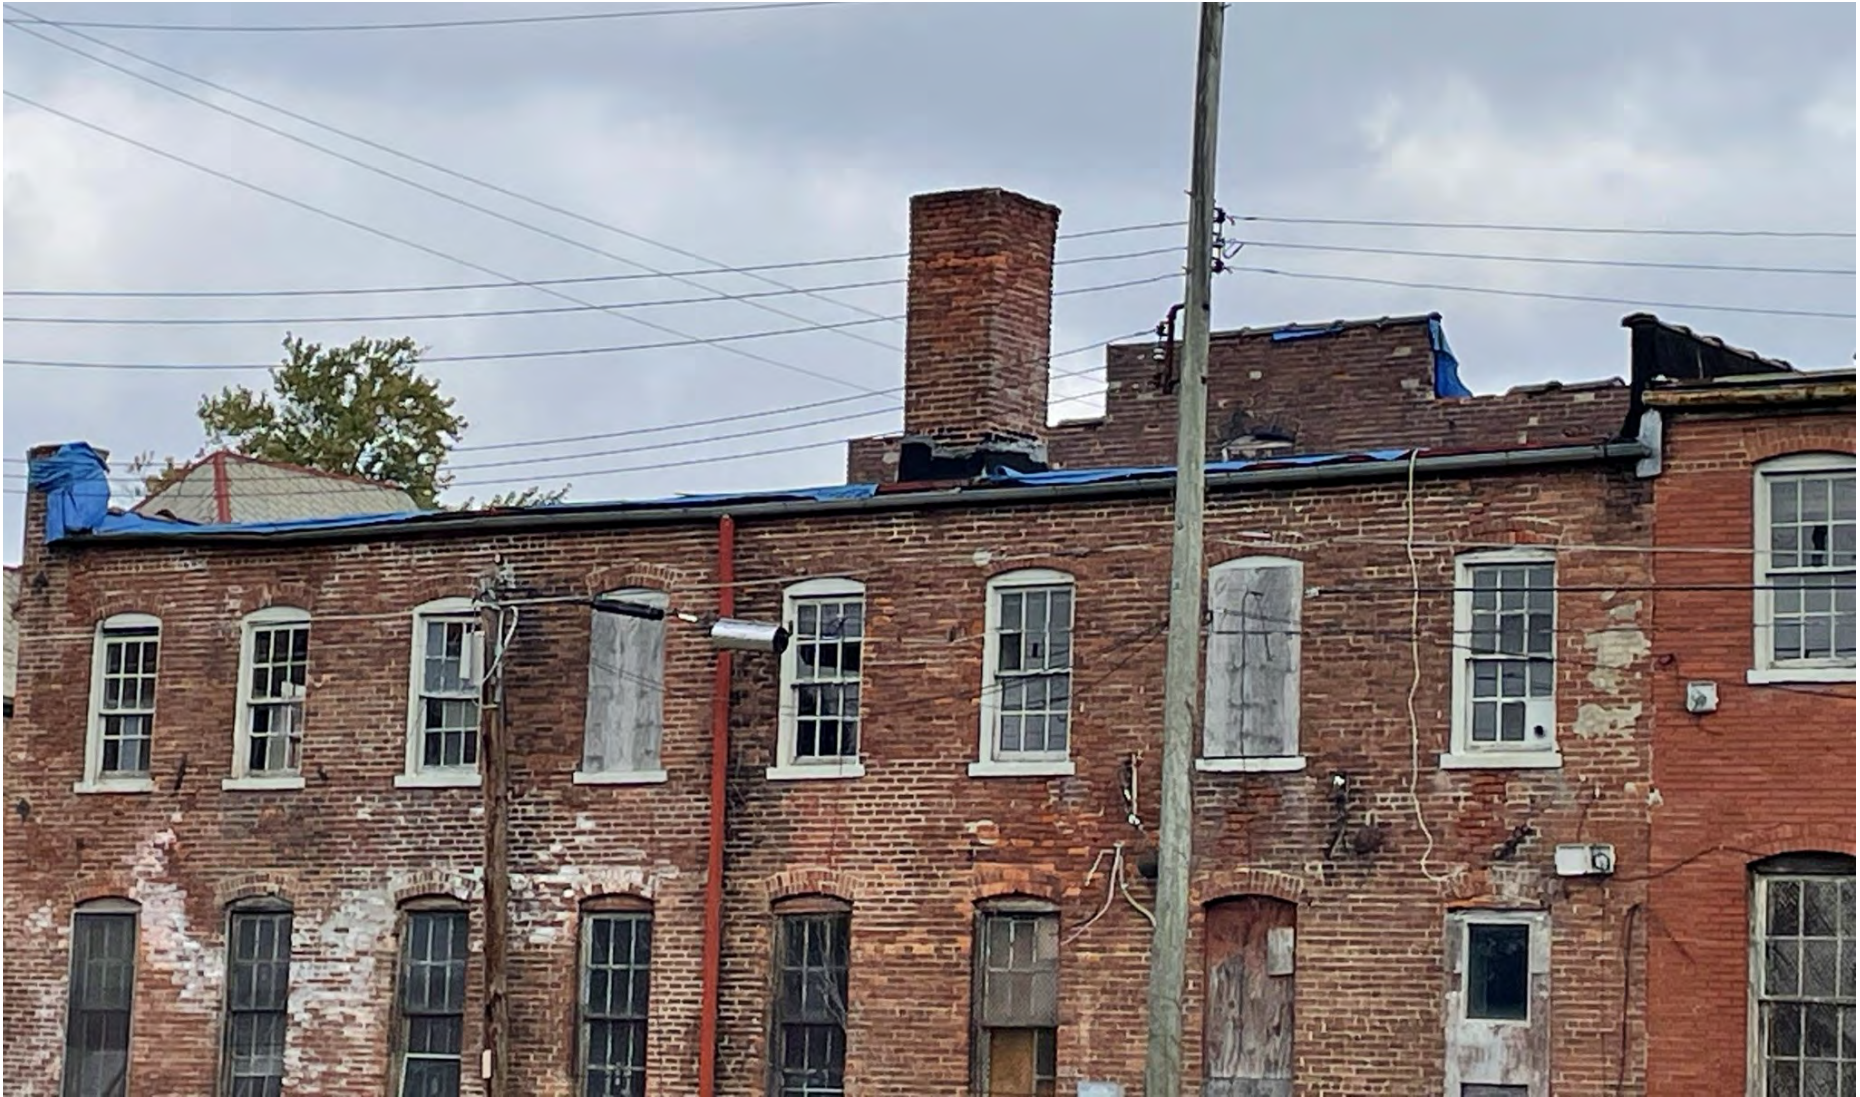
- Violations shown above: Not boarded to Code, bare and exposed wood, broken window, mortar voids throughout, roof covered by tarps.

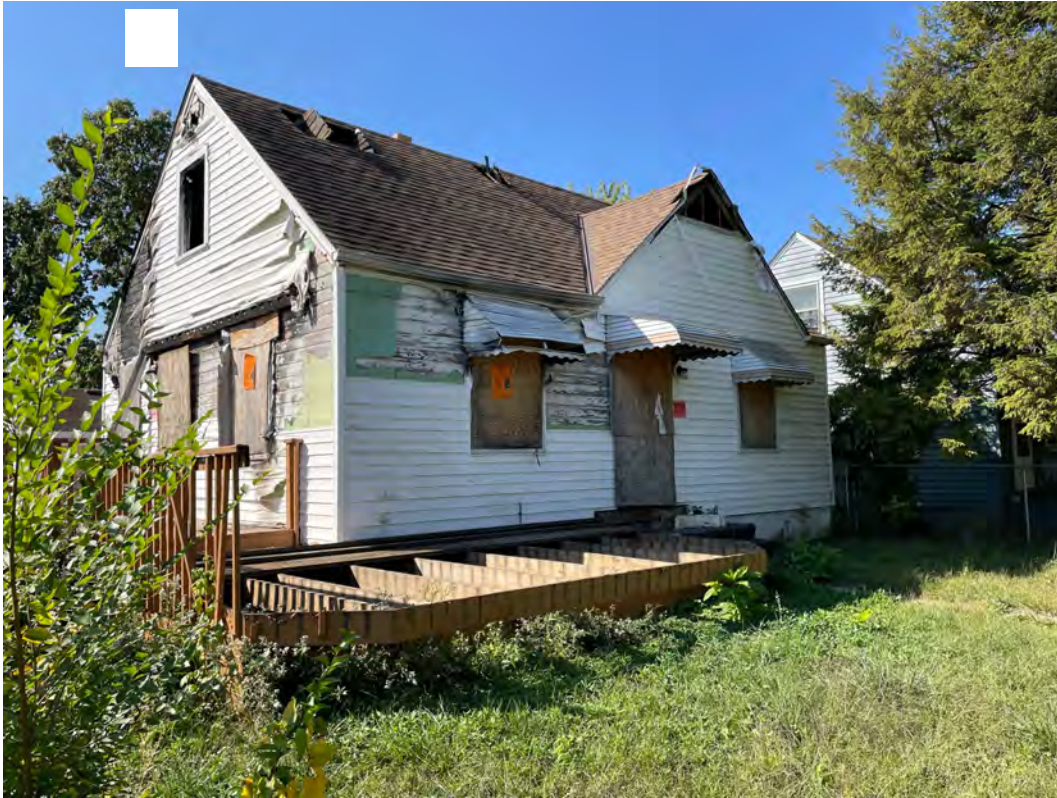
- Vacant structure is not boarded to code standards.
- Bare and exposed wood surfaces.
- Missing handrail.
- Damaged/missing siding and trim.
- Missing porch decking.
- The structure is not weathertight, water-tight, or rodent proof. There are holes in the ceiling and other multiple openings throughout the exterior of the structure.

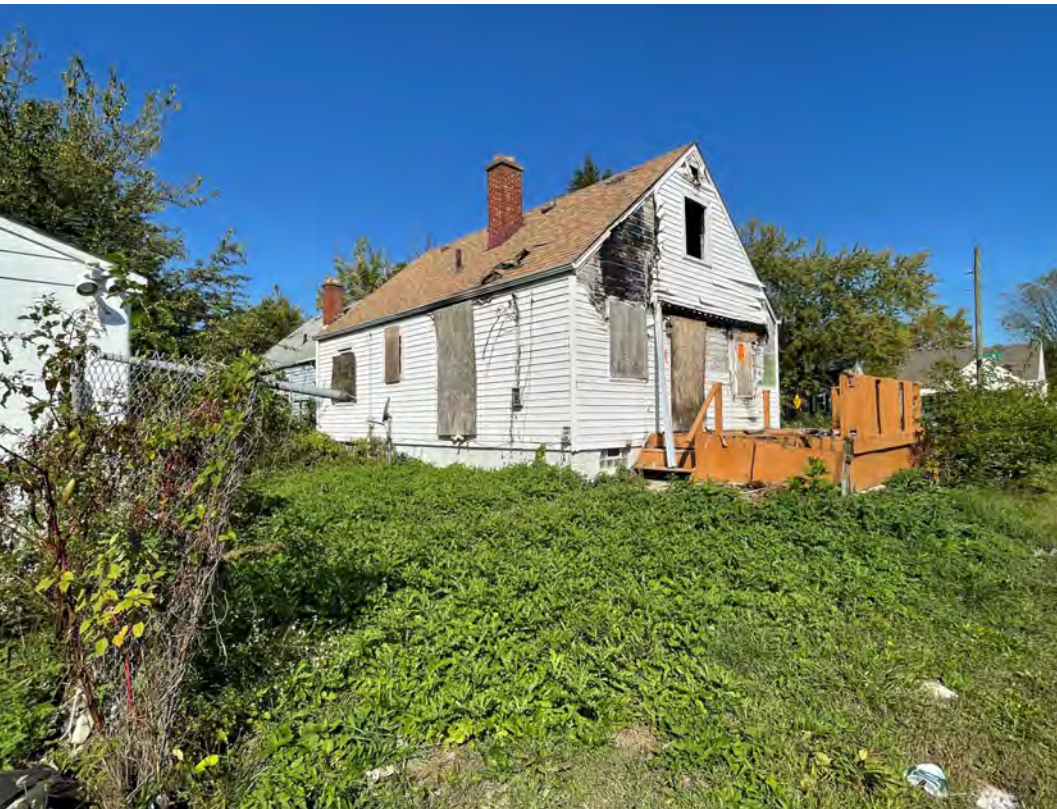
- Vacant structure is not boarded to code standards.
- Missing downspout.
- Bare and exposed wood surfaces.
- Damaged/missing siding and trim.
- Solid waste.
- The structure is not weathertight, water-tight, or rodent proof. There are multiple openings throughout the exterior of the structure.
- Rank growth.

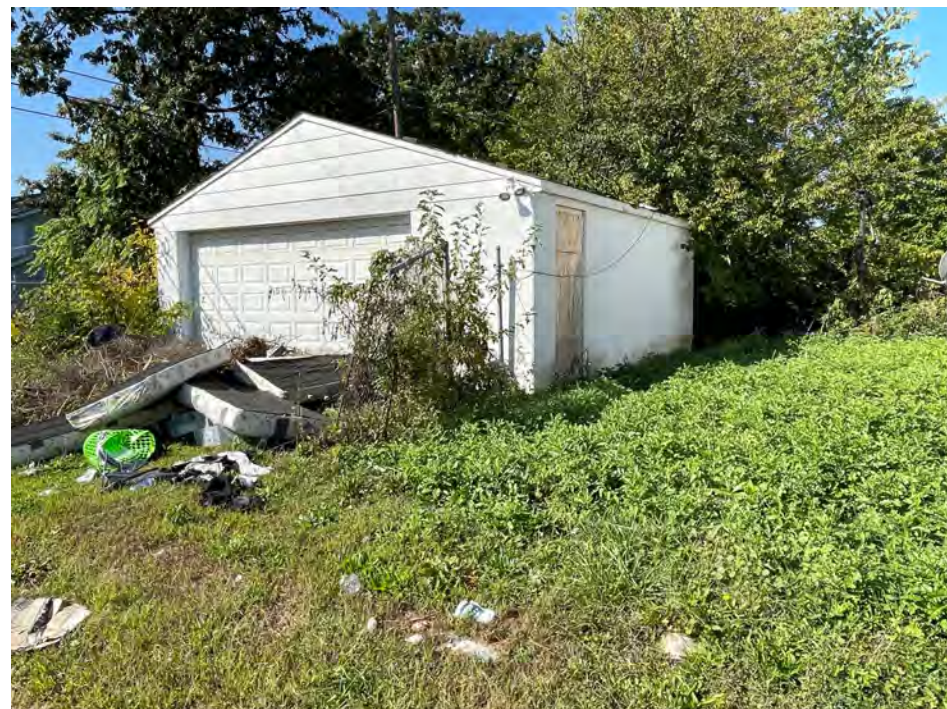
- Vacant structure is not boarded to code standards.
- Solid waste.
- Rank growth.

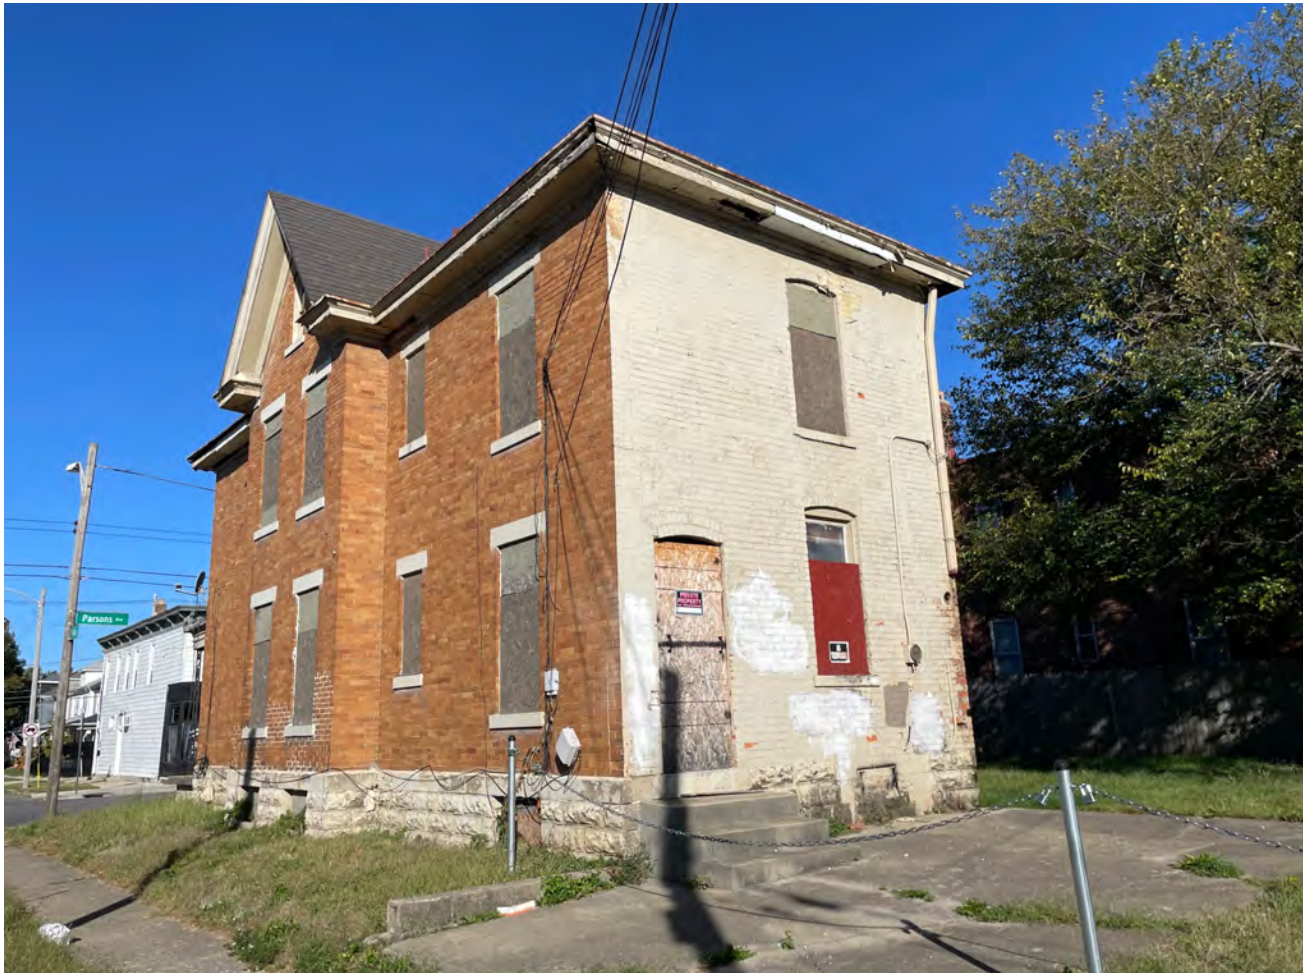
- Vacant structure is not boarded to code
- Bare and/or rotting wood surfaces throughout the exterior
- Damaged/missing raincarrier components
- Mortar voids/holes in exterior walls and foundation
- Rear steps missing handrail

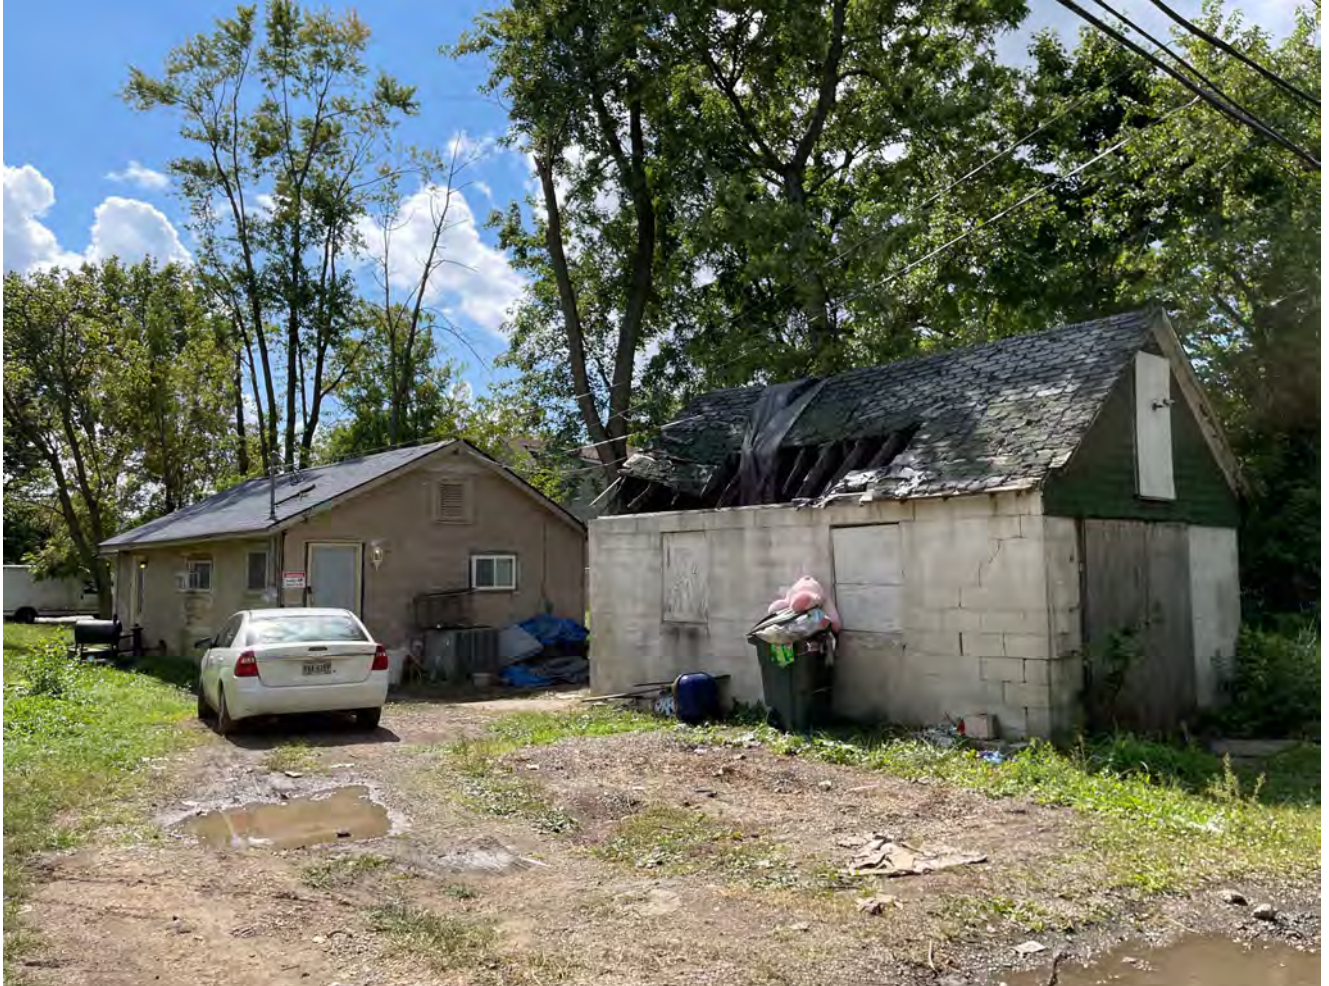
(5)

- Bare/rotting wood surfaces throughout the exterior
- Accessory structure walls cracked, damaged, and/or otherwise in a state of disrepair
- Accessory structure roofing materials are damaged, missing, has holes, and/or is otherwise in a severe state of disrepair
- Motor vehicle parked on an unimproved surface
- Improper exterior storage of miscellaneous items

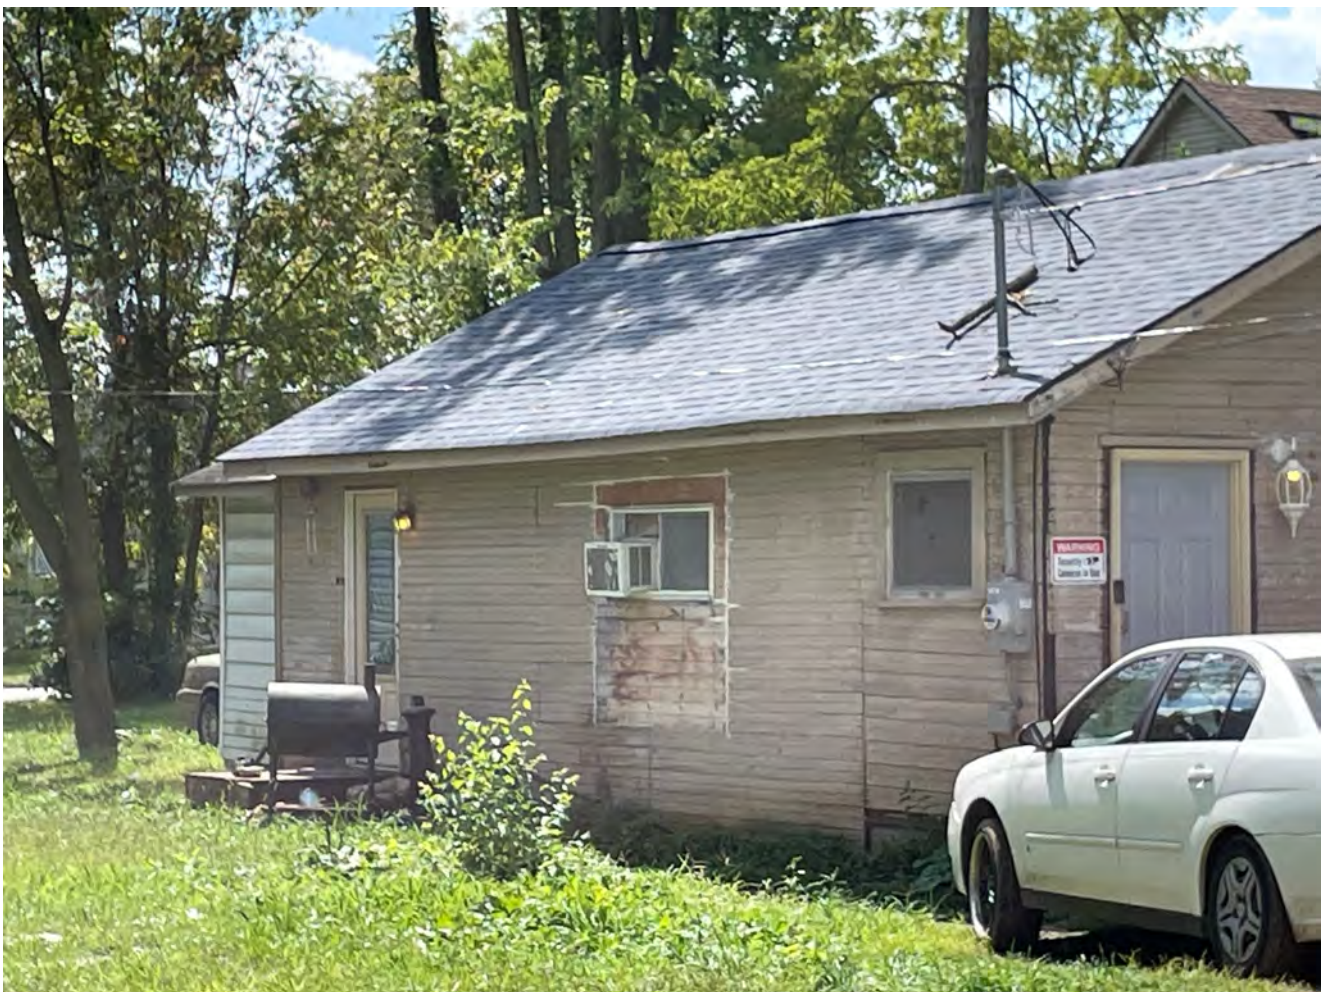
- Bare wood surfaces throughout the exterior
- Missing raincarriers

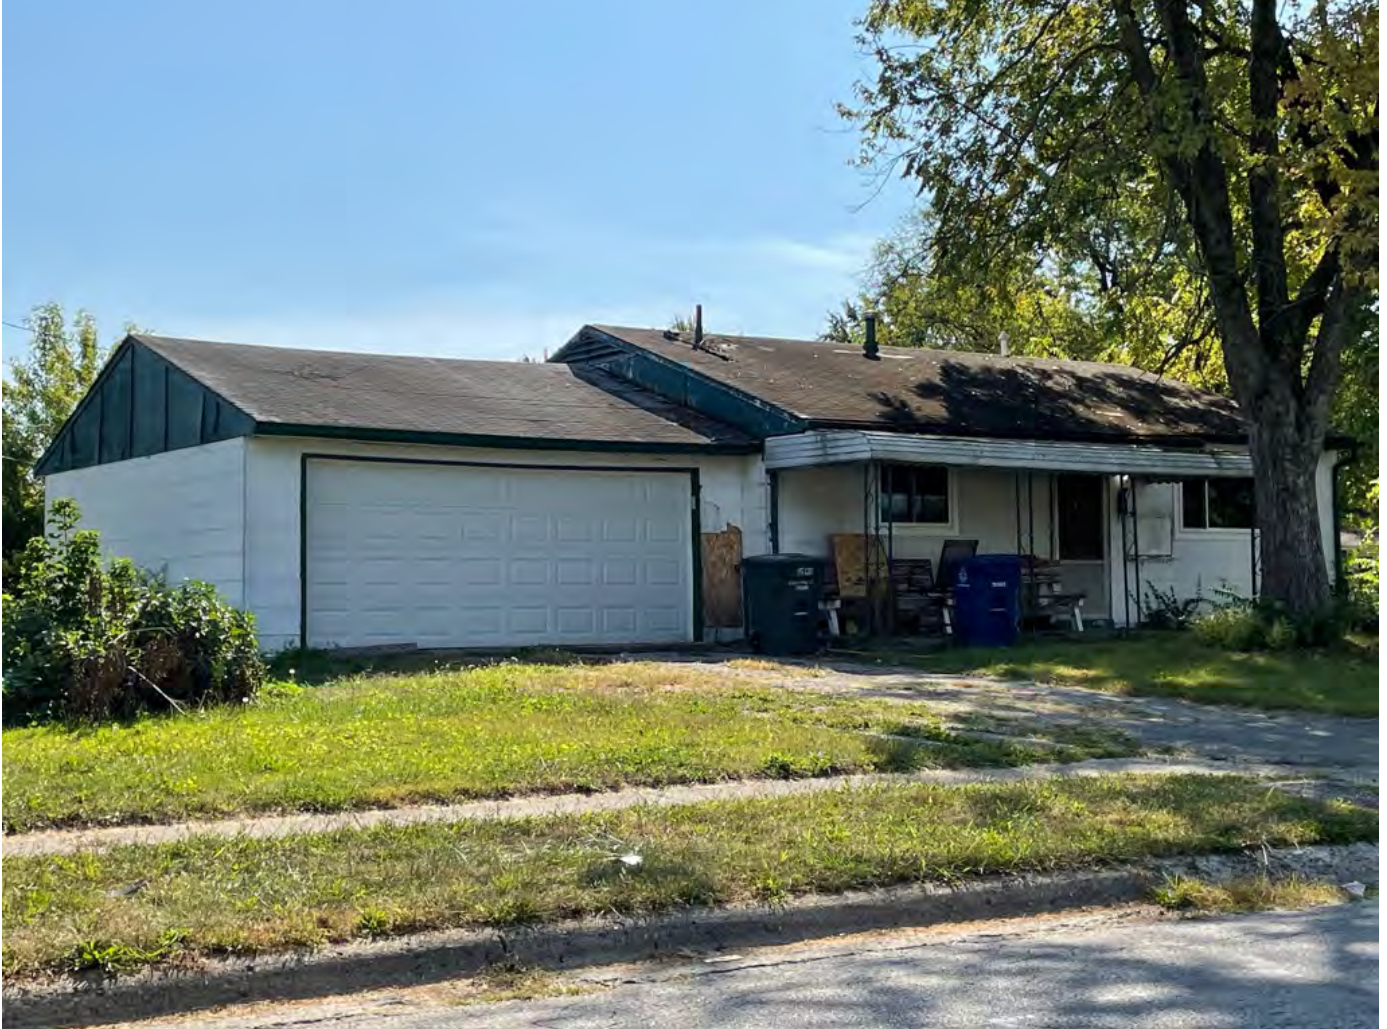
(1)

Roofing materials in disrepair. Rain carriers in disrepair and/or missing sections. Sections of siding in disrepair and/or missing. Siding and fascia boards contain areas of exposed wood. Asphalt driveway deteriorating and becoming overgrown. Prohibited exterior storage of building materials. Some high grass and weeds.

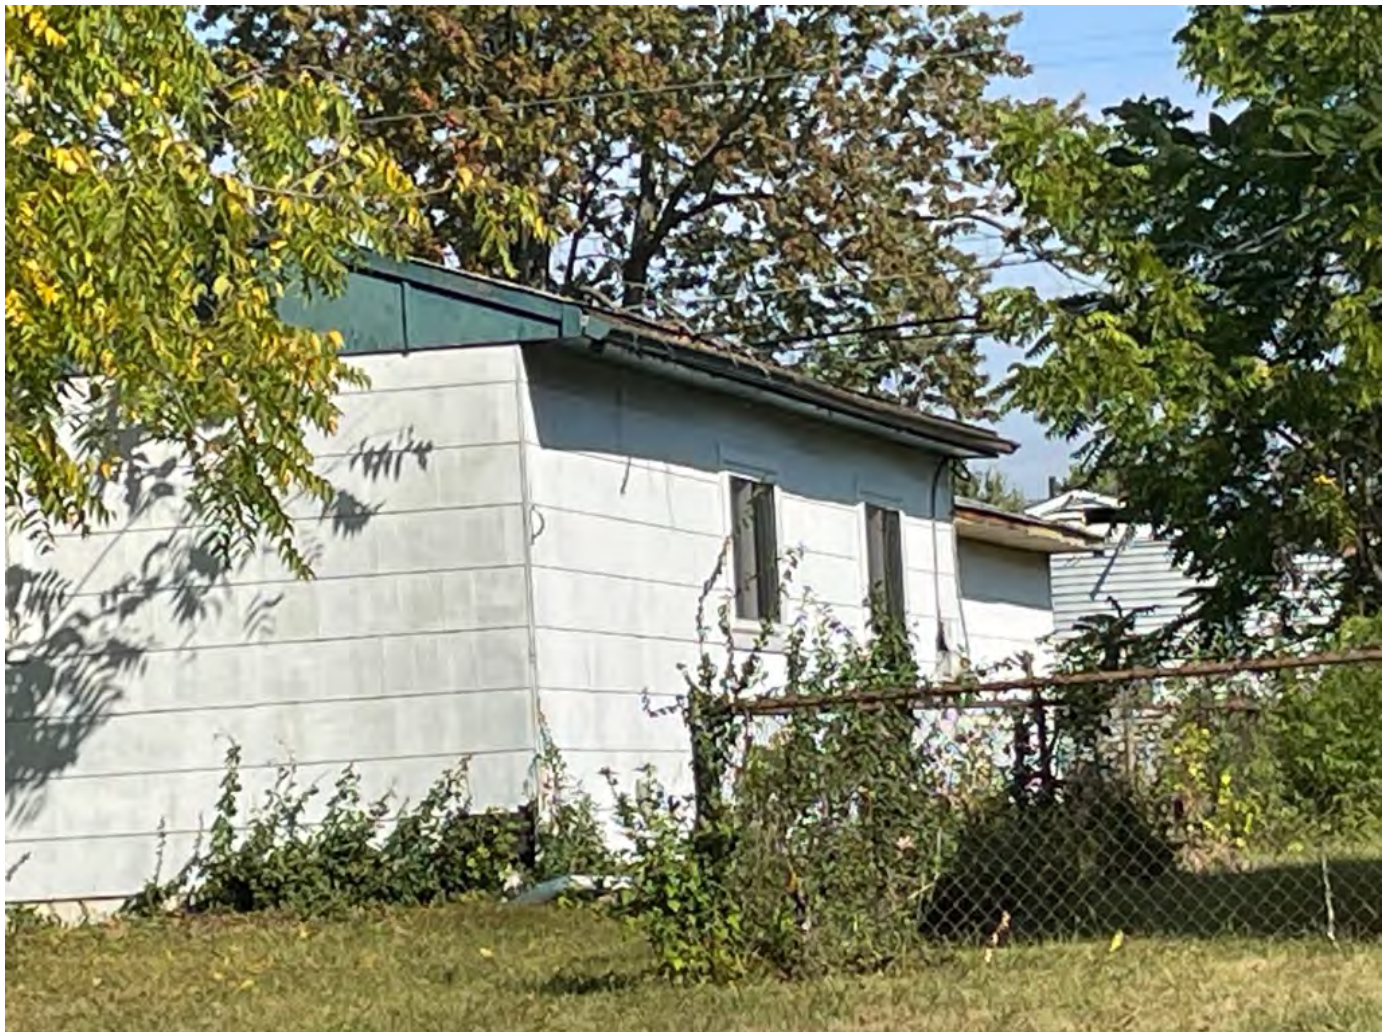
(2)

Rain carriers in disrepair and missing sections in the rear of structure, and missing downspout on corner. Sections of soffit in disrepair. Fascia boards contain areas of exposed wood. Some high grass and weeds.

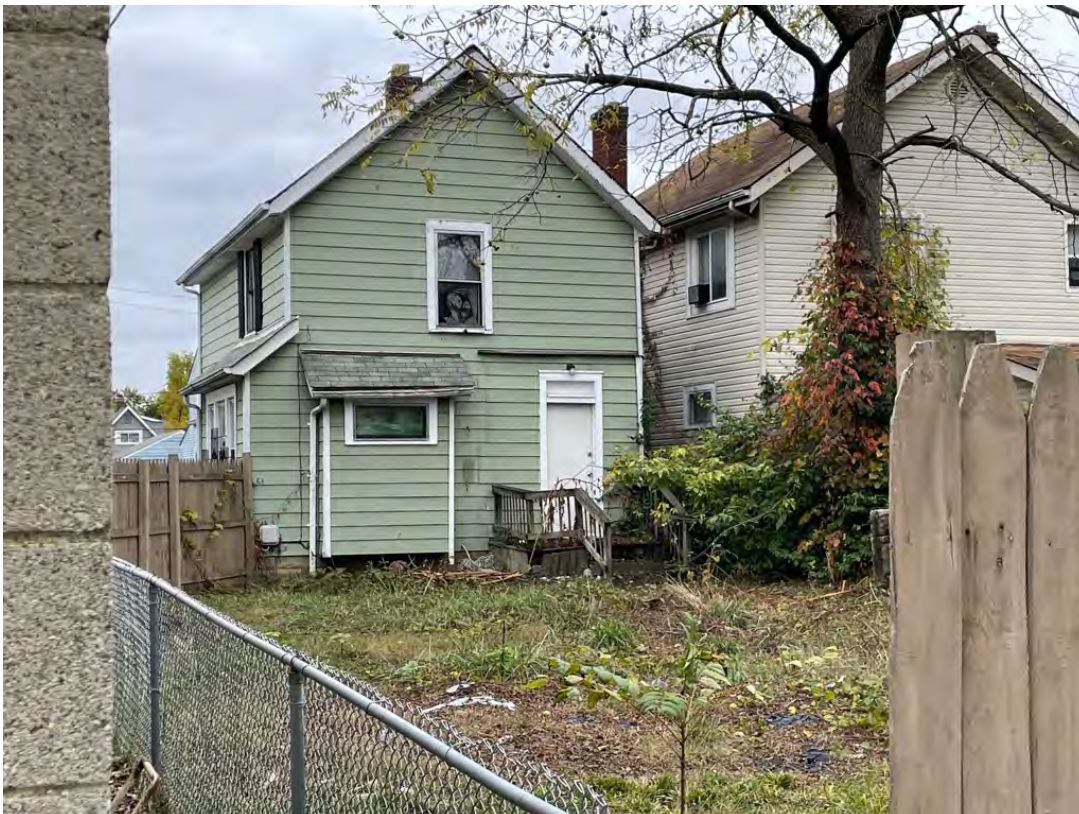
Rear Of House

Vacant structure, not boarded to code.
Weeds in excess of 12 inches in height present on premises.
Damage to rear deck and steps.
Bare and exposed woods on exterior of structure including at trim and fascia.

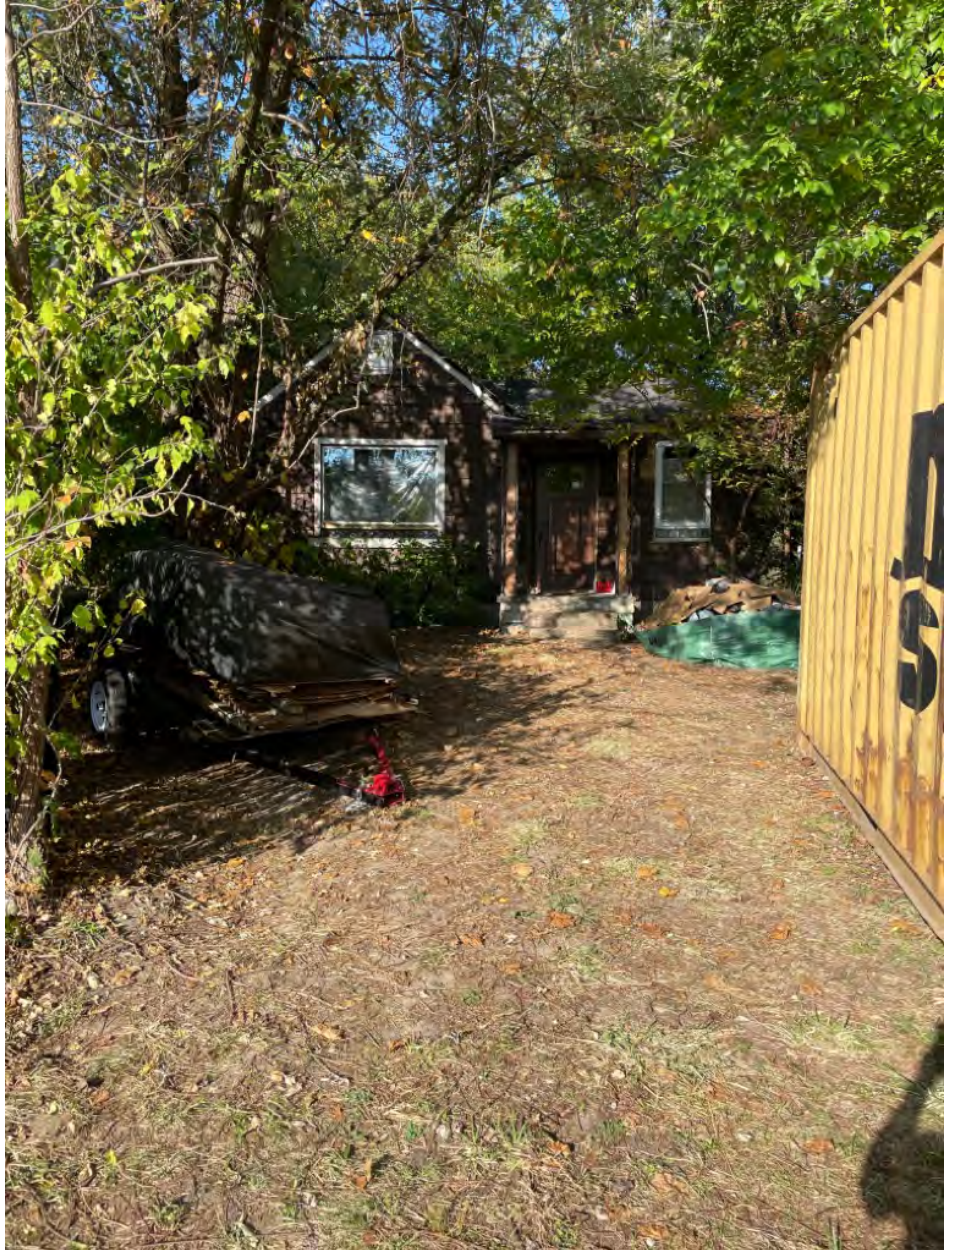
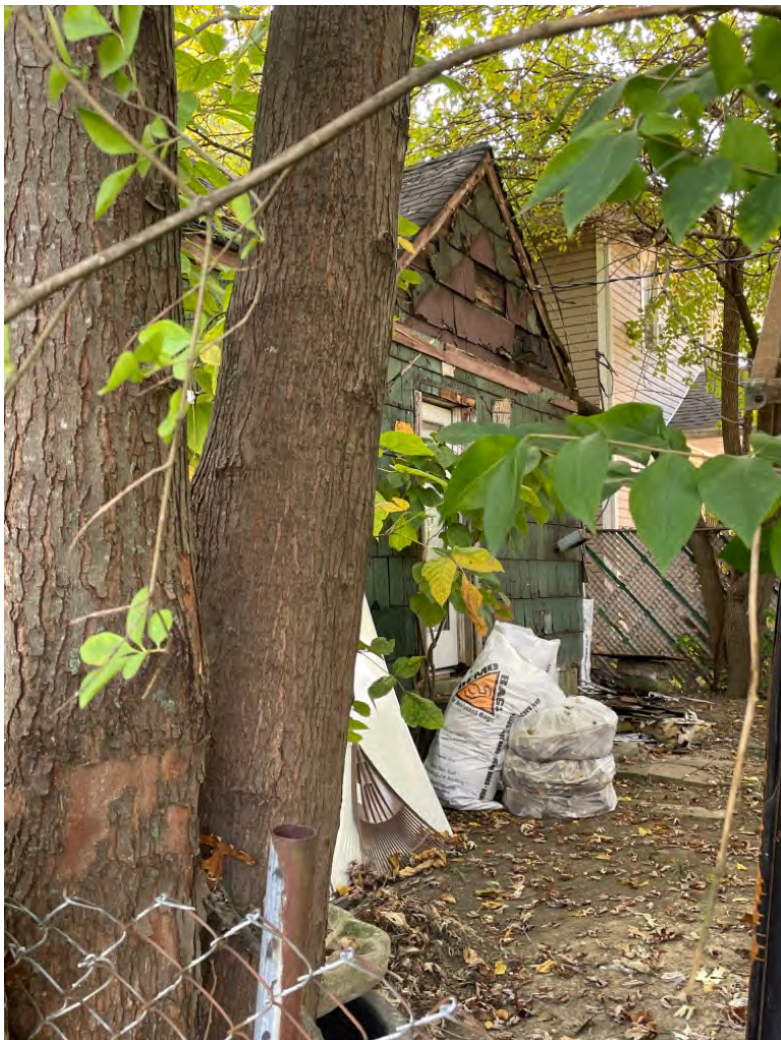
Vacant structure not boarded to City Code standards.
Bare exposed wood throughout.
Missing and or damaged shingles throughout.
Trash, debris and solid waste.
Prohibited exterior storage of building/construction materials.
