Columbus Housing Community Reinvestment Area (CHCRA): Housing Survey

Between August and October 2023, a surveillance survey was conducted in the area to be known as the Columbus Housing Community Reinvestment Area (CHCRA). The purpose of the survey was to determine the location of housing units that appeared to be in need of repair or upgrading, vacant lots in need of redevelopment and the severity of structures that appeared to be in need of repair, and/or needing to be removed.

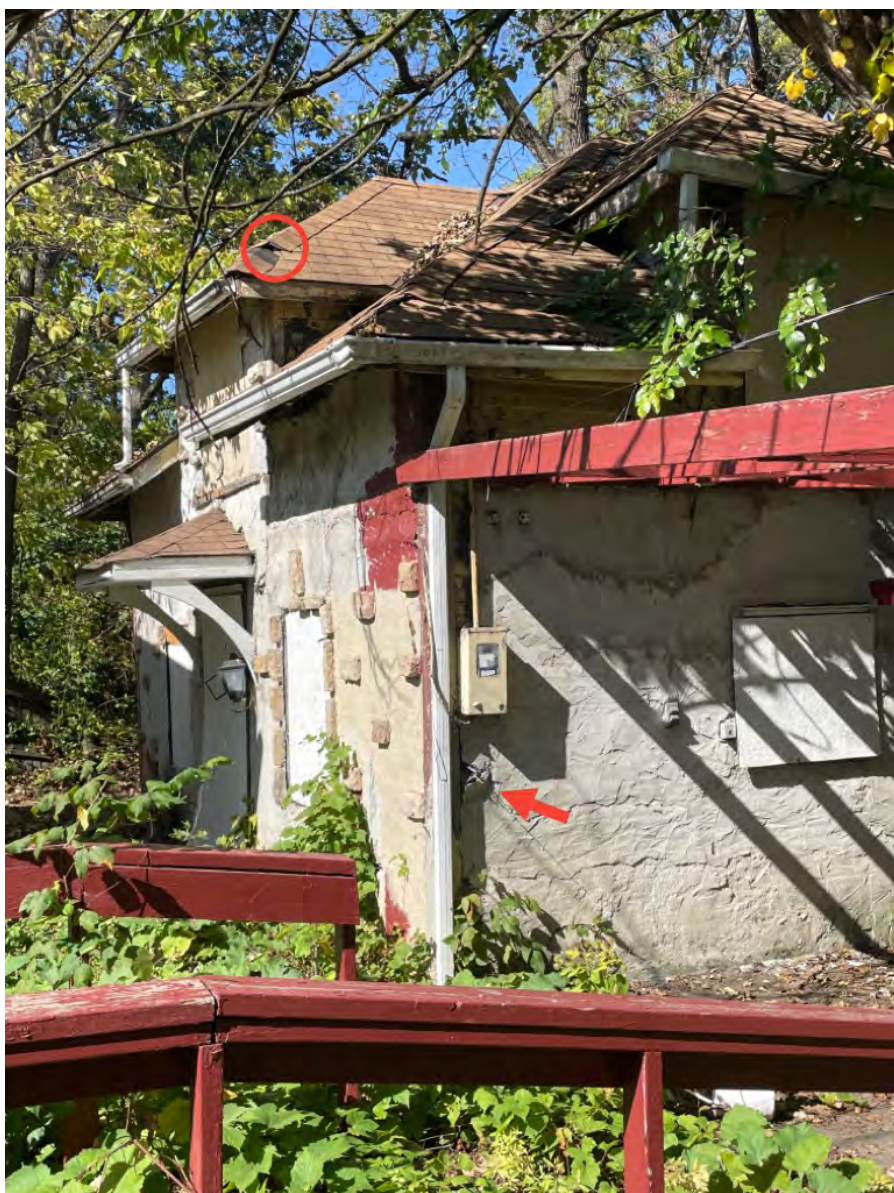
(8)

Bare, exposed wood. Damaged stucco siding.

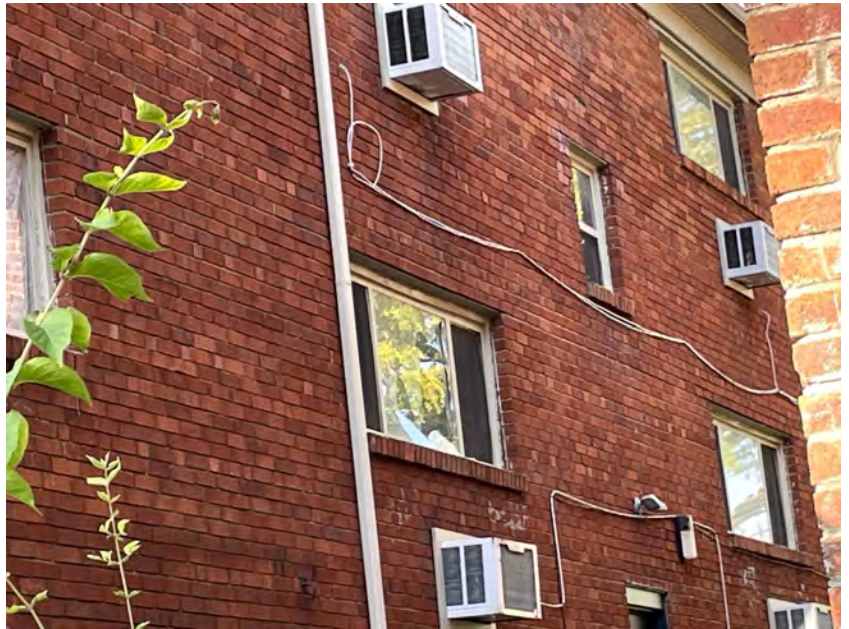
(2)

Broken window pane

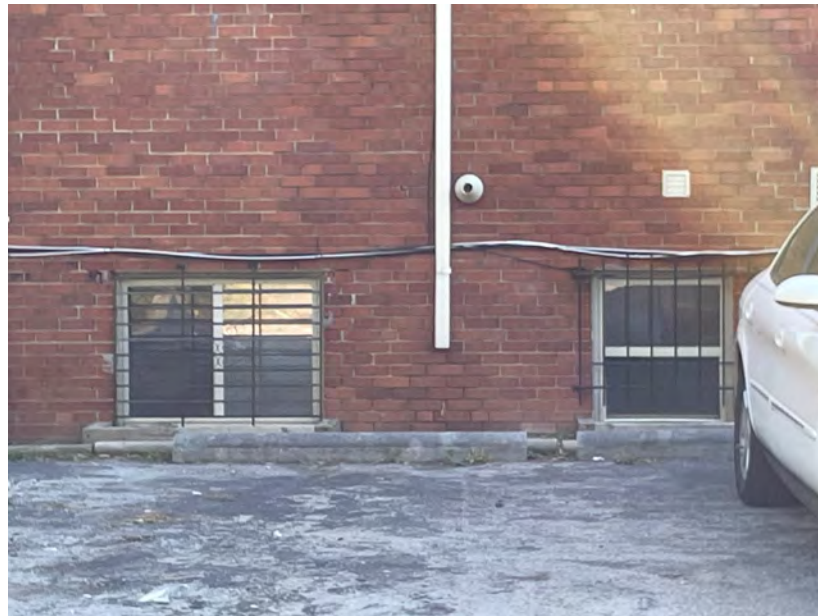
Parking/circulation area is cracked, damaged, and/or otherwise in a state of disrepairSolid waste

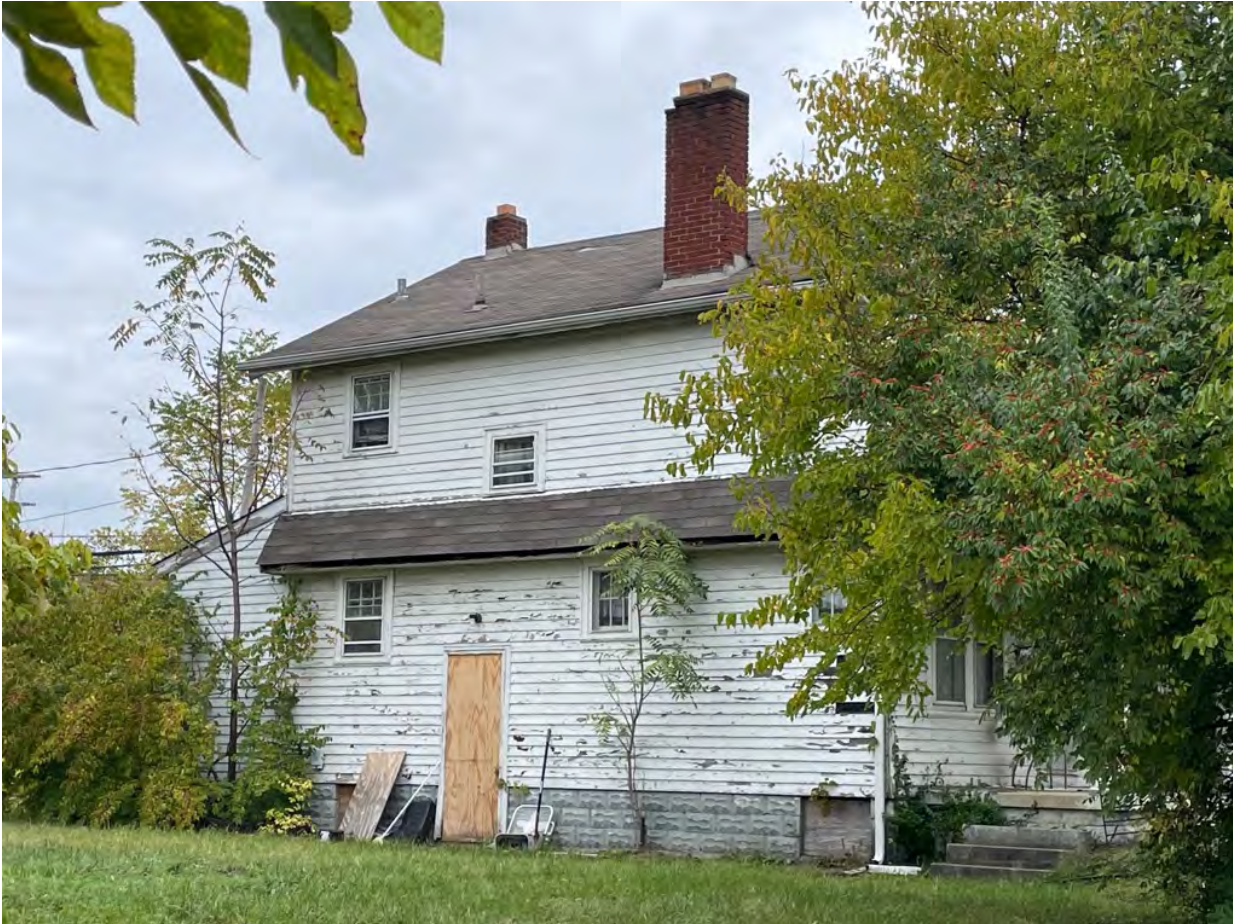
West Side Of House

Vacant structure not boarded to code.

Solid waste present on premises.

Bare and exposed wood present on exterior of structure.

Damaged and/or missing components to exterior of structure including trim or fascia board. Damage to roof.

Porch steps lack required handrail.

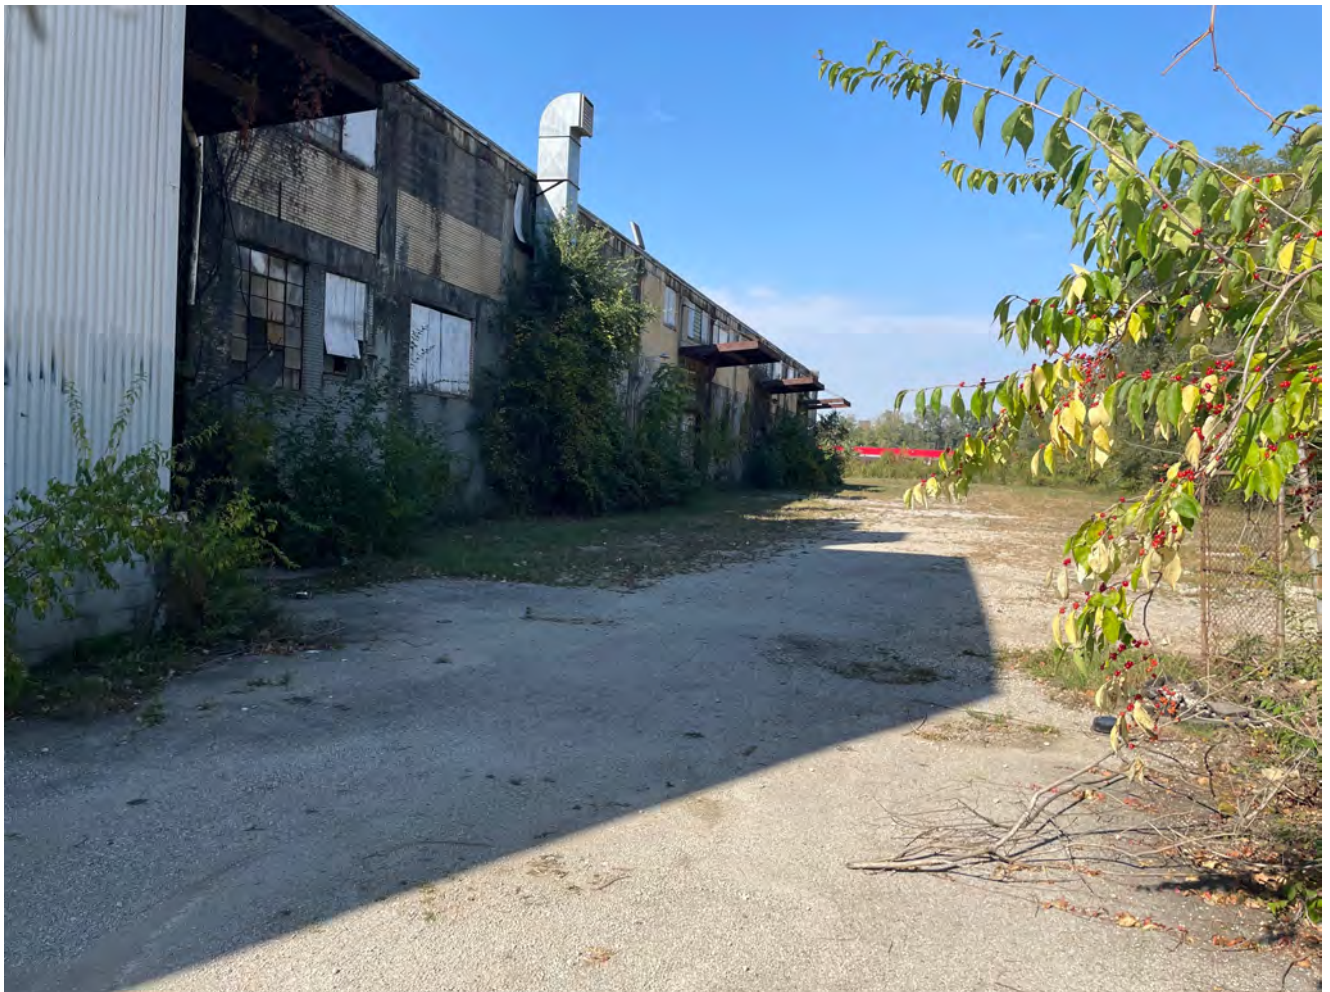
Vacant structure is not boarded to code
Broken windows
High grass/weeds
Bare wood surfaces throughout the exterior

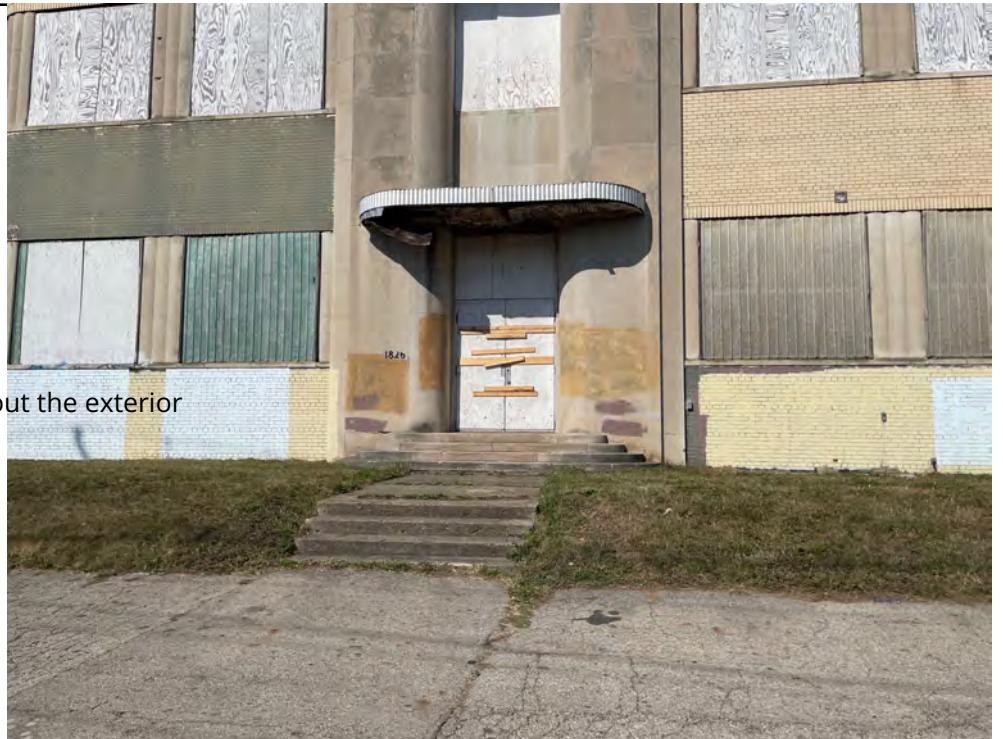
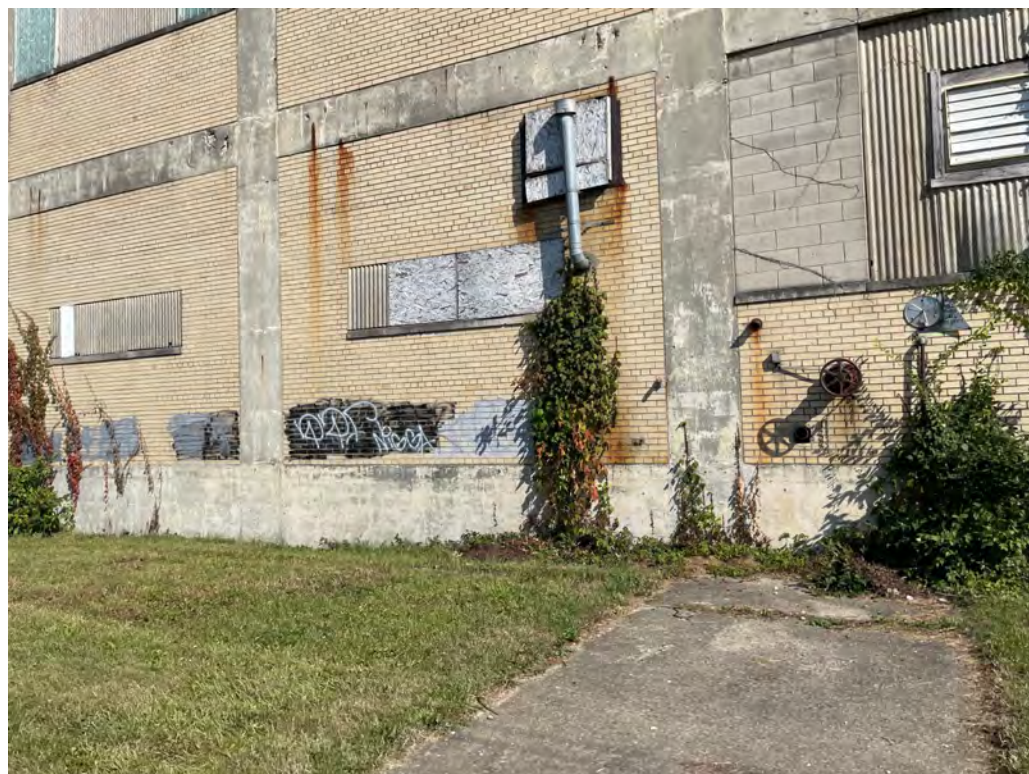
Vacant structure is not boarded to code
Broken windows
Bare wood surfaces throughout the exterior
Damaged masonry with holes in exterior walls
Graffiti
Rank growth
Damaged/missing vent slats

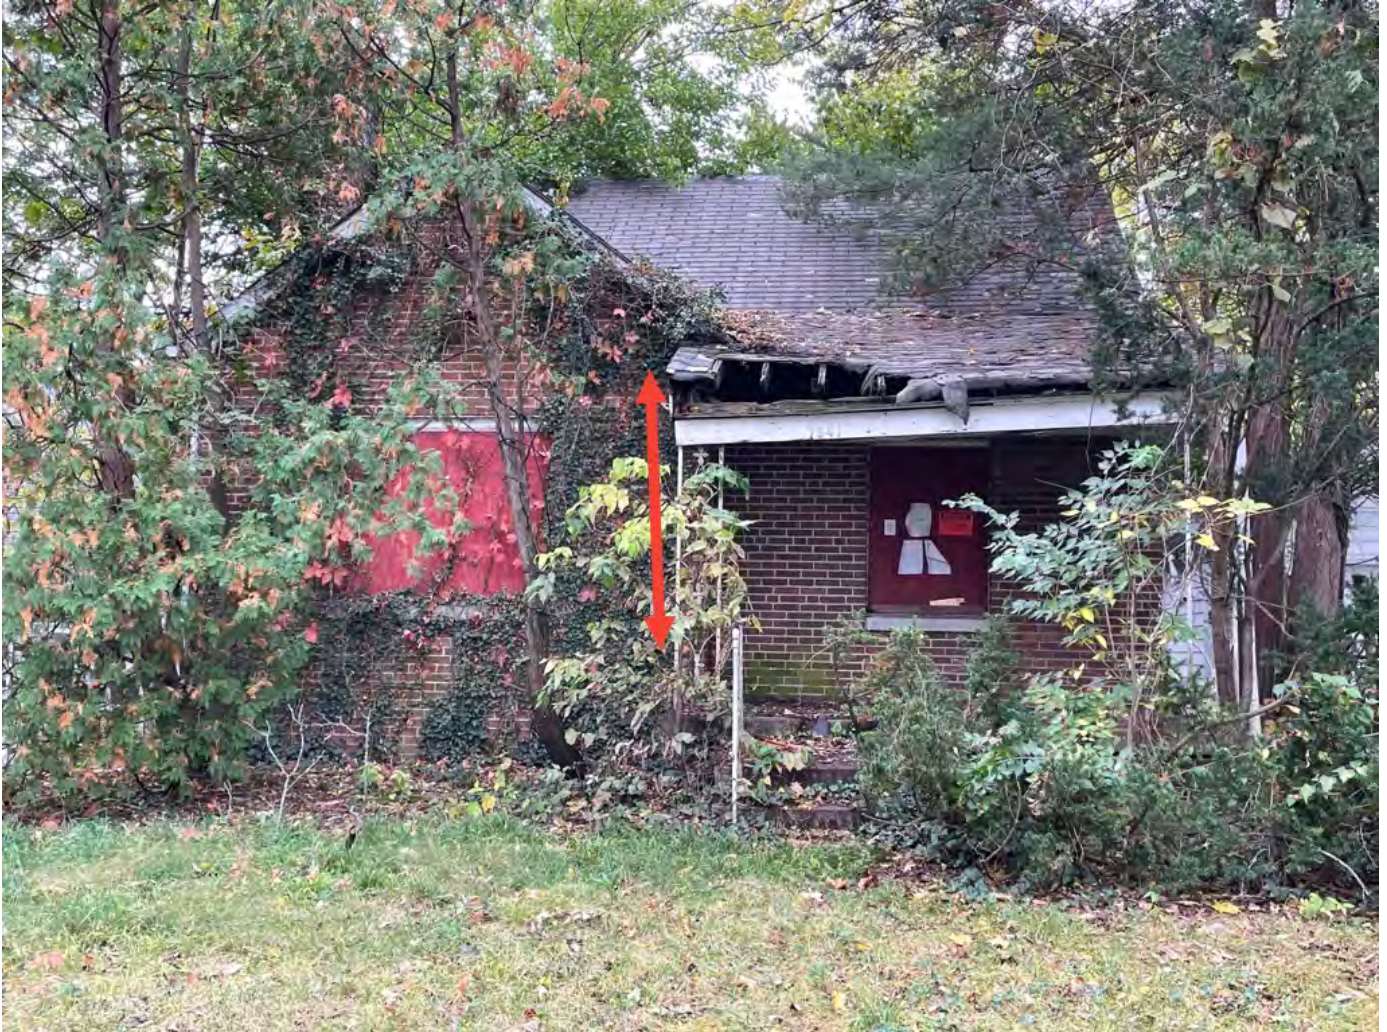
The porch roof has rotted, deteriorated bare exposed wood and has a large hole. There is bare wood exposed wood throughout. There is overgrown vegetation. Missing gutters.

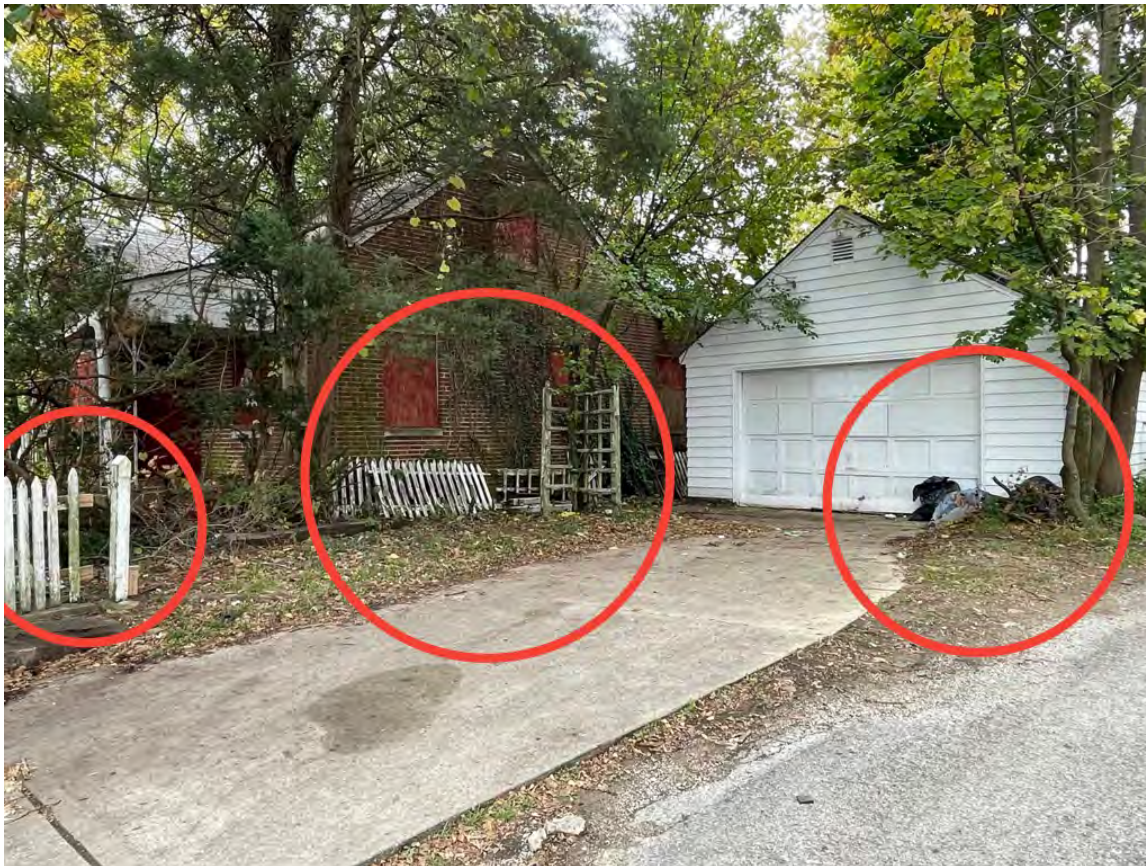
Bare exposed wood.
Yard waste
Damaged fencing.
Solid waste/trash and debris.

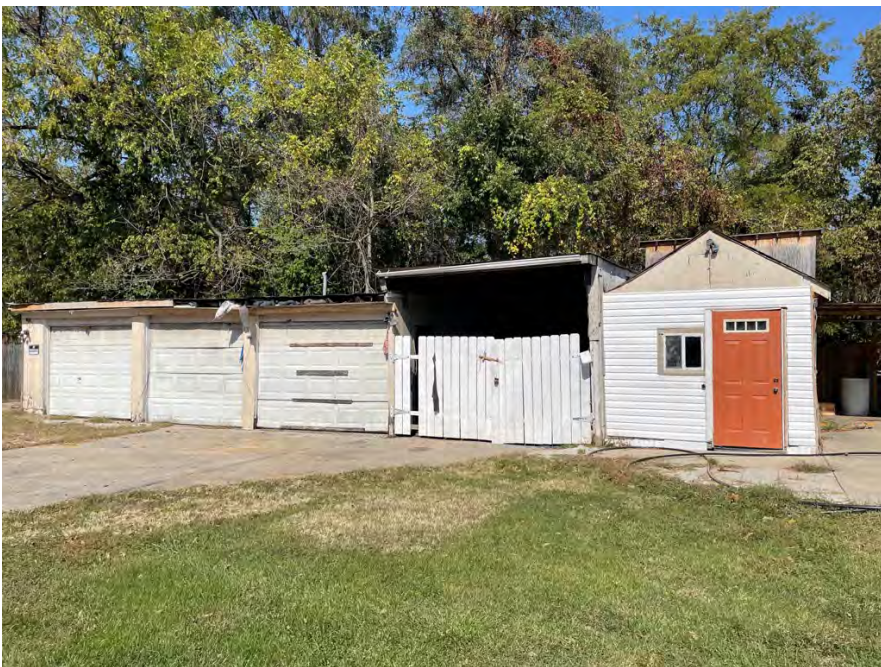
Front Of Accessory Structure

Vacant structure not boarded to code. Bare and exposed wood present on exterior of structure. Damaged and/or missing elements on exterior of structure including fascia and trim.

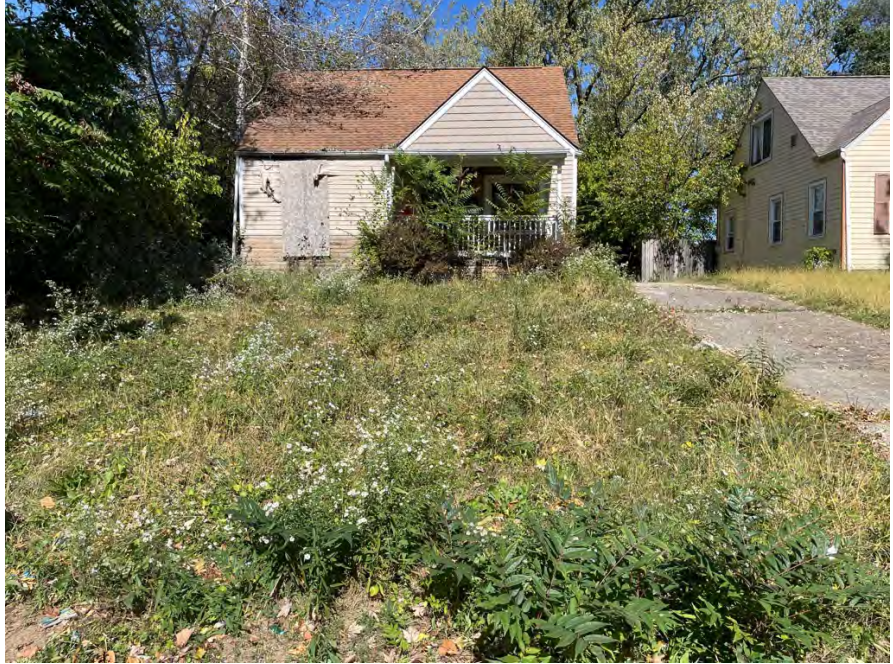
Vacant structure not boarded to code. Bare, exposed wood surfaces present on exterior. Damaged and/or missing sections of siding. Rain carriers full of debris. Missing downspout. High grass/weeds.

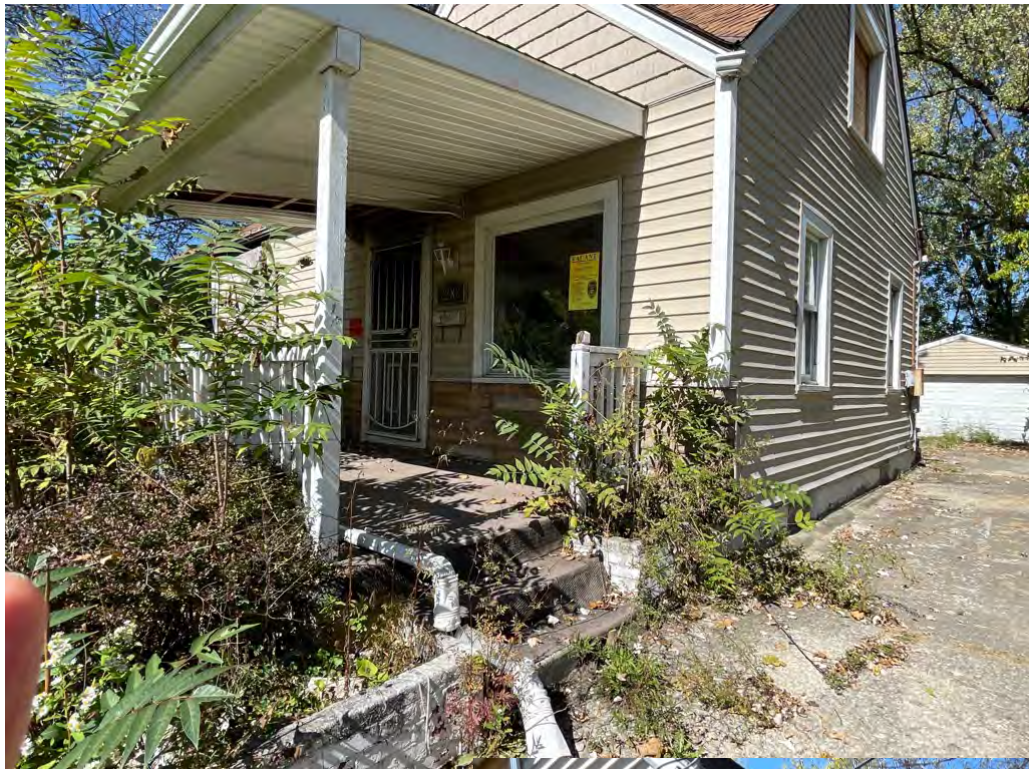
Vacant structure not boarded to code. Bare, exposed wood surfaces present on exterior. Missing downspout. Front porch overhang/ceiling materials missing and/or in disrepair. High grass/weeds. Solid waste.

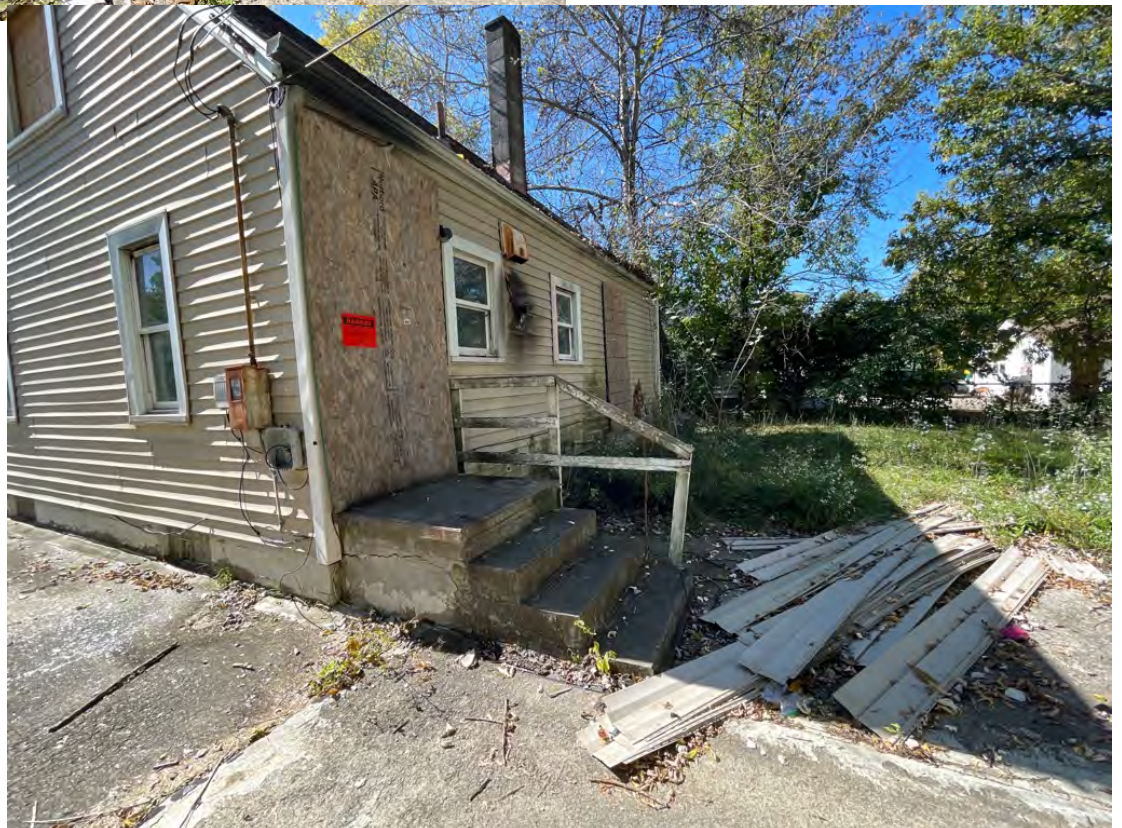
Vacant structure not boarded to code. Bare, exposed wood surfaces present on exterior. Damaged and/or missing sections of siding. Rain carriers full of debris. High grass/weeds. Solid waste.

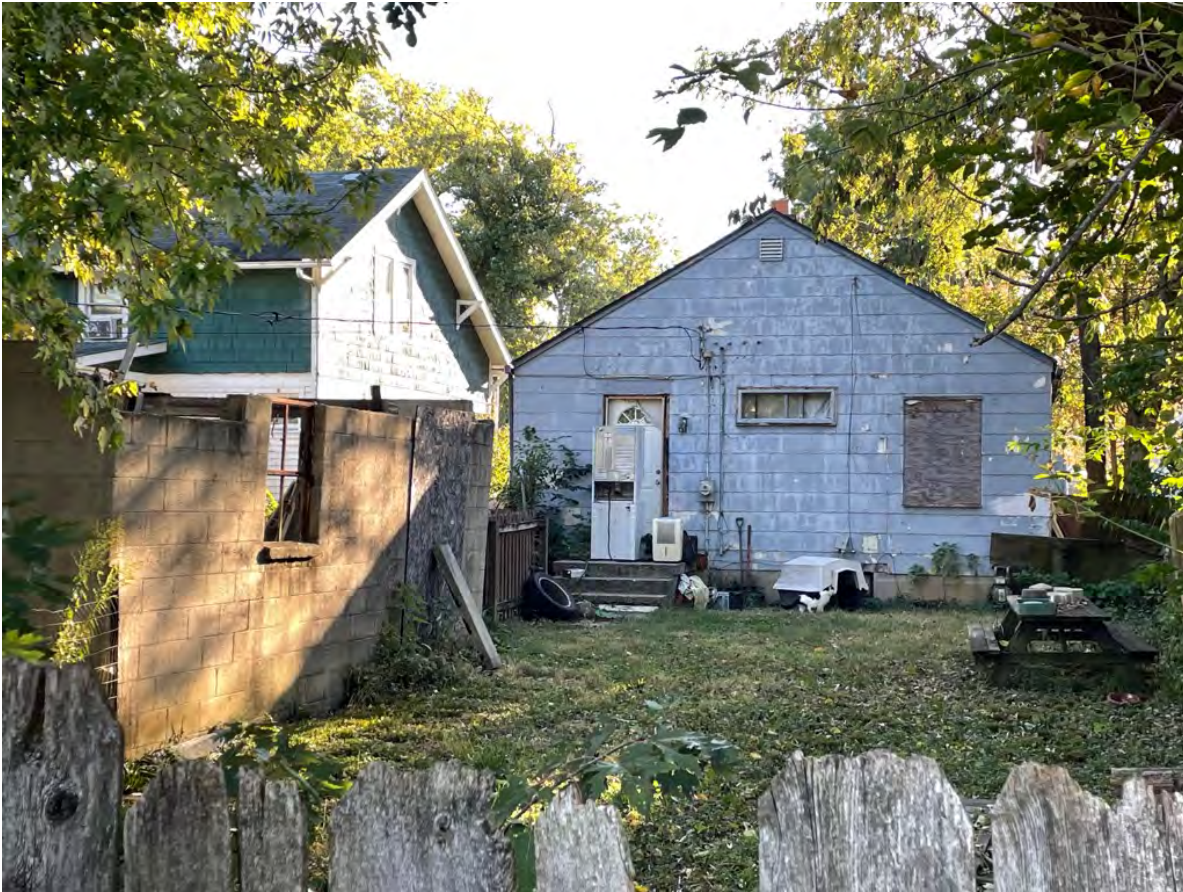
Bare and exposed wood including at window board.
Improper exterior storage of appliances and tire.
Solid waste present on premises.
Accessory structure displays damaged and missing components.

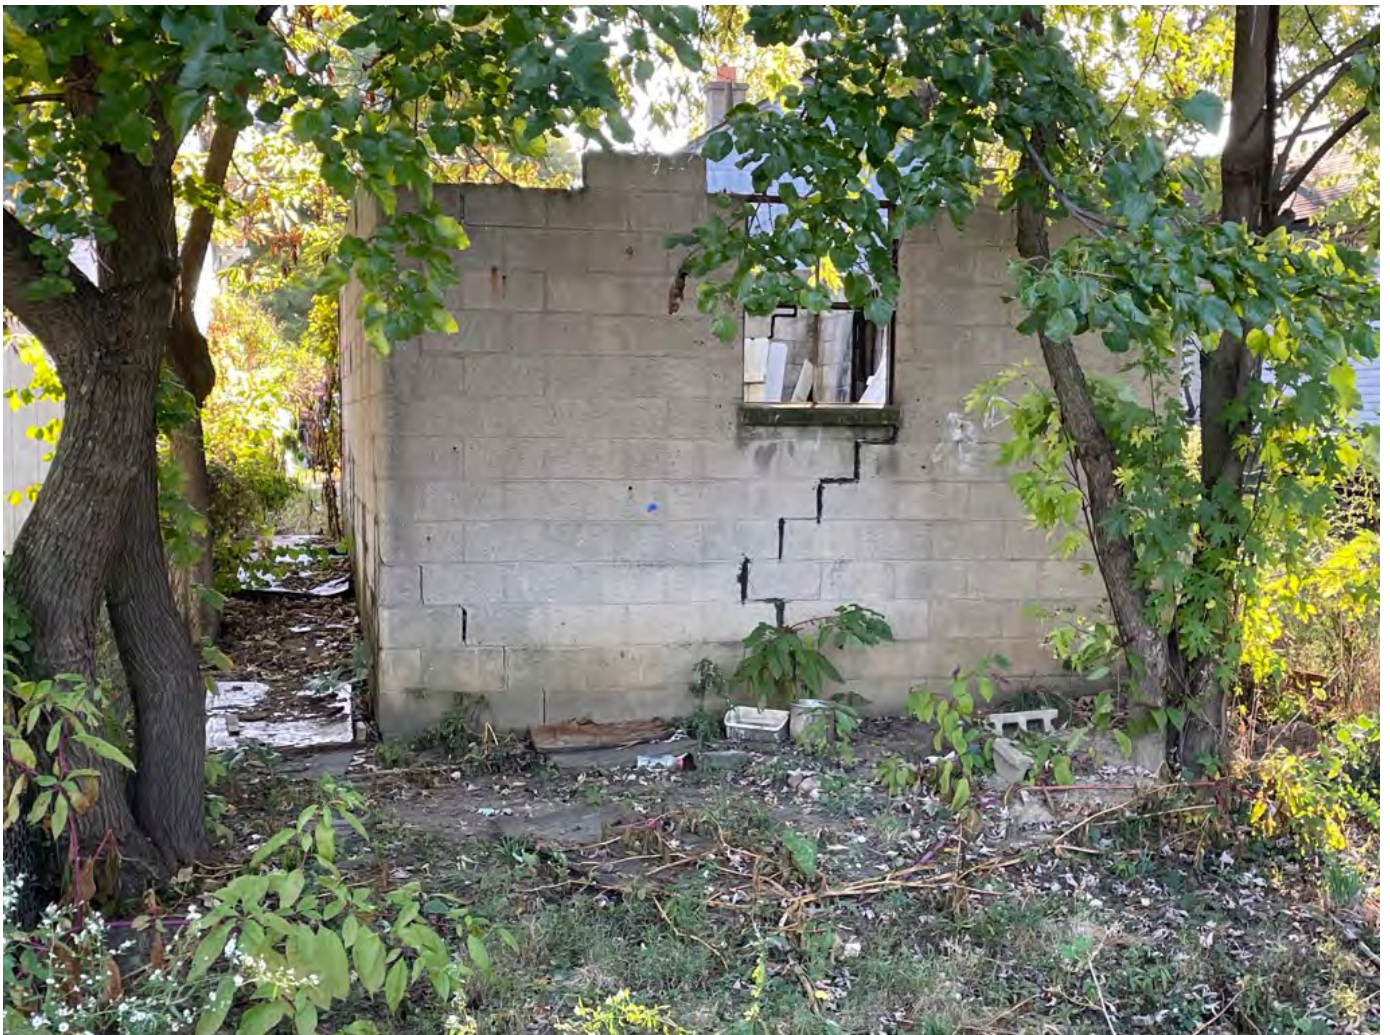
Solid waste present on premises.
Accessory structure displays damaged and missing components.
Grass and/or weeds in excess of 12 inches in height on premises.

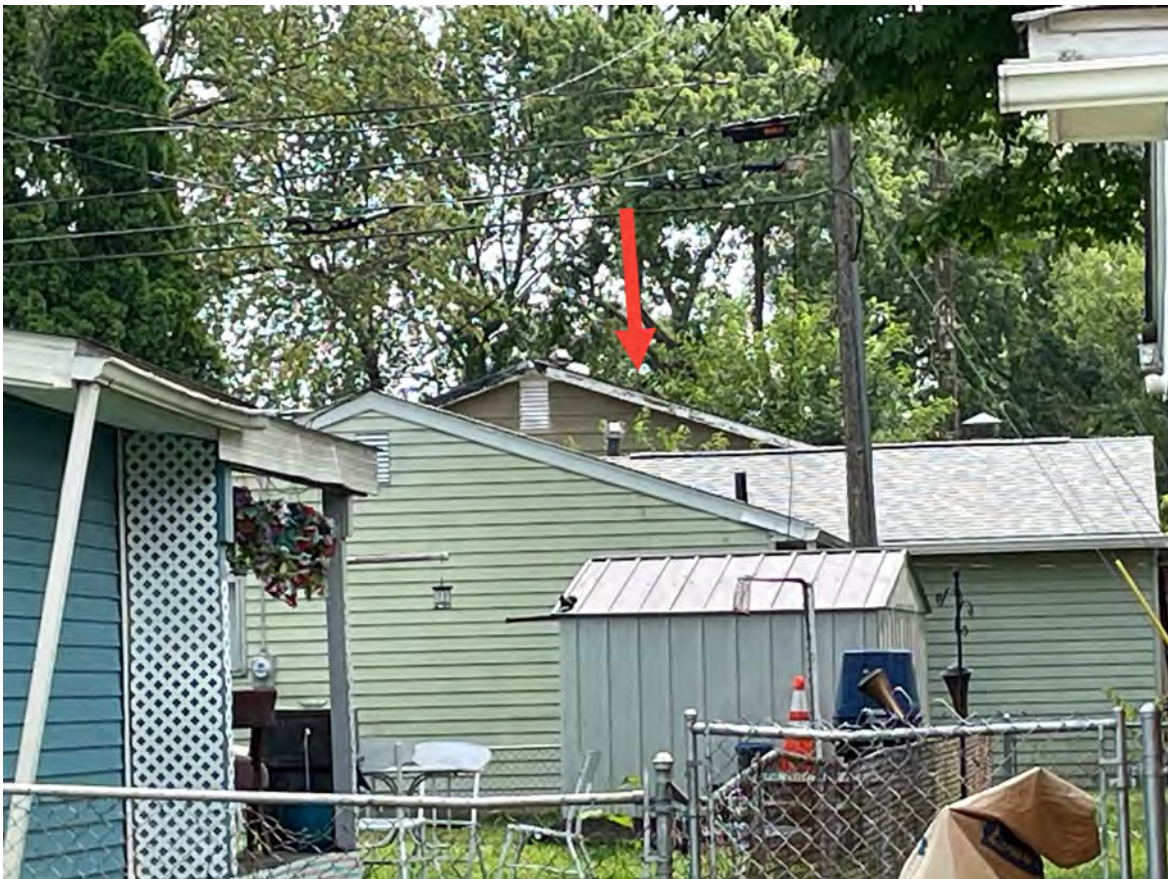
- Bare and exposed wood surfaces.

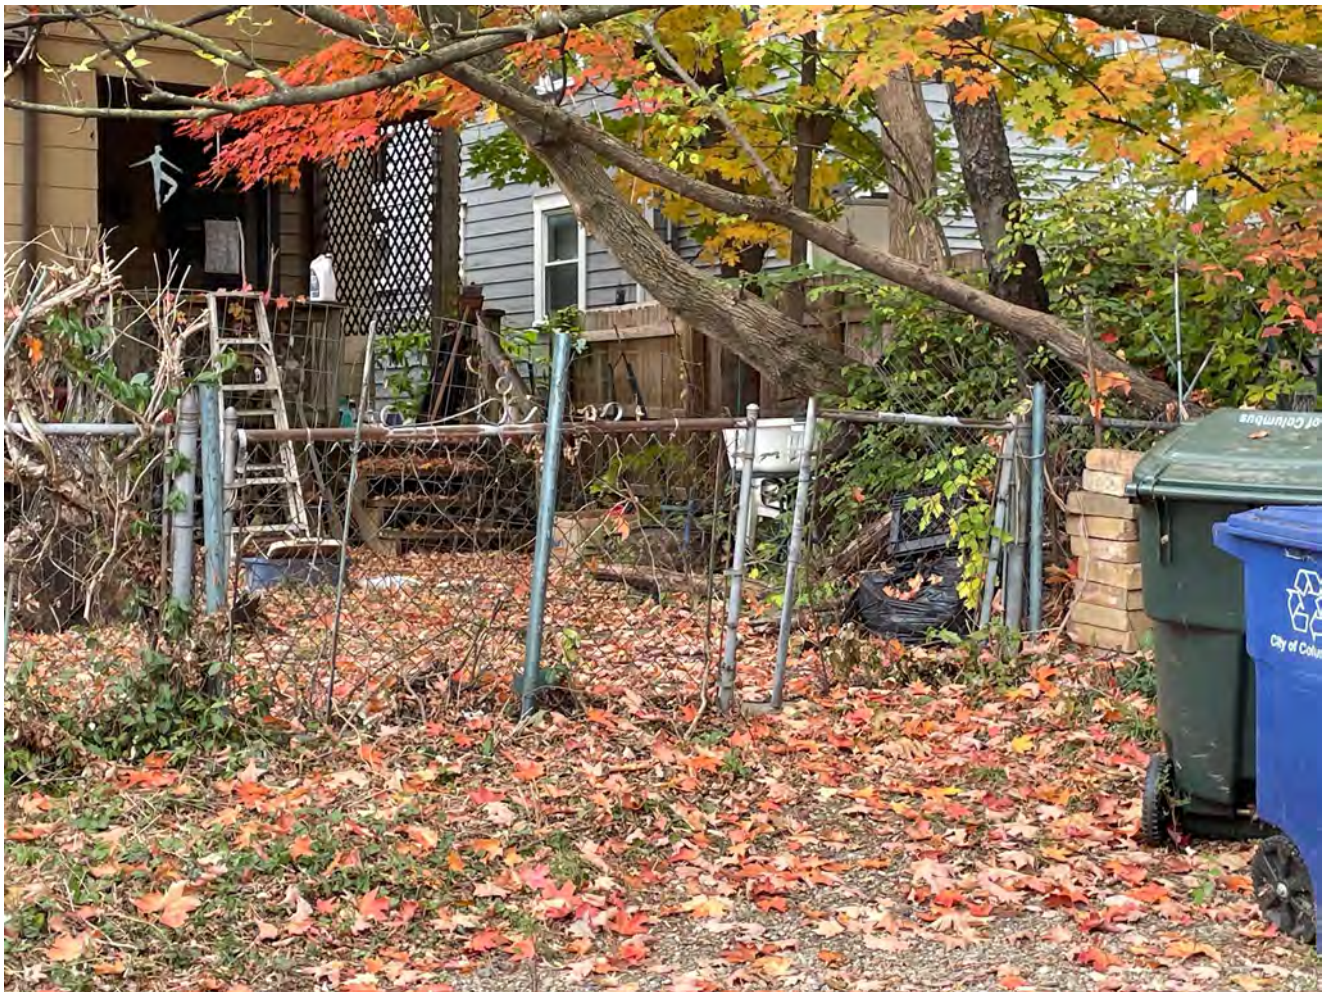
Solid waste and/or improper exterior storage of construction materials and/or miscellaneous items

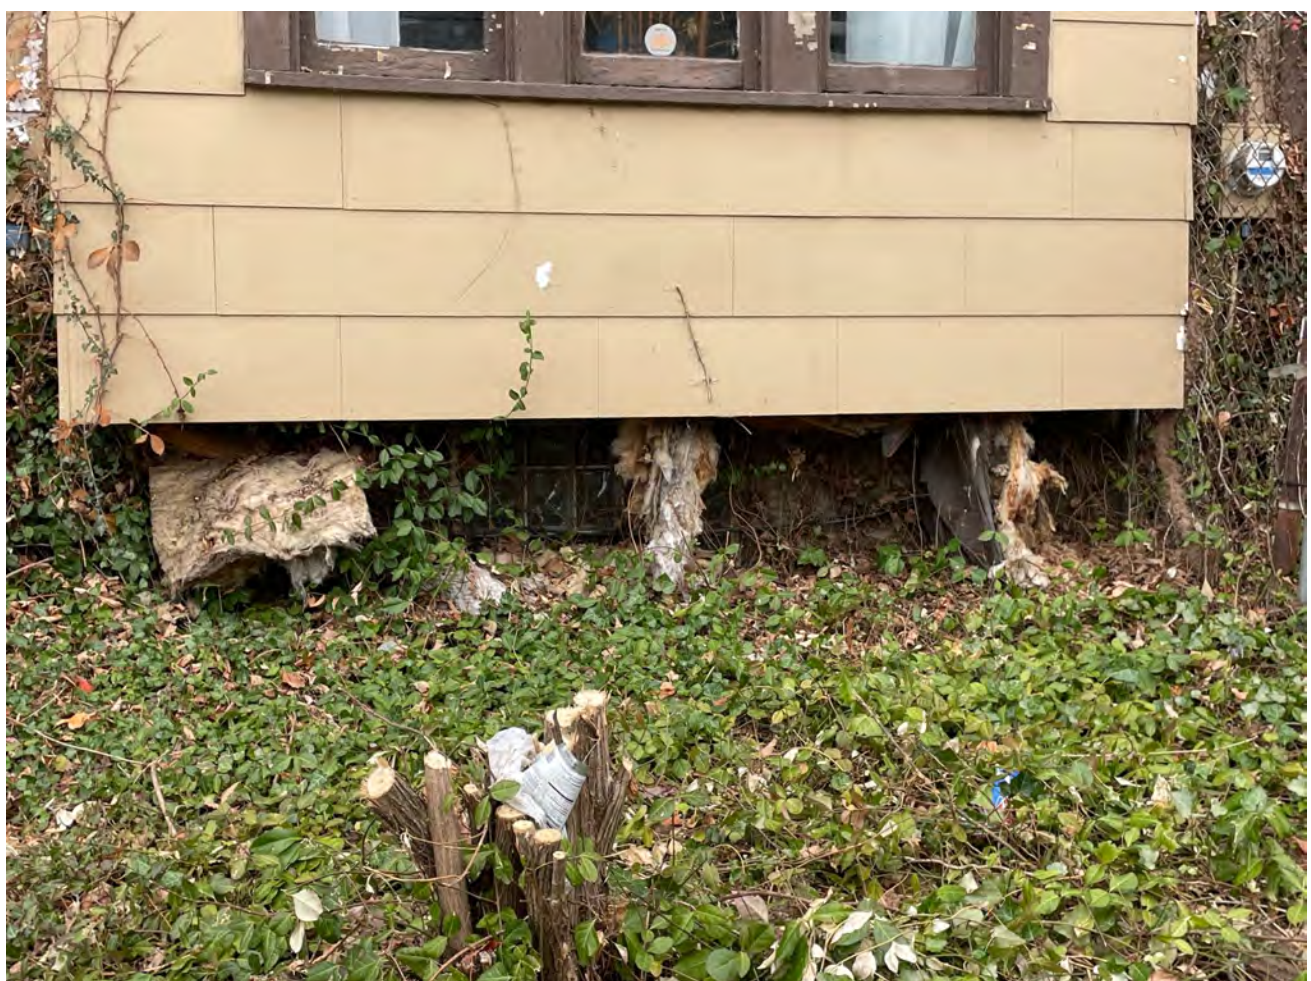
Detached insulation materials under south side of structure

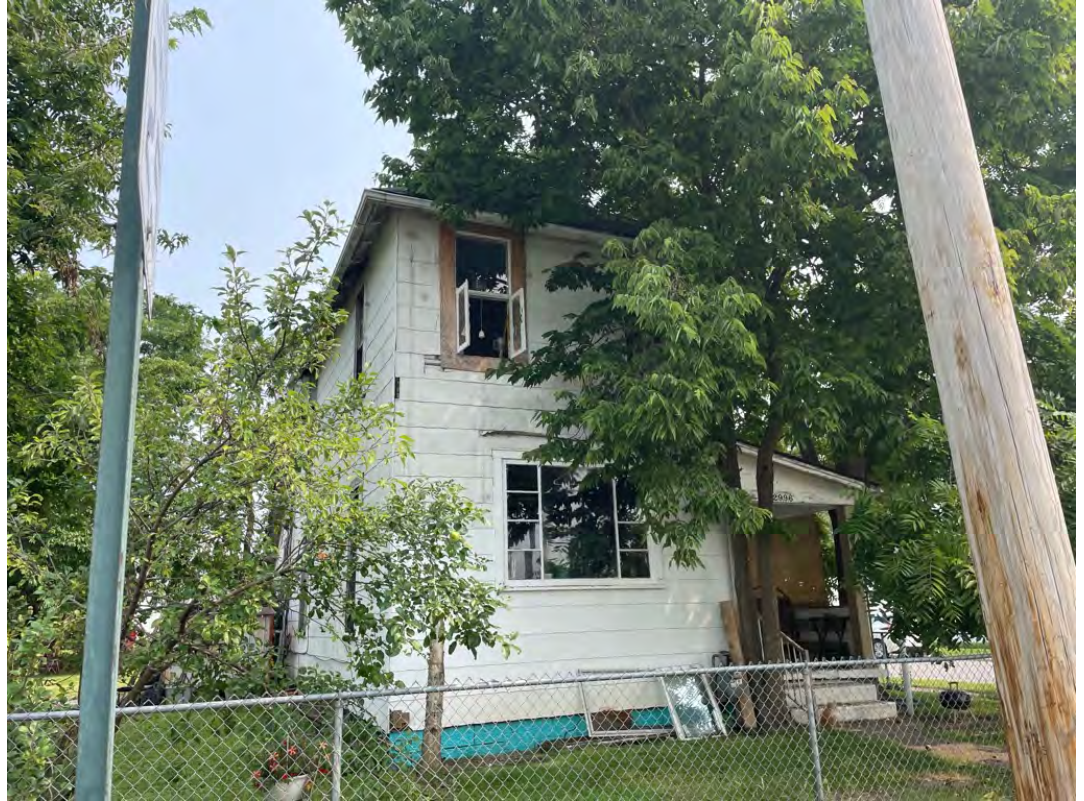
Bare, exposed wood surfaces present on exterior. Damaged and/or missing sections of siding. Improper exterior storage including window components.

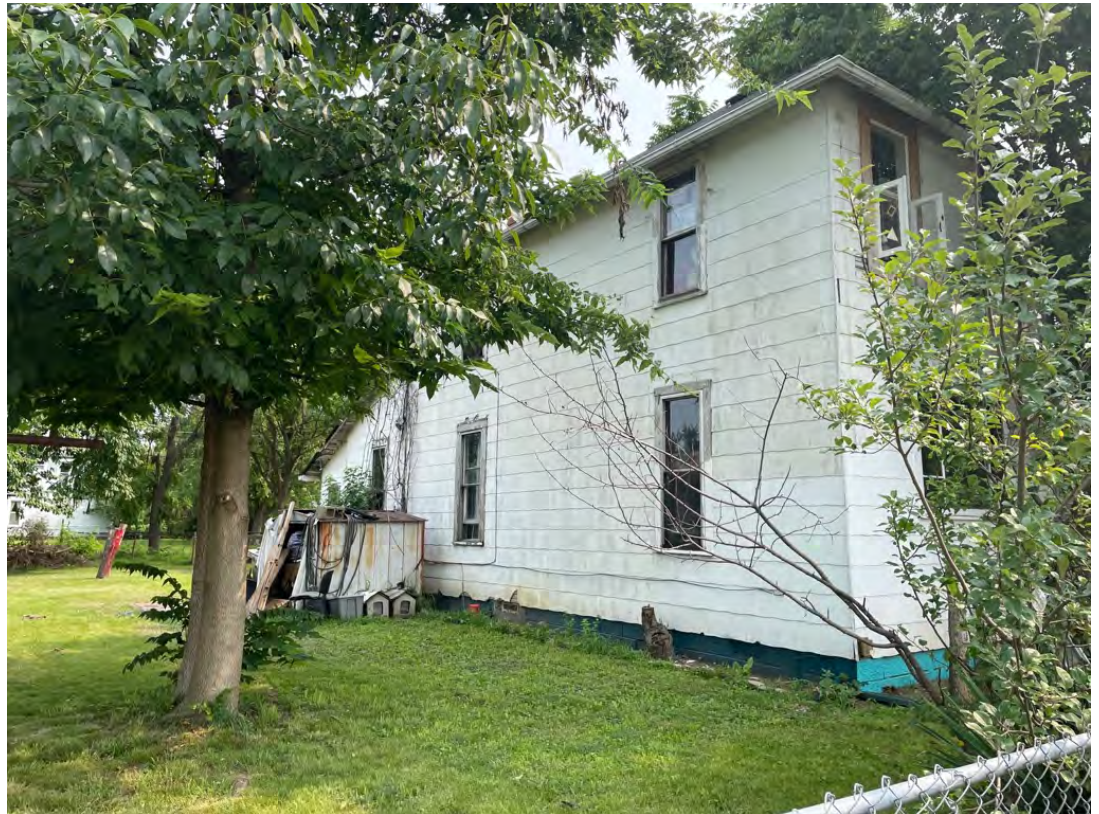
Bare, exposed wood surfaces present on exterior. Damaged and/or missing sections of siding. Improper exterior storage plastic containers, furniture and other miscellaneous items.

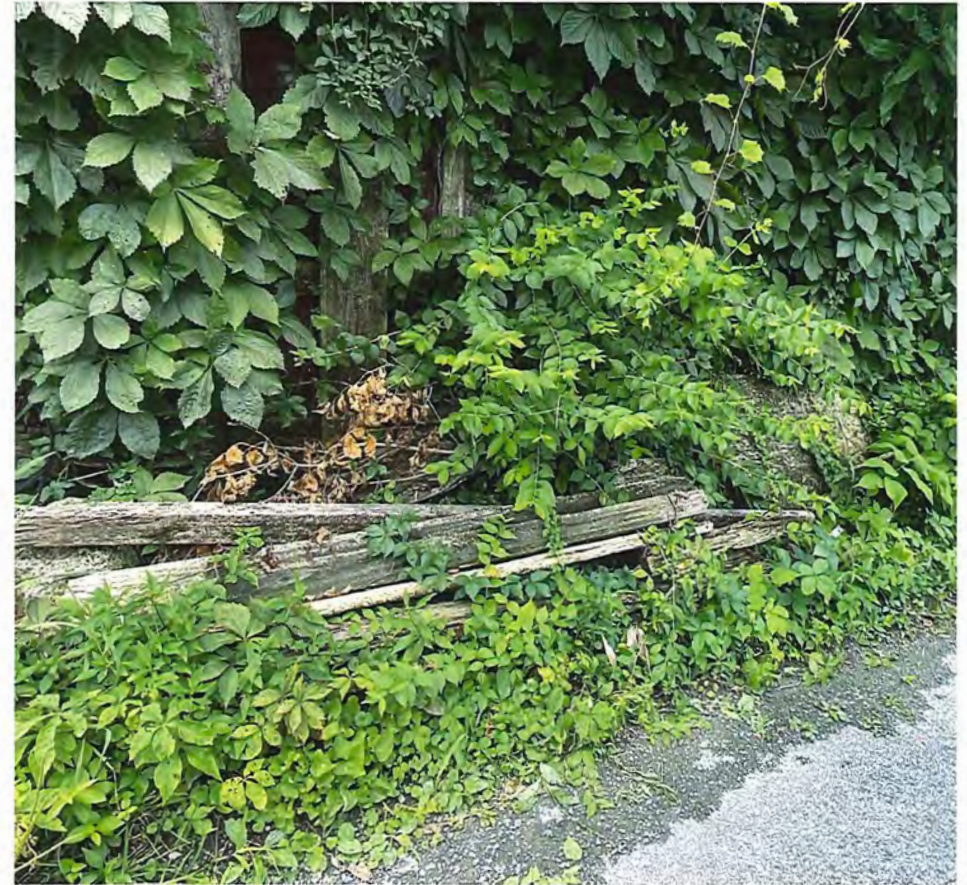
*709.03 - No owner or person having charge of any premises in the city shall permit to grow any grass, brush, vines, shrubs, or noxious weeds in excess of twelve (12) inches in height. Cited parties are responsible for the removal of high grass, noxious weeds, or solid waste to the centerline of any abutting street, alley, or right-of way.

*3332.289 - There is improper storage on the exterior of this property.

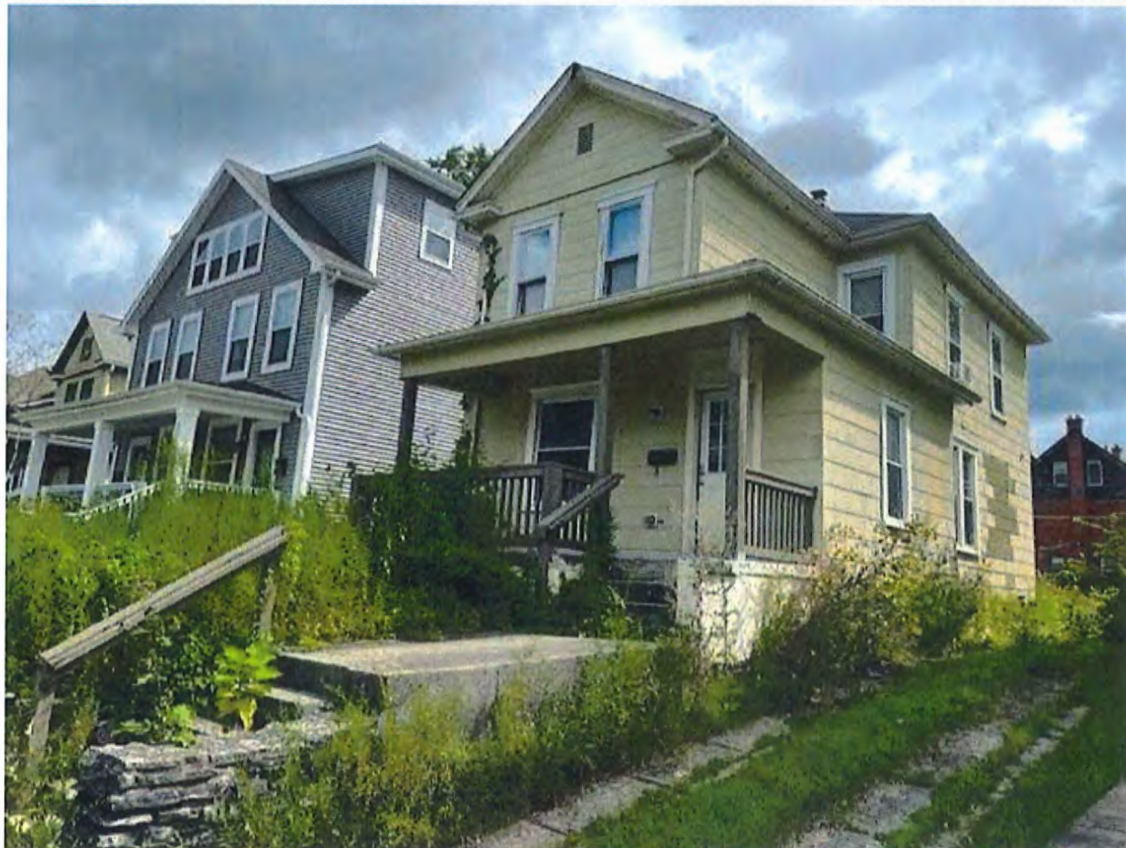
Violations observed: Violations observed: Not boarded to code, damaged retaining wall, trash and debris, high grass and weeds, rain carriers in disrepair

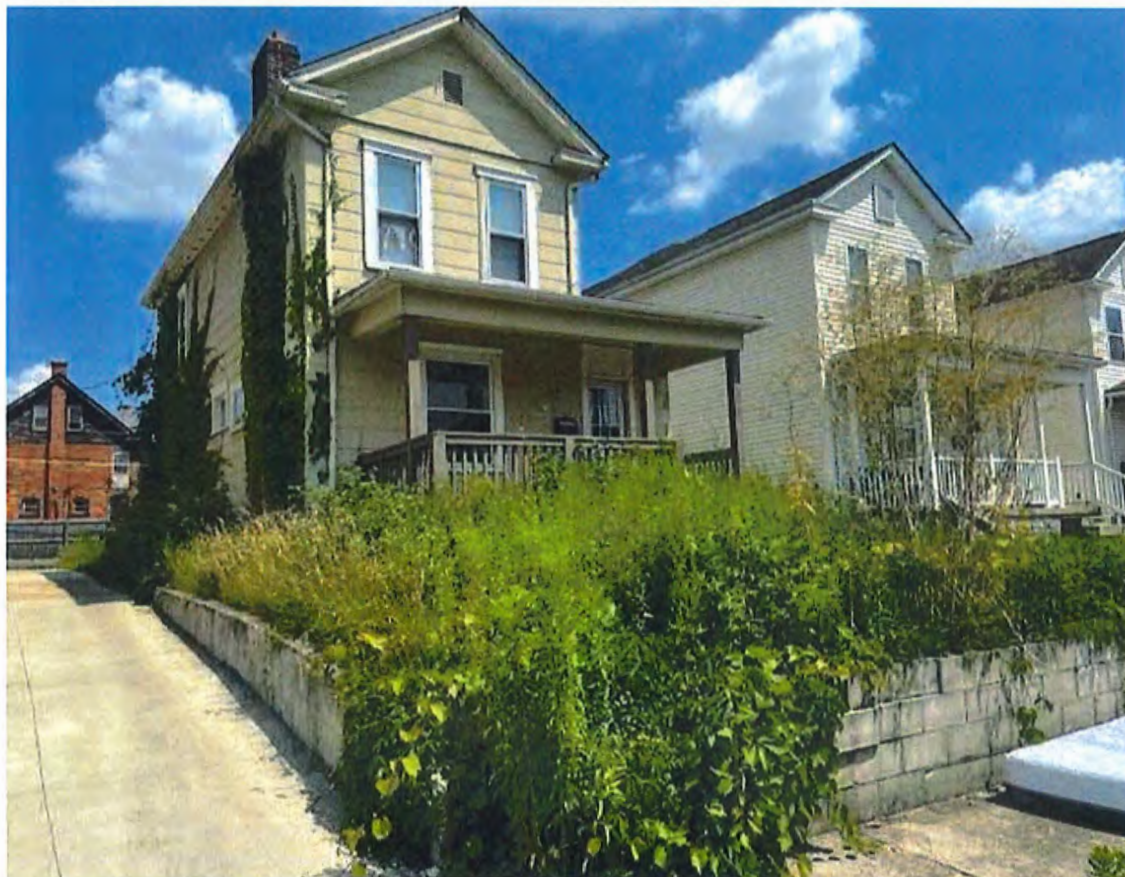
Violations observed: Not boarded to code, damaged retaining wall, trash and debris, high grass and weeds, rain carriers in disrepair
