Columbus Housing Community Reinvestment Area (CHCRA): Housing Survey

Between August and October 2023, a surveillance survey was conducted in the area to be known as the Columbus Housing Community Reinvestment Area (CHCRA). The purpose of the survey was to determine the location of housing units that appeared to be in need of repair or upgrading, vacant lots in need of redevelopment and the severity of structures that appeared to be in need of repair, and/or needing to be removed.

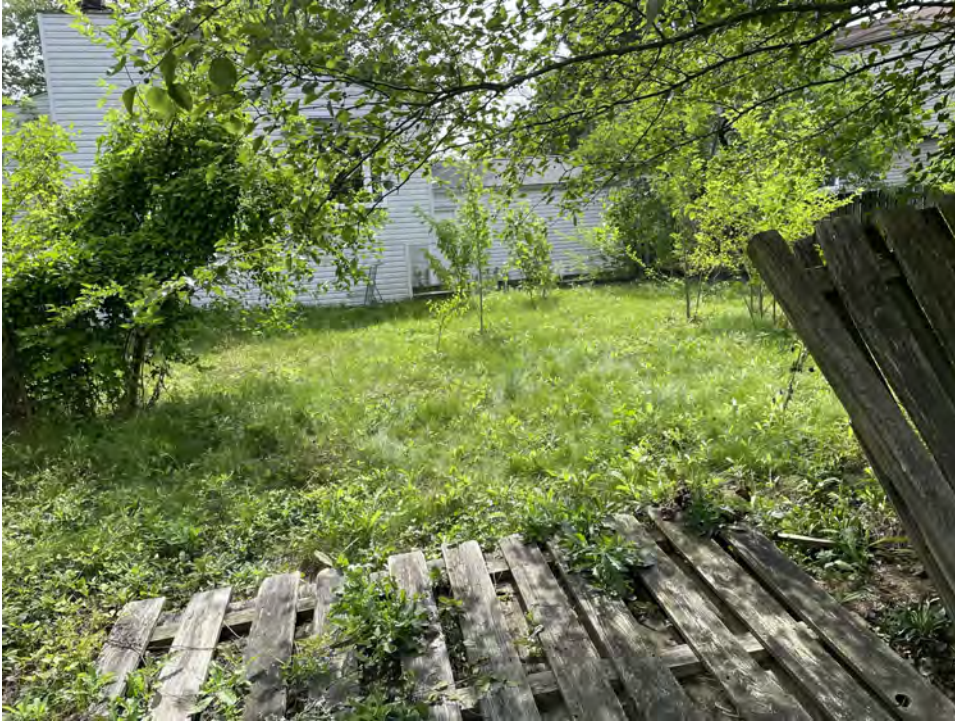
Damaged fence; high grass/weeds; vacant structure not secured to code.
