## **EXHIBIT B: HOUSING SURVEY, RICKENBACKER C.R.A.**

On May 4, 2007, a housing survey was conducted by the City of Columbus Department of Development/Economic Division in the area to be designated as the Rickenbacker CRA. The residential structures surveyed in this area were constructed primarily between the 1960s to the early 1970s except for those housing structures related that could be described as farm houses and were all likely constructed prior to 1950. Due to the age of the housing, and some neglect, many properties are showing visible signs of deterioration or disrepair in one or more of the following areas: roofs, siding, doorways, windows, garage doors, gutters, trees/landscape.

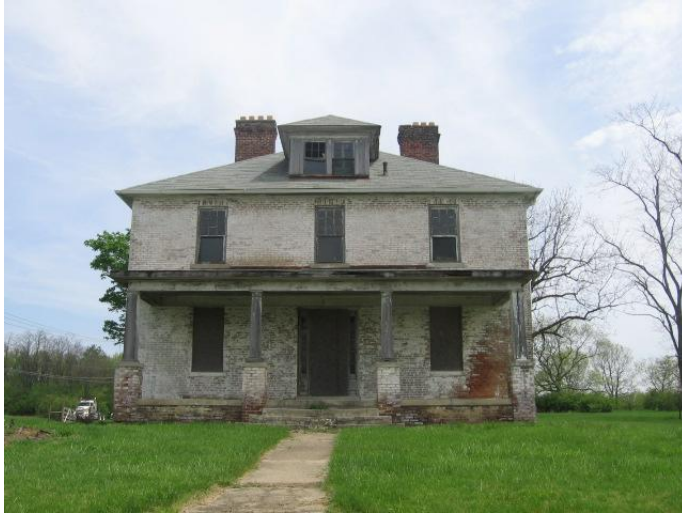
Slide A

This unit is showing signs of disinvestment by broken window panes, loose brick work with missing mortar, worn and peeling paint, boarded-up windows, and broken up concrete steps.

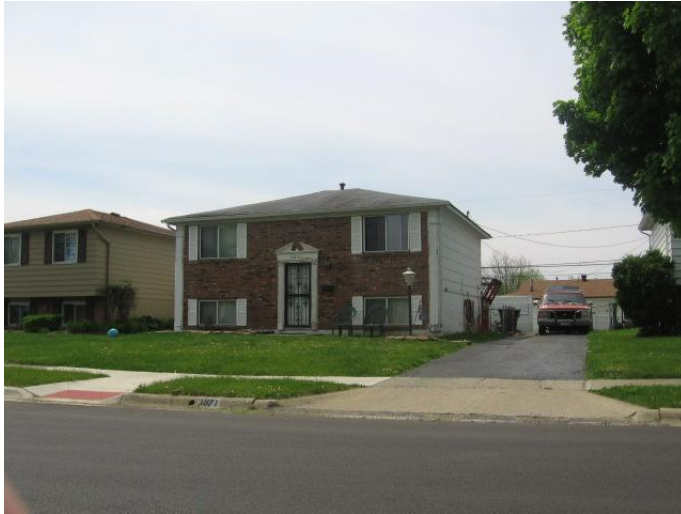
Slide A

This unit is showing signs of disinvestment by peeling paint and the apparent poor condition of the roof.

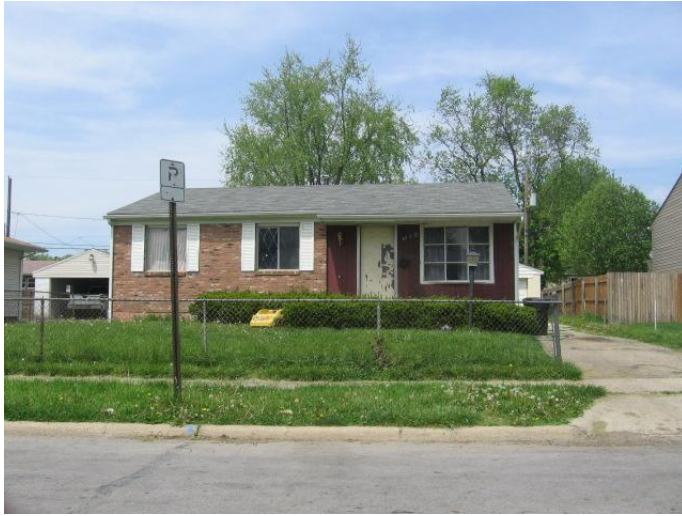
Slide A

This unit is showing signs of disinvestment by warped siding on the side of the structure, peeling paint, crookedly hanging mailbox, poor condition of the driveway, cracked sidewalk, and the general unkempt length of the grass as compared to the neighboring units.

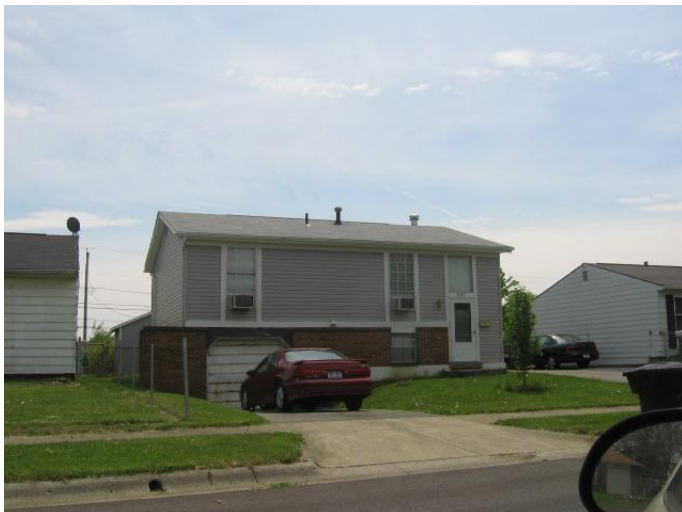
Slide A

This unit is showing signs of disinvestment by visible staining on the foundation, rusted garage door and peeling paint.
