Columbus Housing Community Reinvestment Area (CHCRA): Housing Survey

Between August and October 2023, a surveillance survey was conducted in the area to be known as the Columbus Housing Community Reinvestment Area (CHCRA). The purpose of the survey was to determine the location of housing units that appeared to be in need of repair or upgrading, vacant lots in need of redevelopment and the severity of structures that appeared to be in need of repair, and/or needing to be removed.

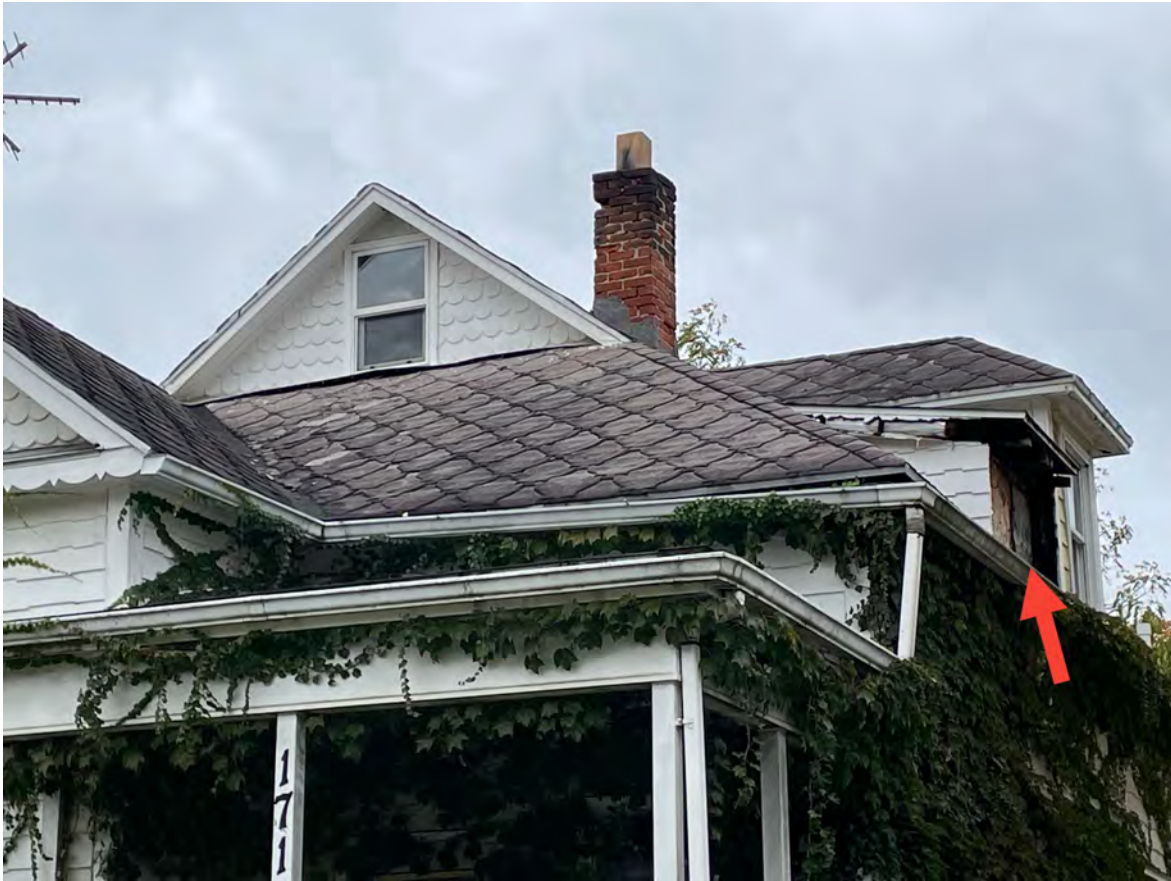
171 S Warren Ave / 2021EVH060588 / 10.19.23

- Mortar voids and damaged bricks in the chimney.
- Damaged exterior wall.
- Rank growth on the structure.

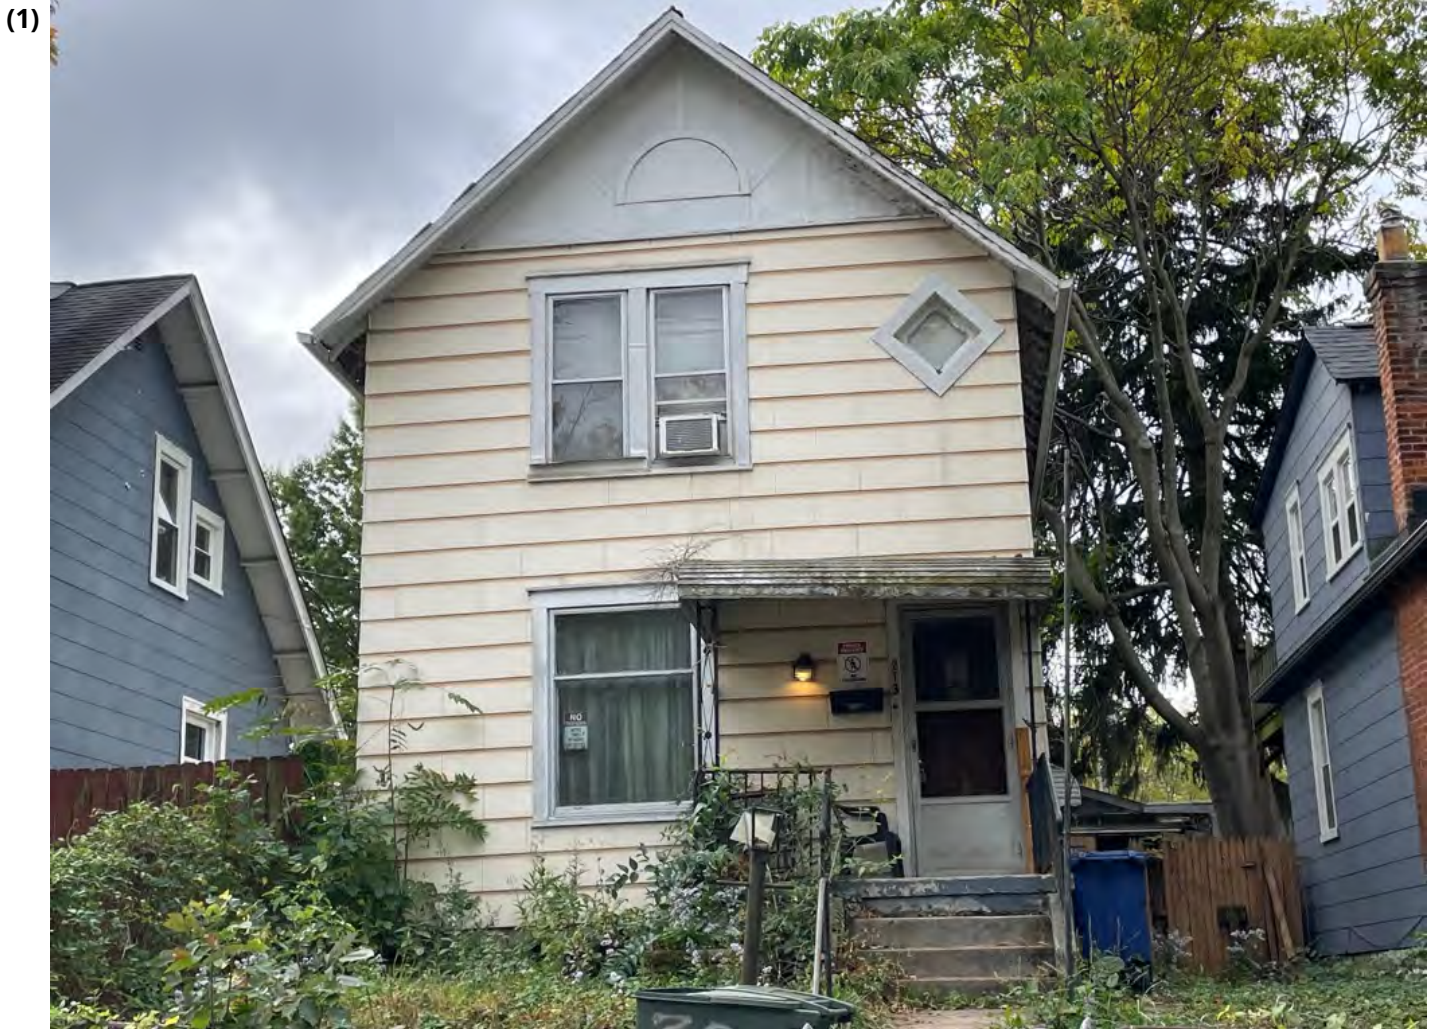
Soffit, fascia, and wood siding contain areas of exposed wood throughout. Front lamp post in disrepair. High grass and weeds.

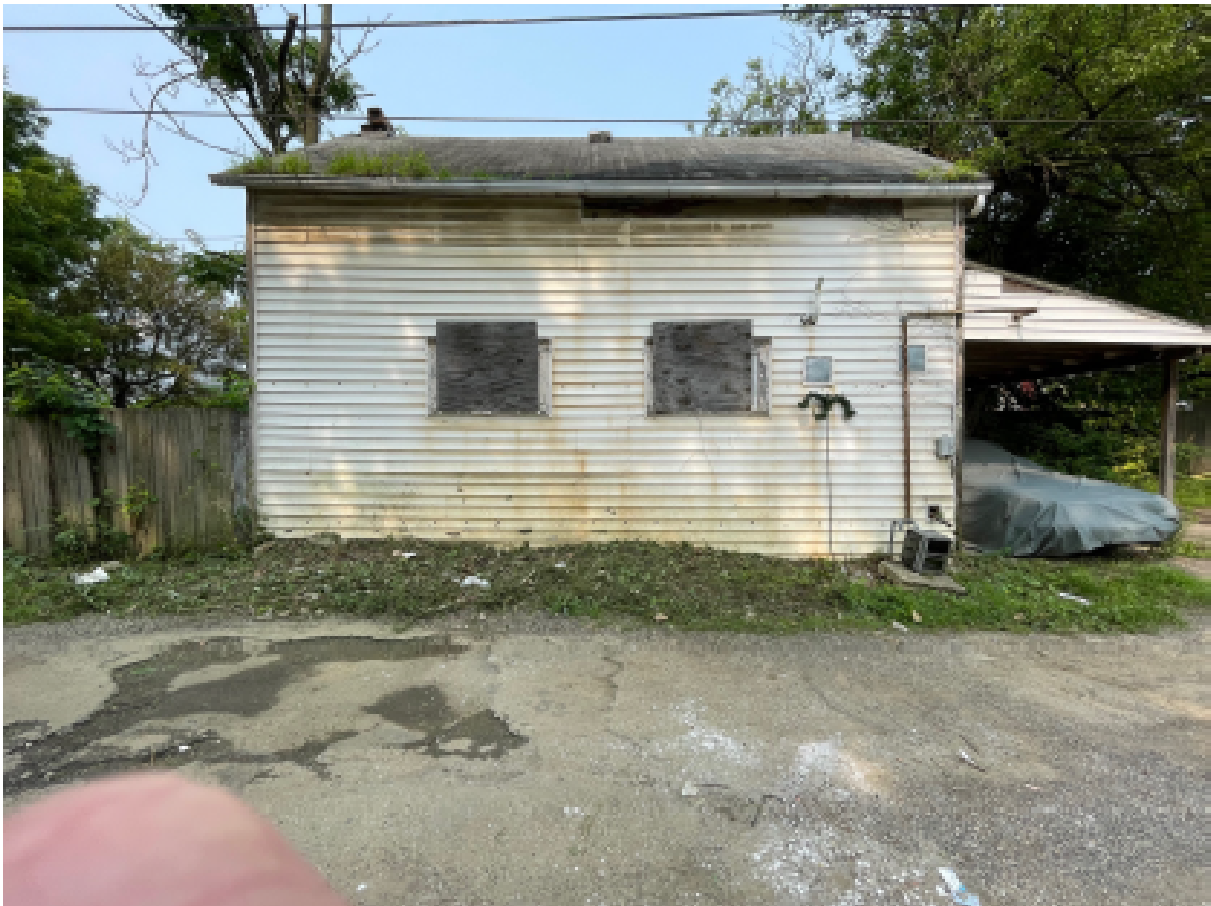
510 S Ohio Ave / 2023EVH060171 / 8.4.23

- Bare and exposed wood surfaces throughout the exterior of the accessory structure.
- Damaged and/or missing siding.
- Raincarrier needs maintenance.
- Missing downspout.

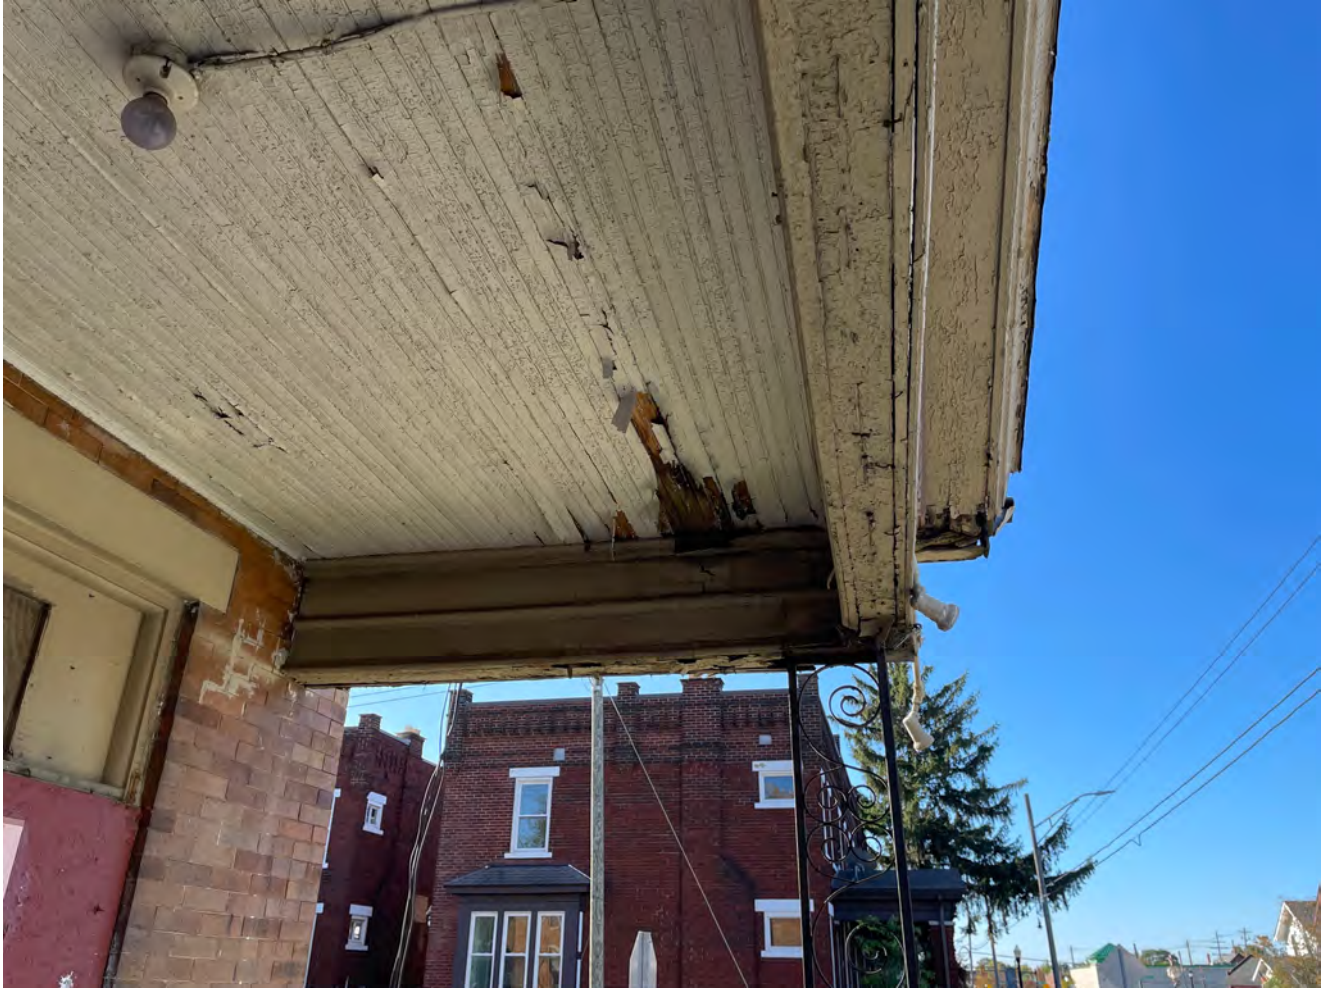
Bare and/or rotting wood surfaces on the front porch ceiling, fascia, soffits, and/or trim

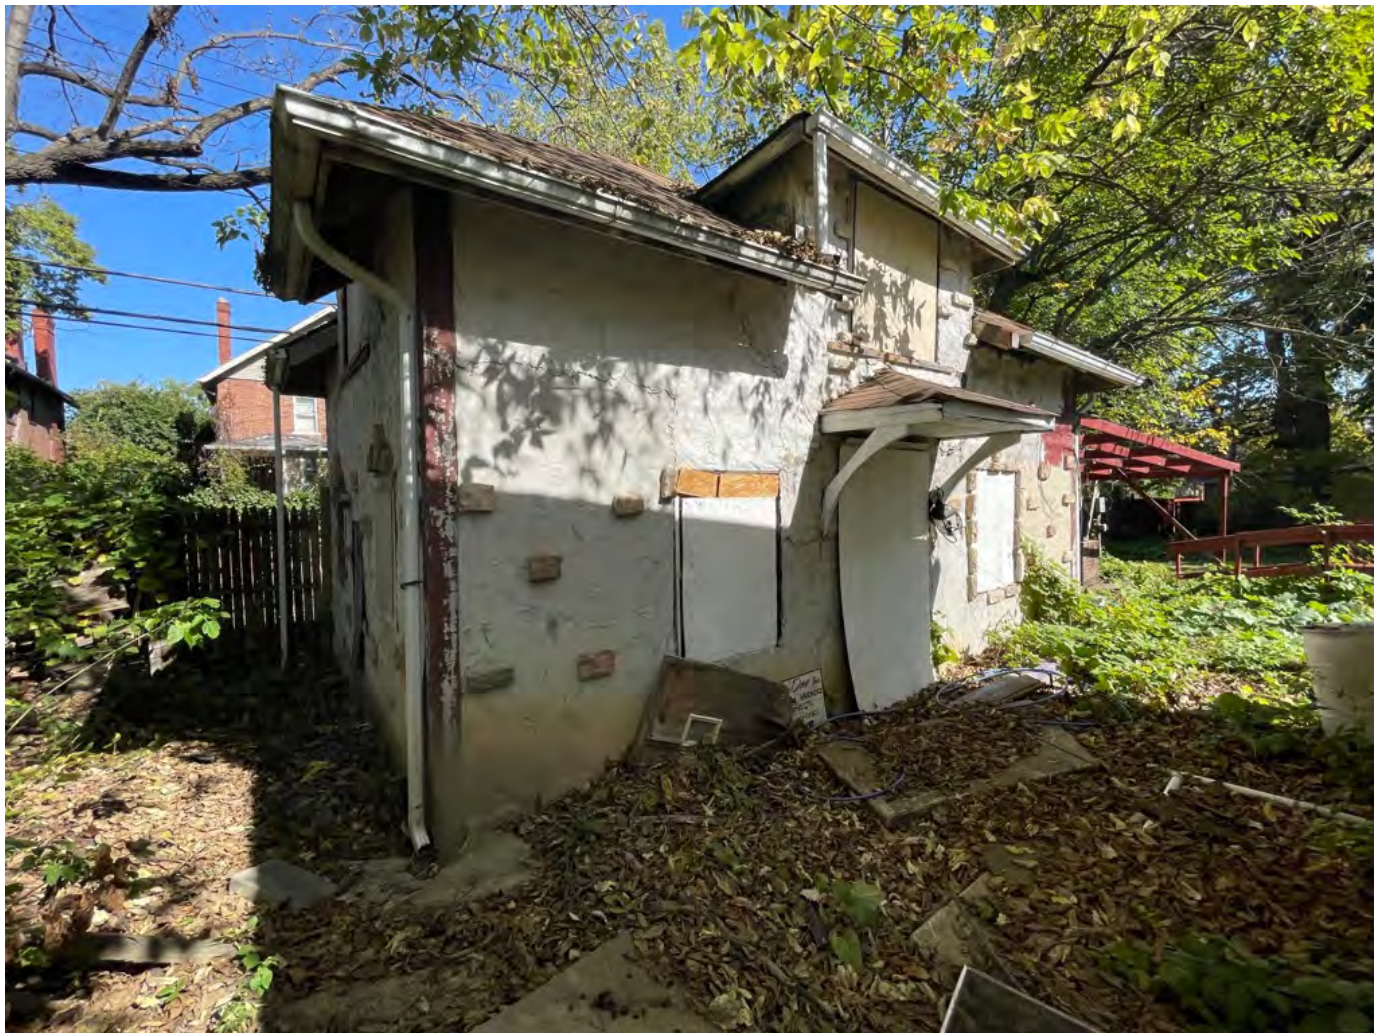
Bare, exposed wood throughout the accessory structure.

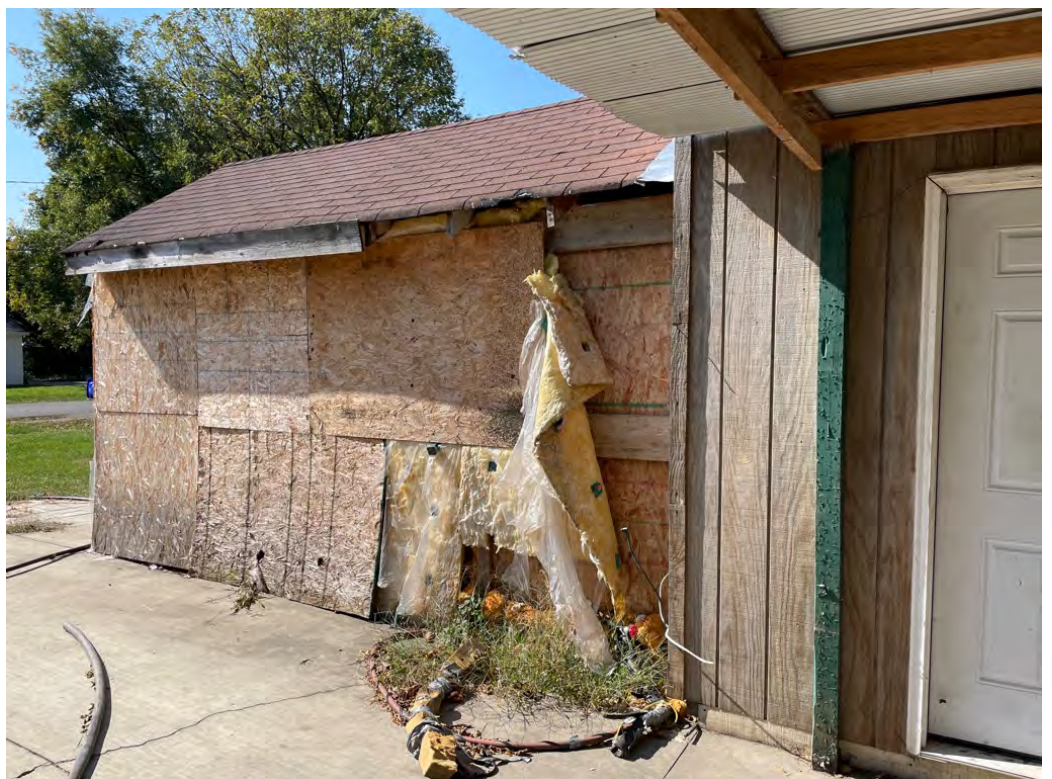
Vacant structure is not boarded to code. Bare and exposed wood present on exterior of structure. Solid waste present on premises.

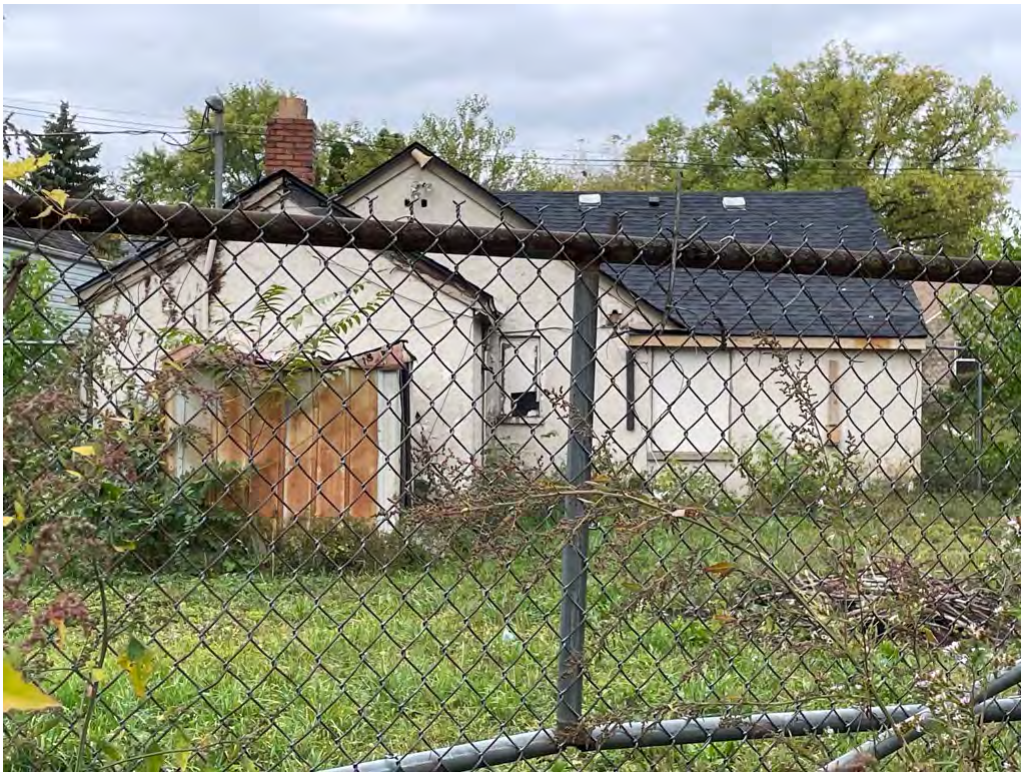
Rear Of House

Bare and exposed wood on exterior of structure including at fascia board.

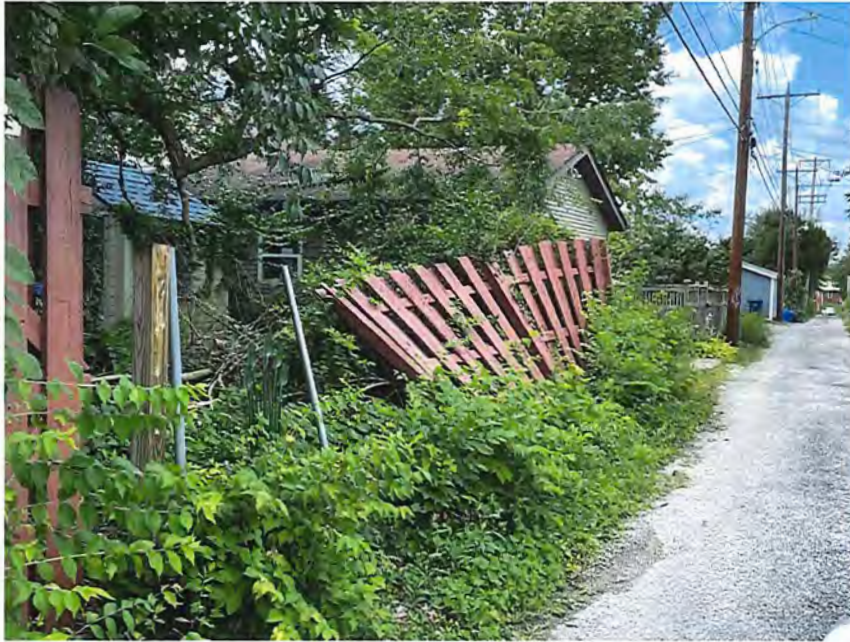
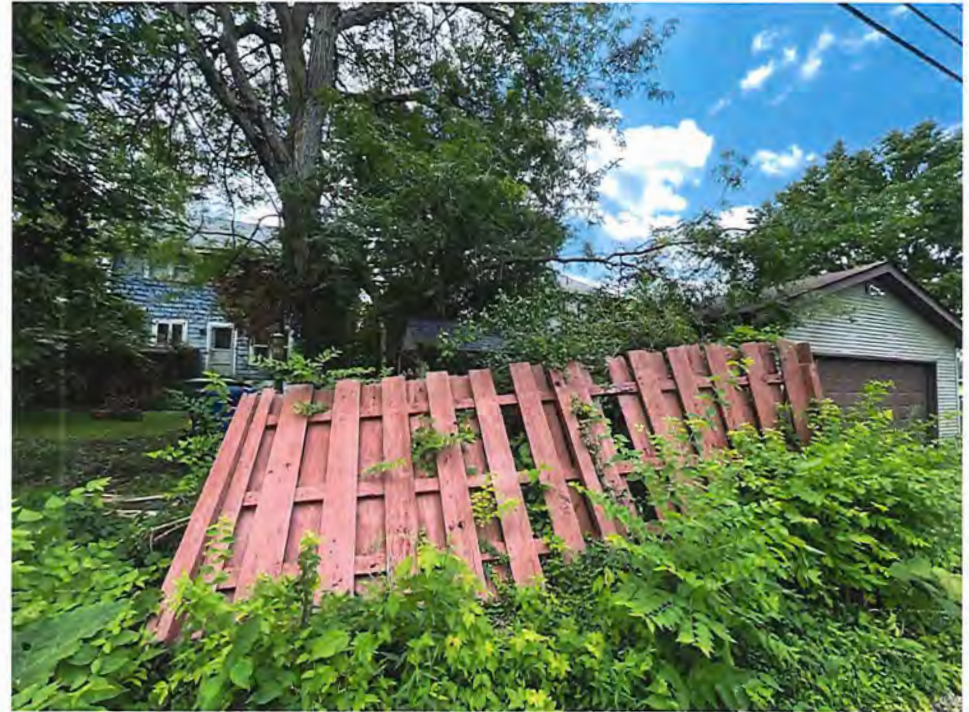
*4525.13 - Sections of the rear fencing are in disrepair.

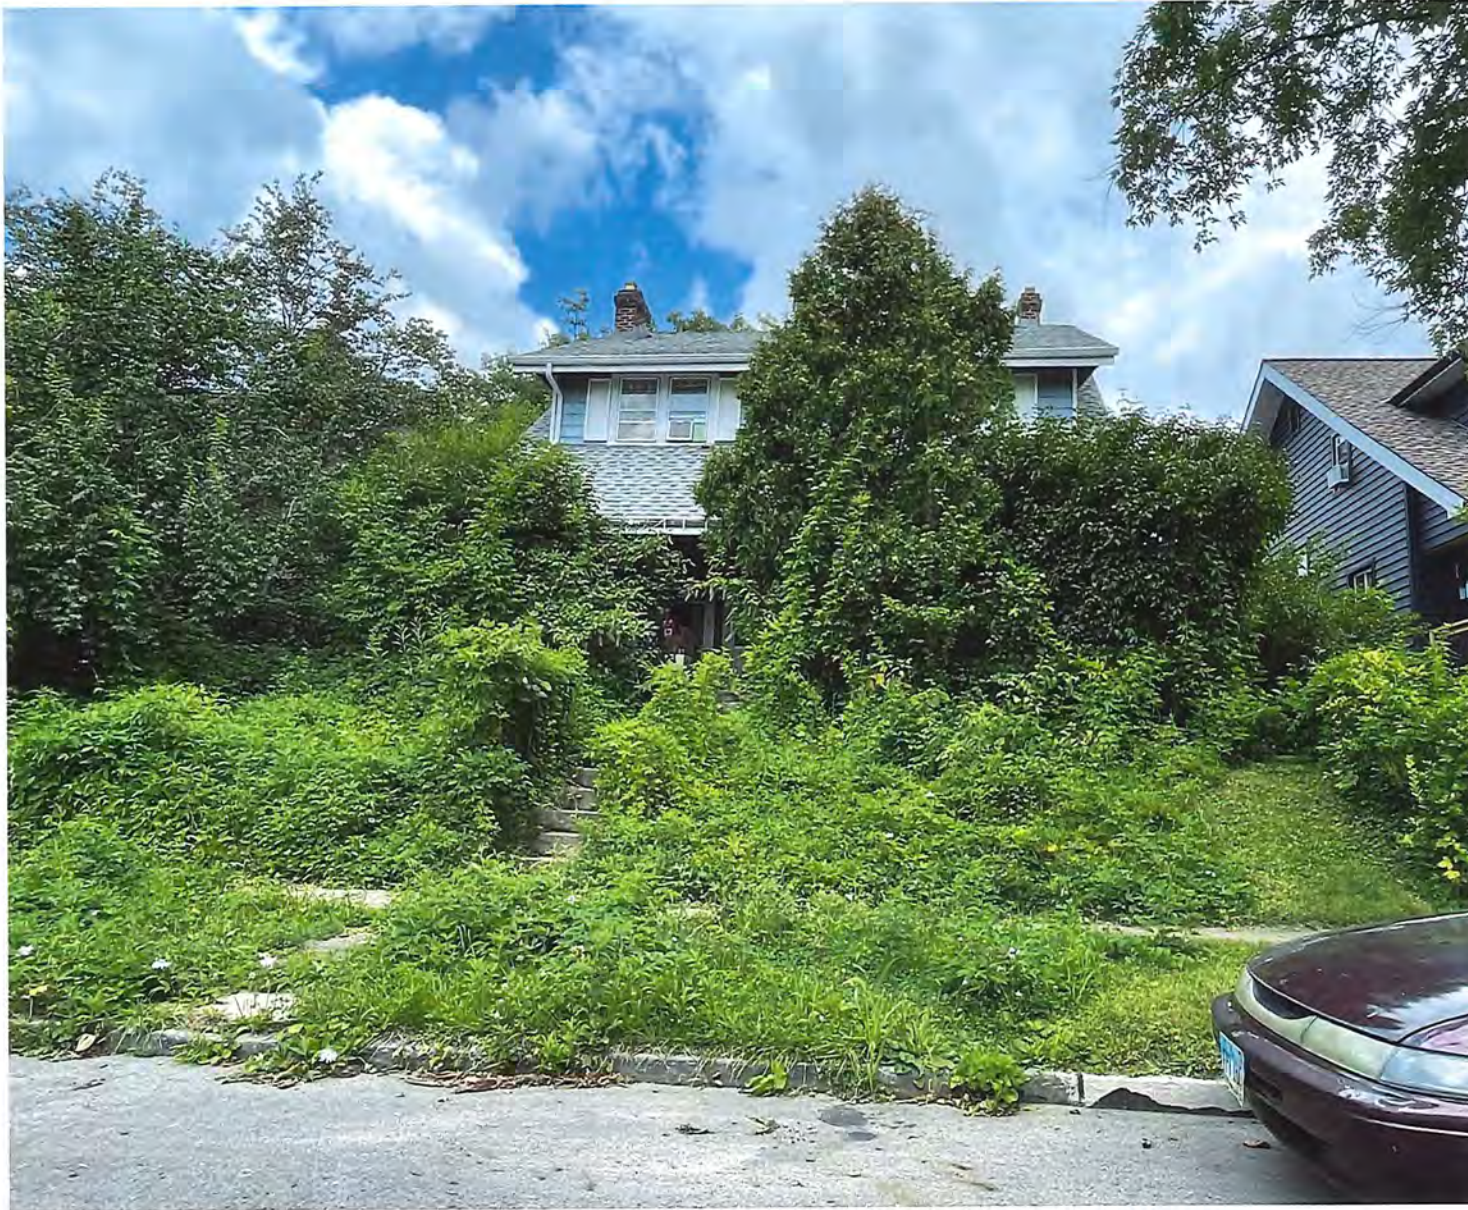
*709.03 - No owner or person having charge of any premises in the city shall permit to grow any grass, brush, vines, shrubs, or noxious weeds in excess of twelve (12) inches in height. Cited parties are responsible for the removal of high grass, noxious weeds, or solid waste to the centerline of any abutting street, alley, or right-of way.

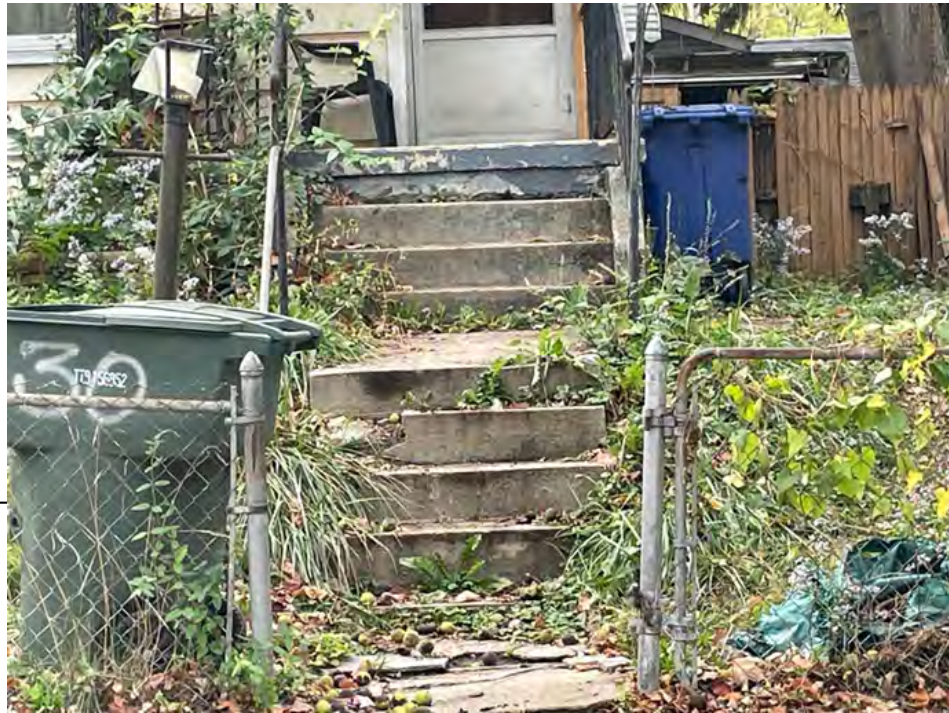
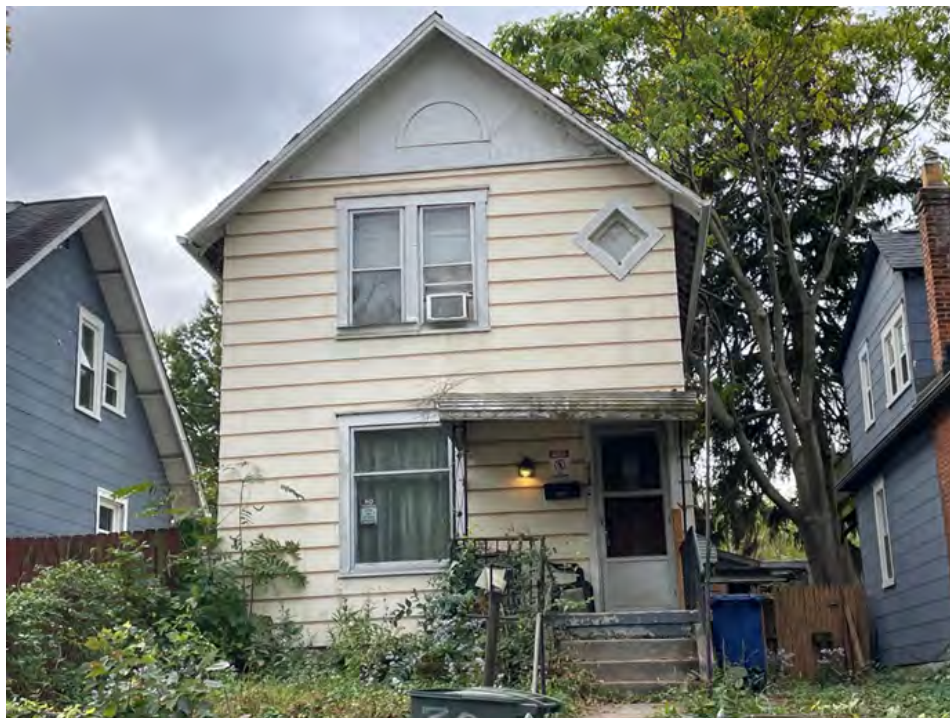
Violations observed: Violations observed: Not boarded to code, damaged retaining wall, trash and debris, high grass and weeds, rain carriers in disrepair

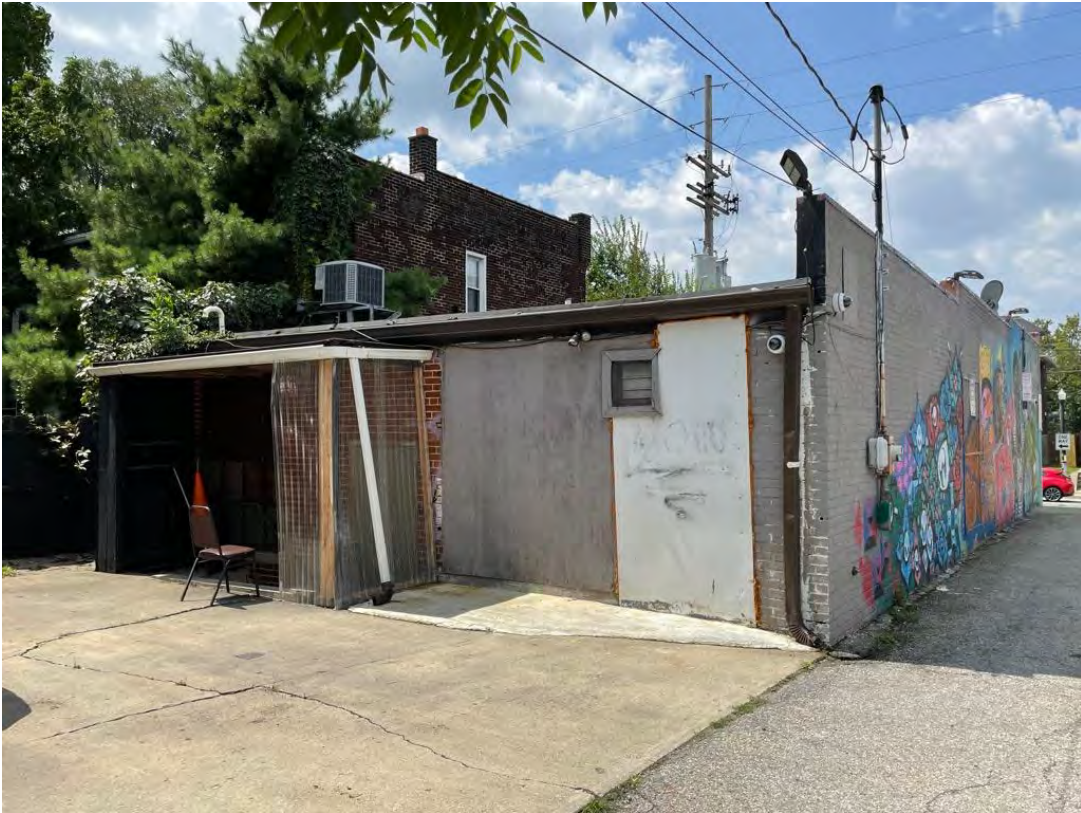
Brick corner contains mortar voids near the downspout.

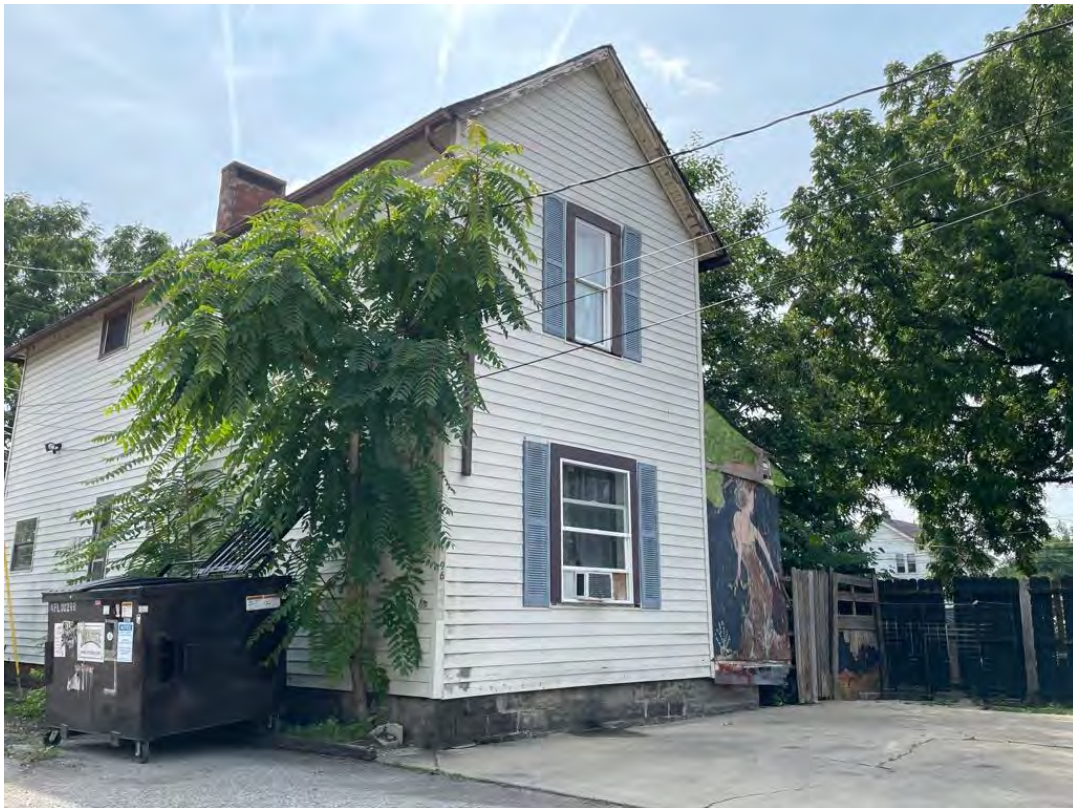
Address number for rear residential structure not clearly visible from the street or right-of-way. High grass and weeds. Solid waste.

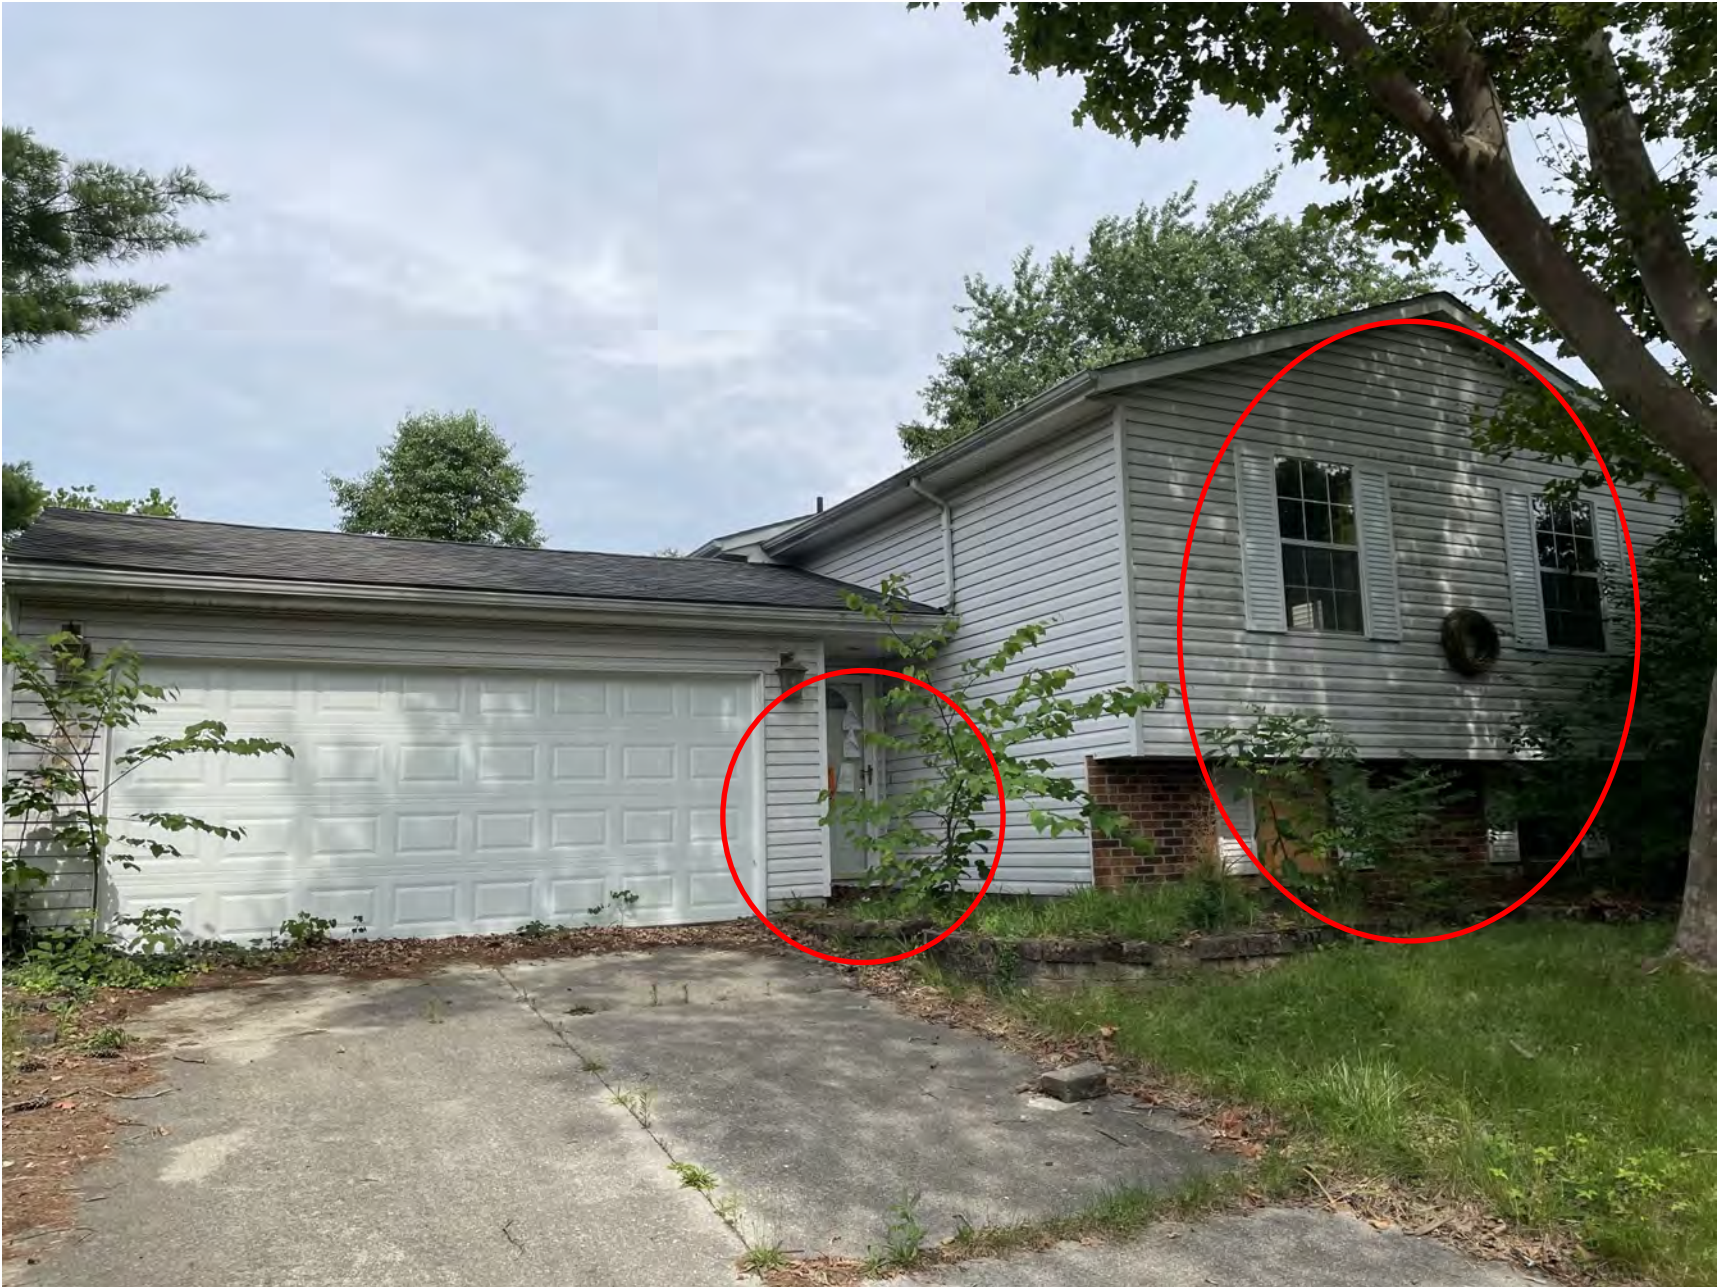
Vacant structure not secured to code.
