Crawford Farms Basic Project Proposal

Original Grant Proposal

Project Description

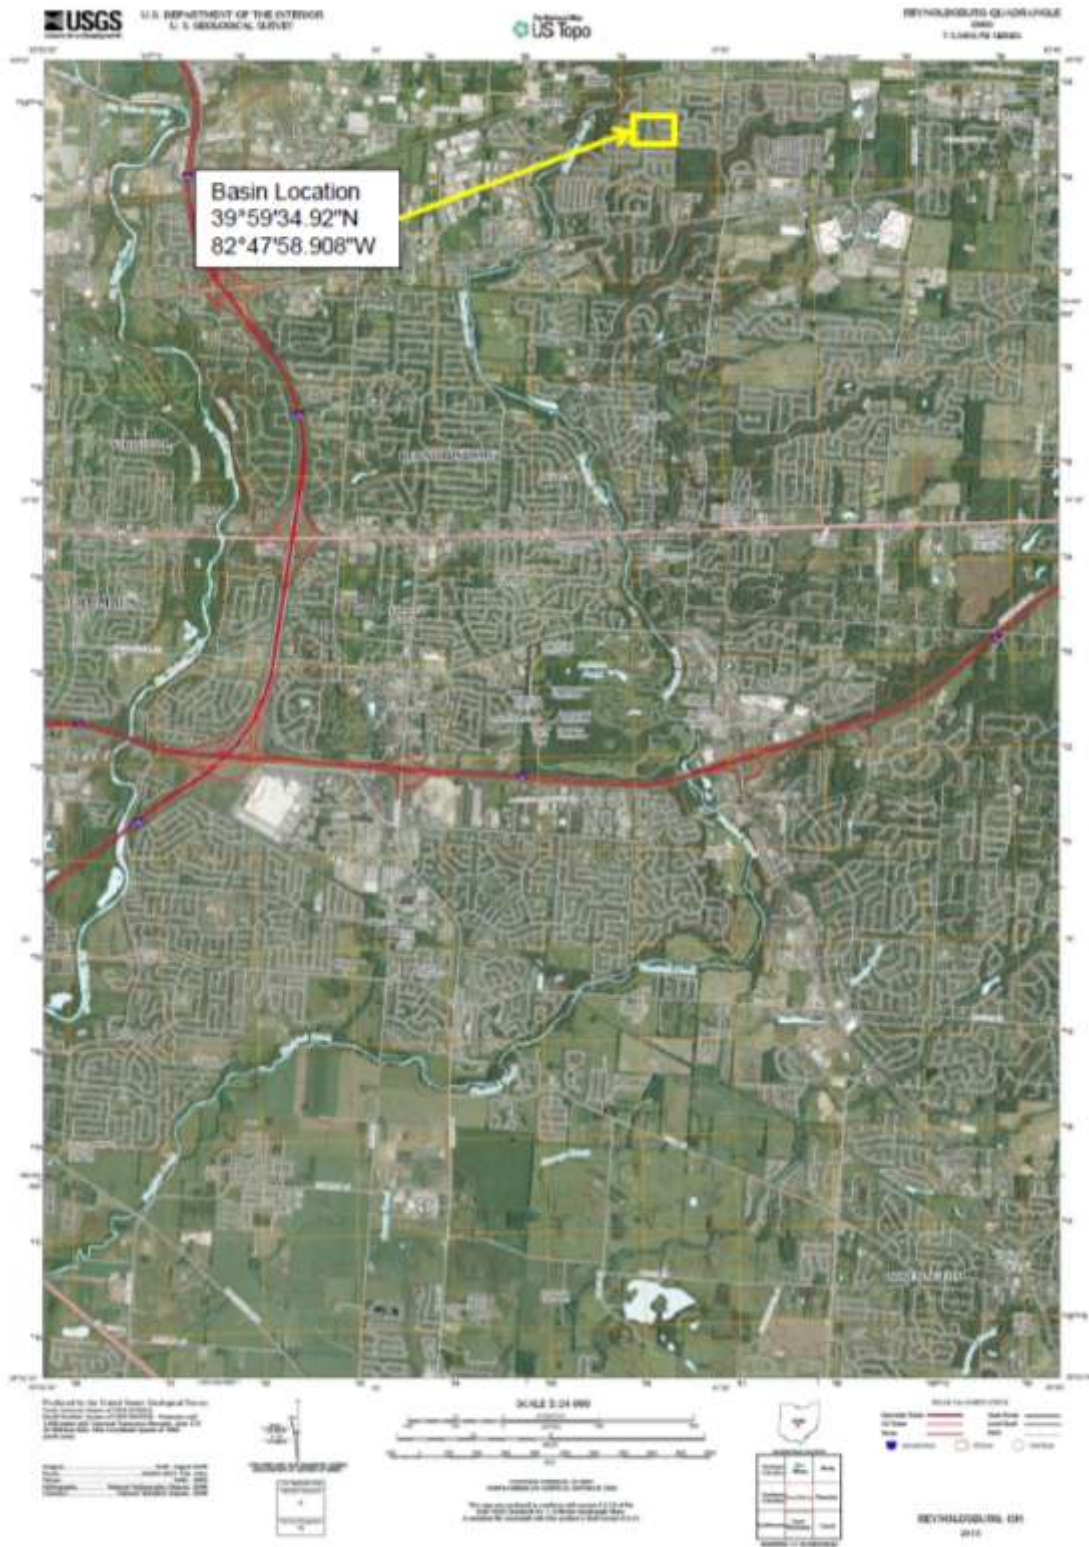
Figure 1: USGS Topo Map with proposed project location marked

Basin Location
PID # 515-250755

Located off of the bend on Grandlin Park Dr. (39°59'34.92"N 82°47'58.908"W) (Figure 1) between Brunfield Dr. and Fairfax Loop Dr. in Crawford Farms Park in the City of Columbus, retrofit site is a dry basin located on public land—the only basin in the Dysart Run subwatershed located on public land. It is approximately 0.5 miles from Waggoner Rd. and 0.9 miles from E. Broad St., two of the major streets in this part of Franklin County (Figures 2 and 3).

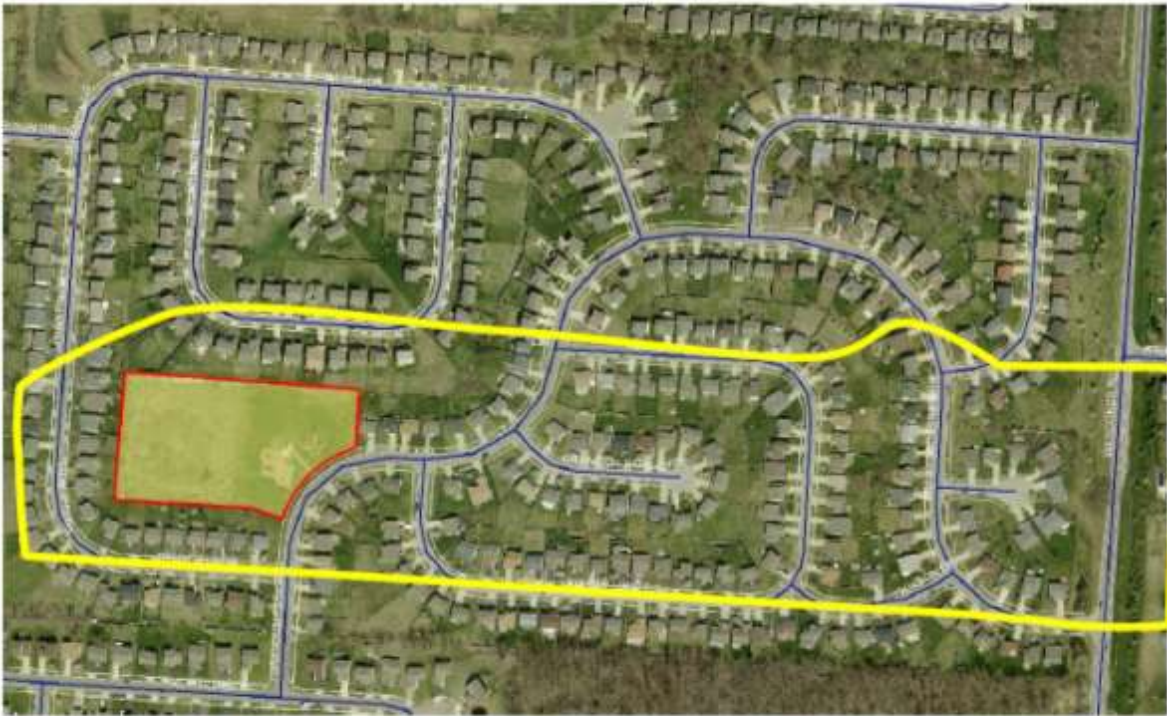
Figure 3: Crawford Farms subdivision with Crawford Farms Park marked and the approximate sewer shed for the park stormwater basin outlined

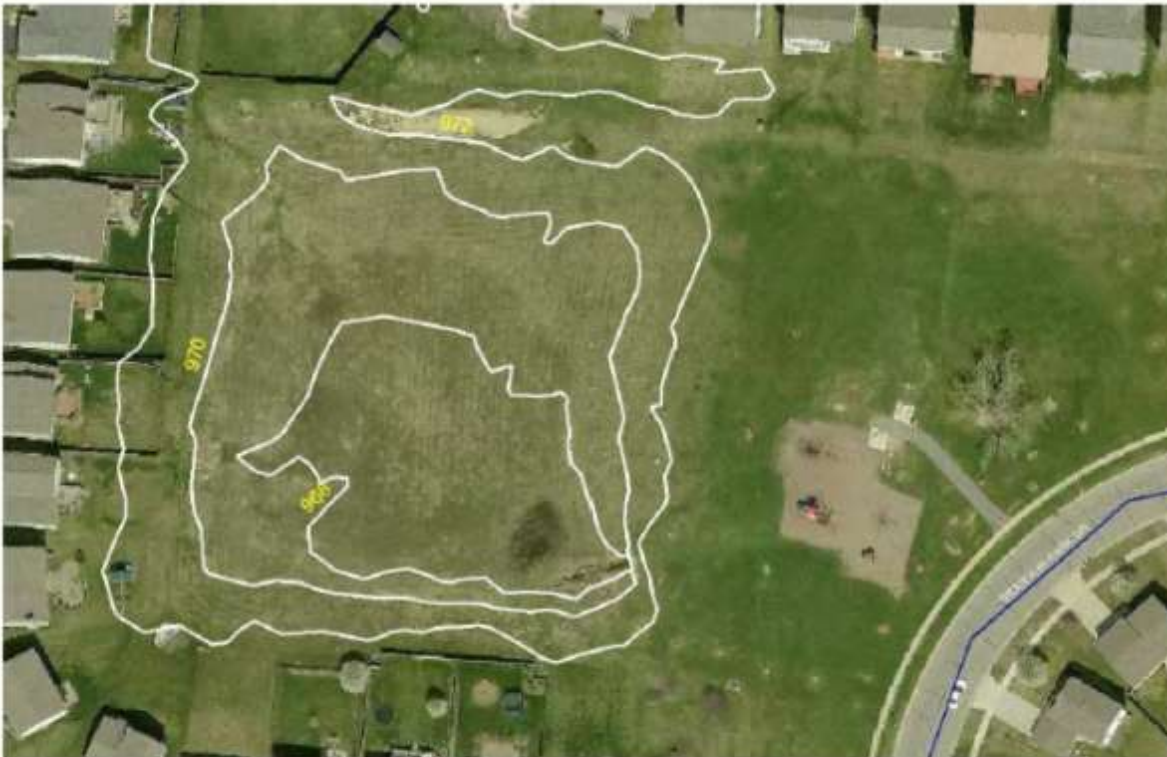
Figure 4: Crawford Farms Park stormwater basin with elevations in feet above sea level contours marked

This basin has an area of 1.3 acres with an elevation change of 4' from the southeast corner to the northeast corner (Figure 4). Shaped like a baseball diamond (Figure 5), the basin receives runoff from a total area of 31 acres, 10 acres of which is impervious. Roughly 40% of the soil is identified as the hydric soil, Pewamo silty clay loam (the west/northwest area), with the remainder being the somewhat poorly drained Bennington B (the east and southeast section) (Figure 6).

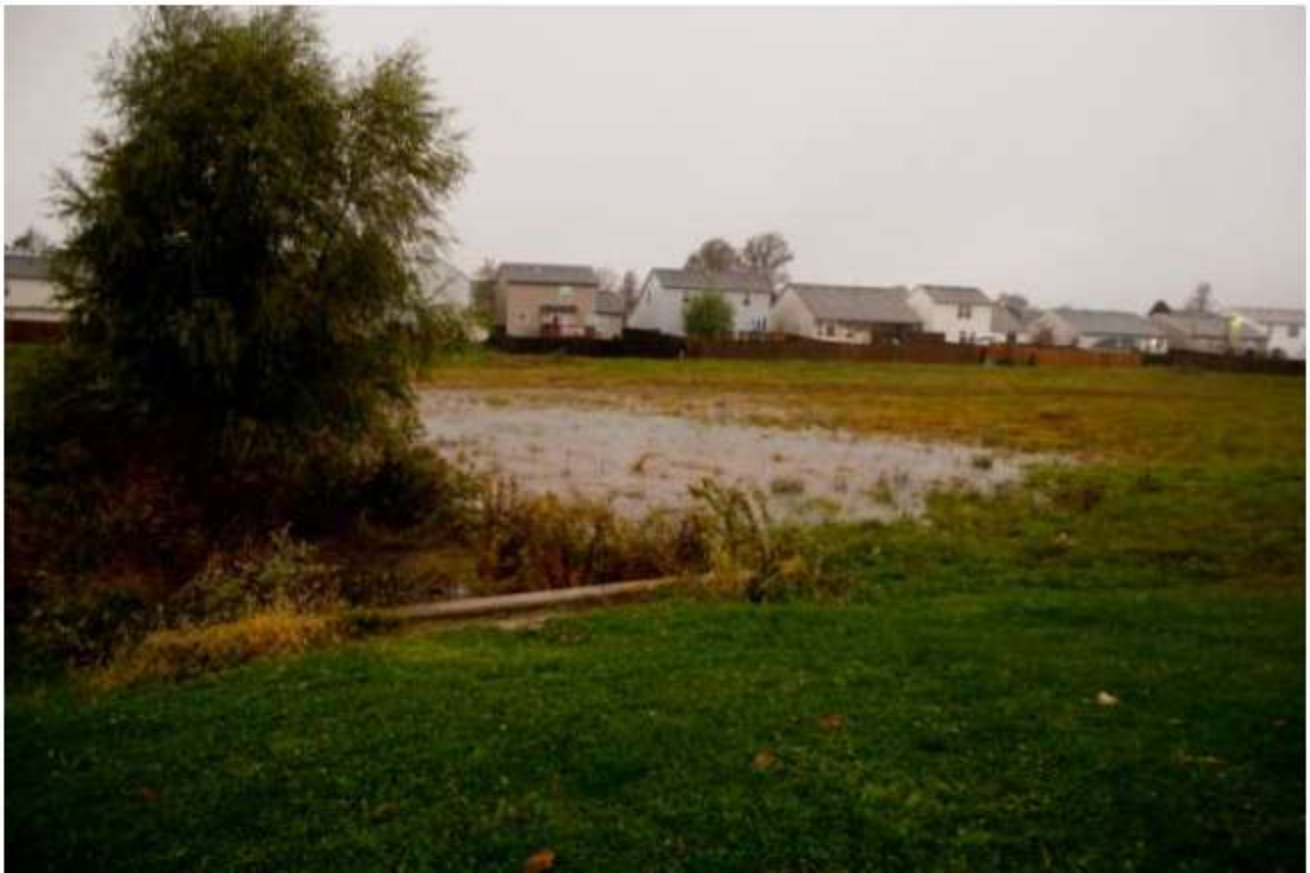
Figure 7: Basin at 6:40 PM October 19, 2011 after 3" of rain over 18 hours

A playground area and additional park open space are located to the east of the basin. The total area effectively consumed by this stormwater infrastructure encompasses approximately 60% of the park, and this area is underutilized for stormwater retention and infiltration. Given its configuration, only 10% of the basin at most is filled during a normal rain event. Even after a 3" rainfall, most of the basin remains unfilled (Figure 7).

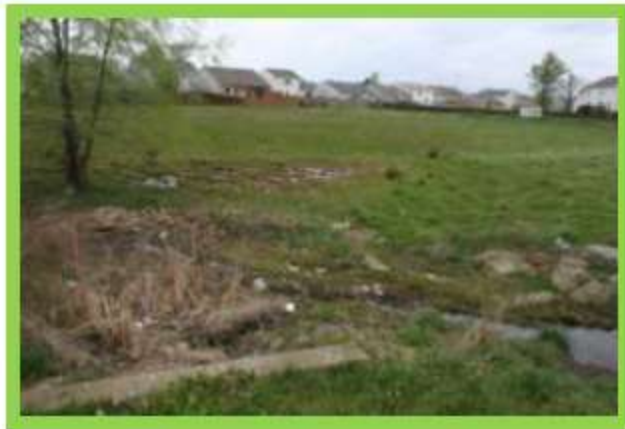
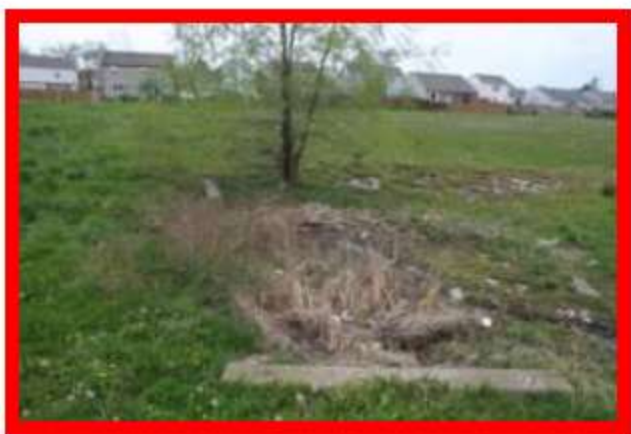
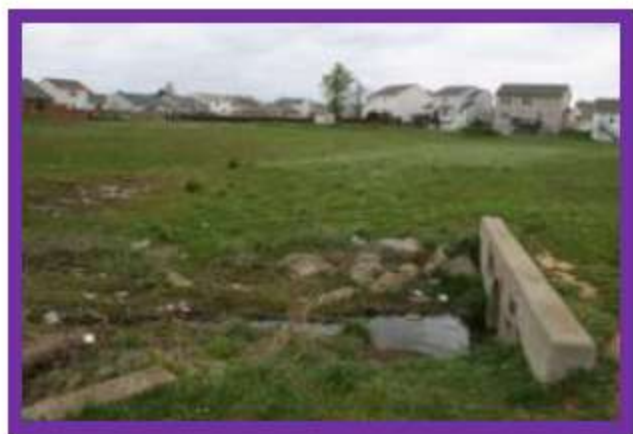
Figure 8b: The view to the northwest from the 18" inflow pipe at the southeast corner of the basin

Figure 8a: The view to the west from the 18" inflow pipe at the southeast corner of the basin

Figure 8c: The view to the north from the 18" inflow pipe at the southeast corner of the basin

Figure 8: On-the-ground views of the Crawford Farms Park basin from the southeast corner.

There is a visible flow path between the 36" inflow and the 18" outflow pipes, with trash accumulating in and along the channel (Figures 8 and 9). A small willow tree is growing approximately 20' north of the outflow. The southeast area of the basin (within 65' of the outflow) remains fairly soggy, with tire tracks evident in the soil and vegetation there indicating that it is kept mowed. Facultative wetland vegetation is growing in much of the basin, with poverty grass and fescue in the better drained north and east sections. The surface of the ground is best described as hummocky (Figure 10). With the exception of perhaps 2-3" of standing water in the lowest 5% of this excavated structure, the basin normally drains with 12 hours (Figure 11 and 12). During most rain events, runoff enters and leaves with little or no residence time.

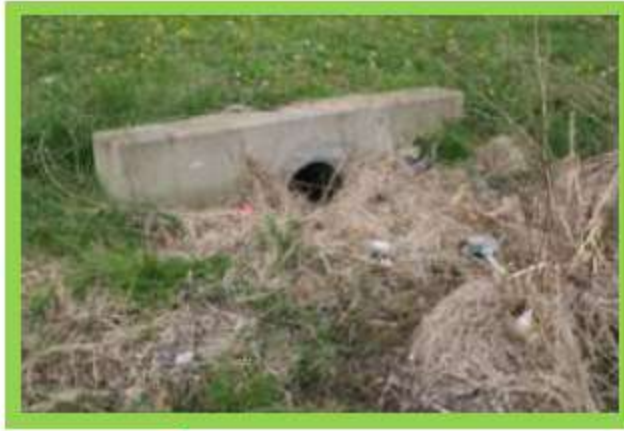
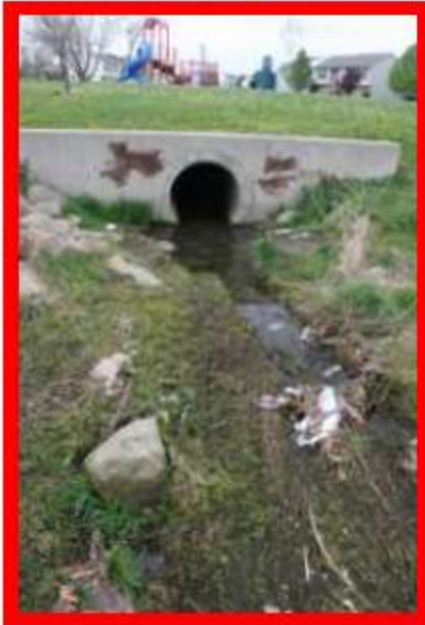
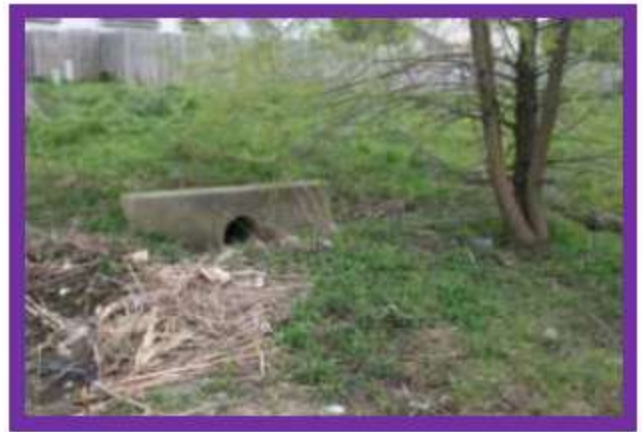
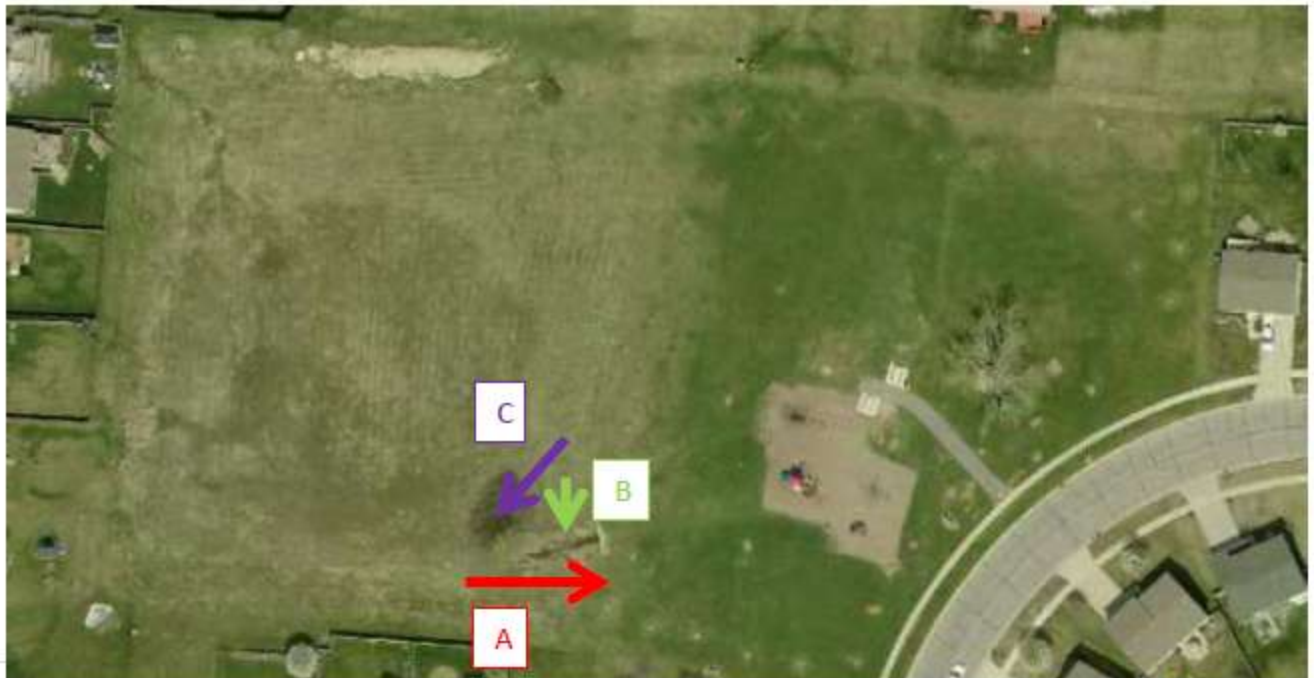
Figure 9b: 18" inflow pipe

Figure 9a: 36" inflow pipe

Figure 9c: 18" inflow pipe

Figure 9: On-the-ground views of the outflow and inflow pipes at the southeast corner of the Crawford Farms Park stormwater basin

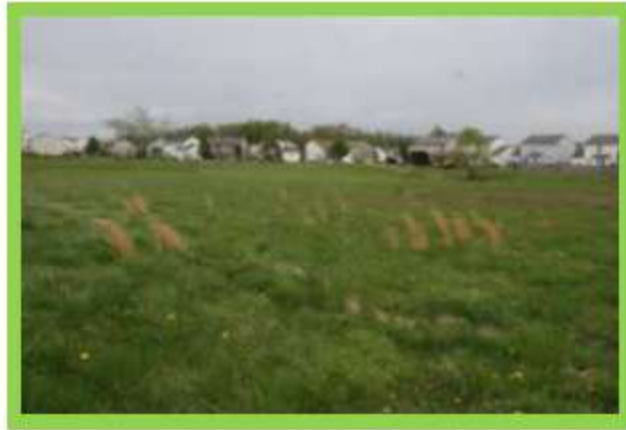
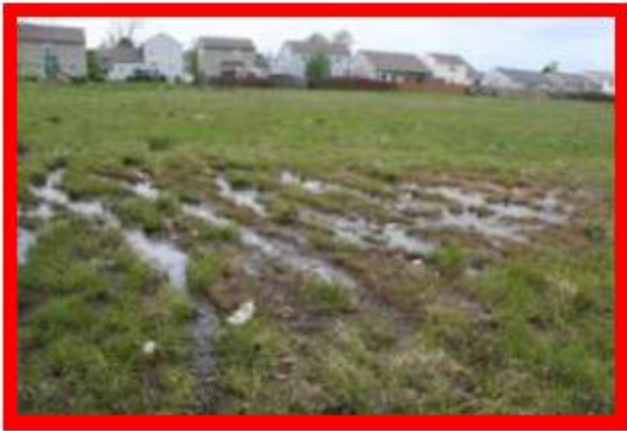
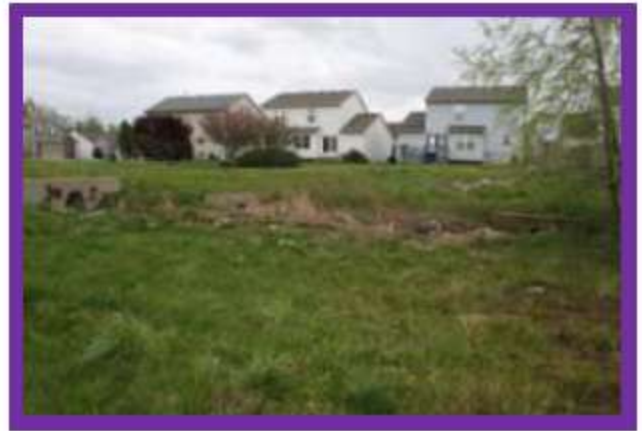
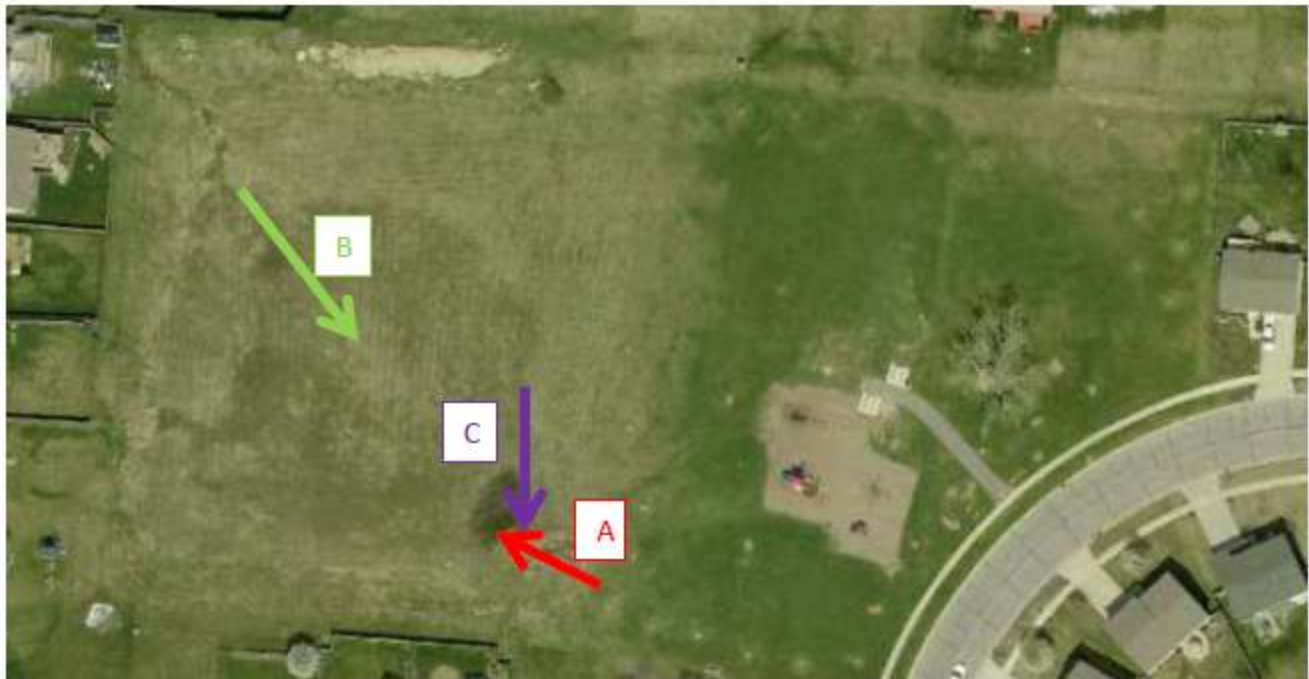
Figure 10b: The upland vegetation in the northwest area of the basin

Figure 10a: The wet area of the basin with tire tracks

Figure 10c: Vegetation around outflow and inflow pipes at southeast corner of basin

Figure 10: On-the-ground views of the Crawford Farms Park basin illustrating vegetation and terrain.

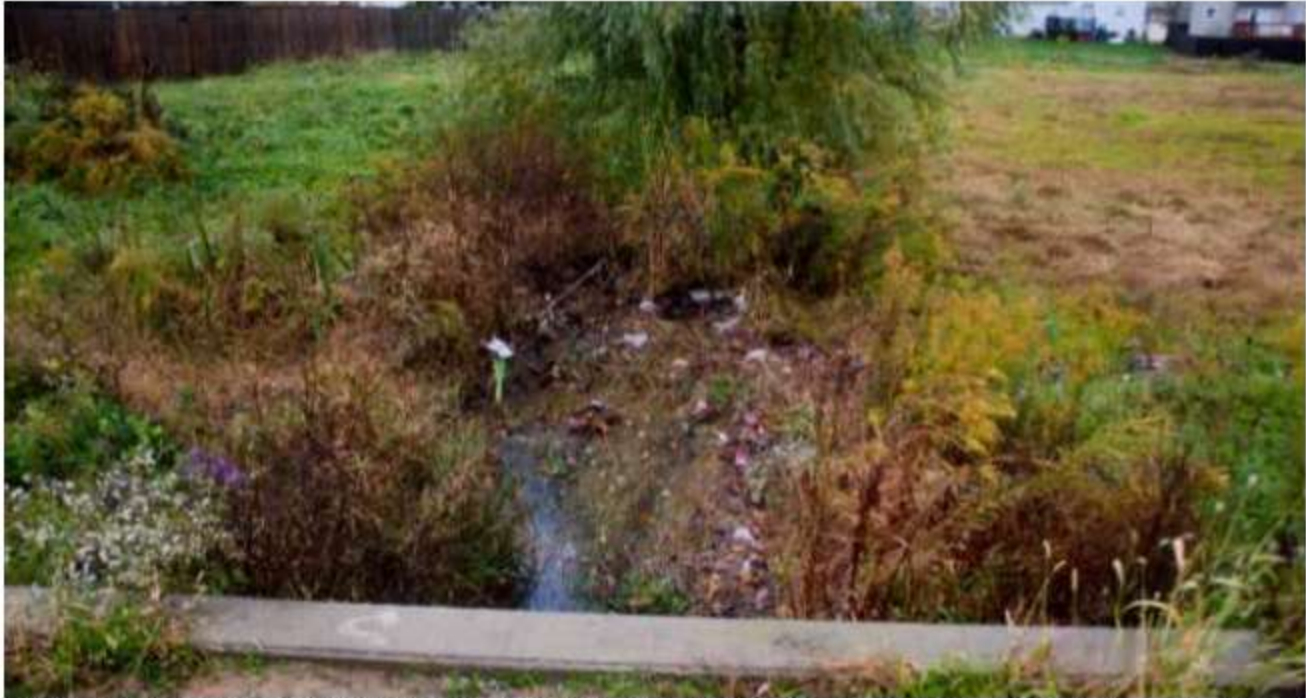
Figure 11: Basin inflow at 4:30 PM October 19, 2011, 22 hours after the photo in Figure 2 was taken and at the end of a 4.95" rain event over a 40 hour period. Records indicate that 3.85" total fell on October 19, 2011, and 1.15" fell on October 20, 2011.

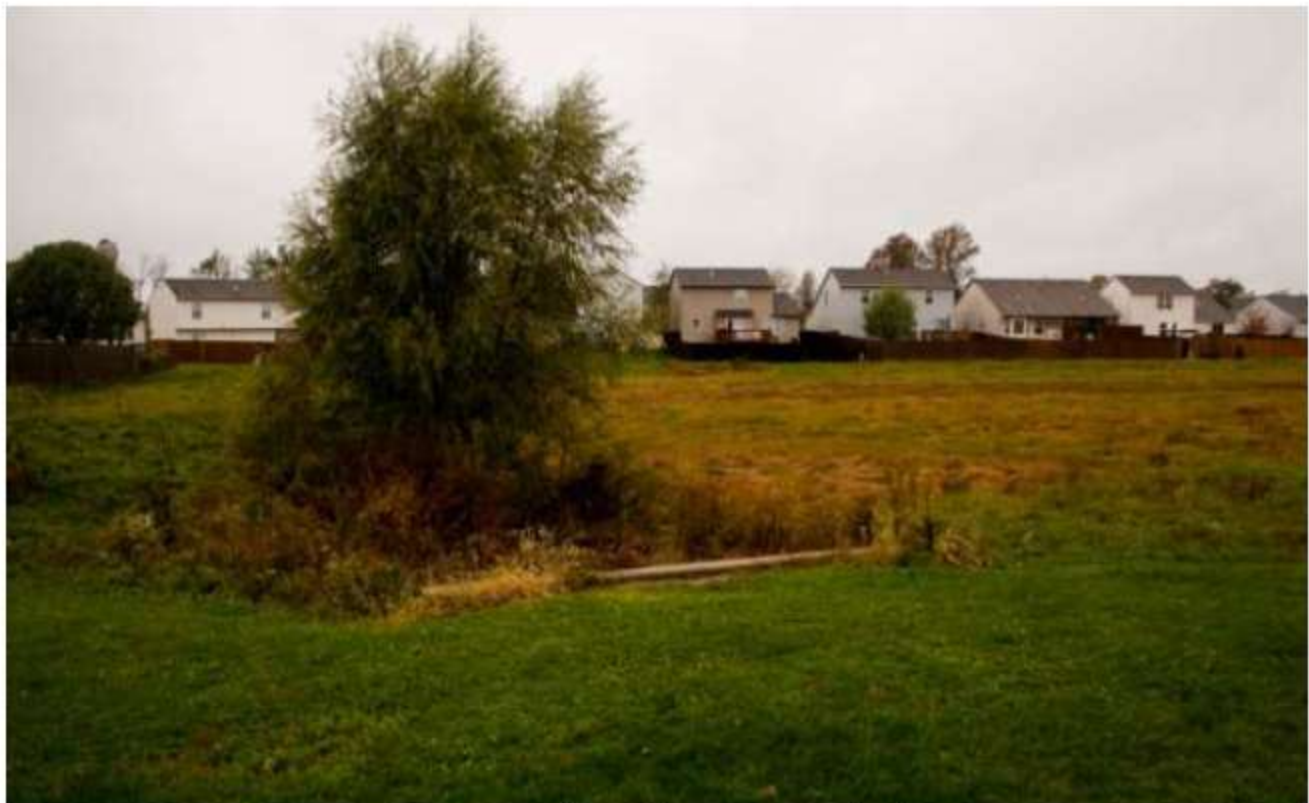
Figure 12: Basin at 4:30 PM October 20, 2011, taken at the same time as the photo in Figure

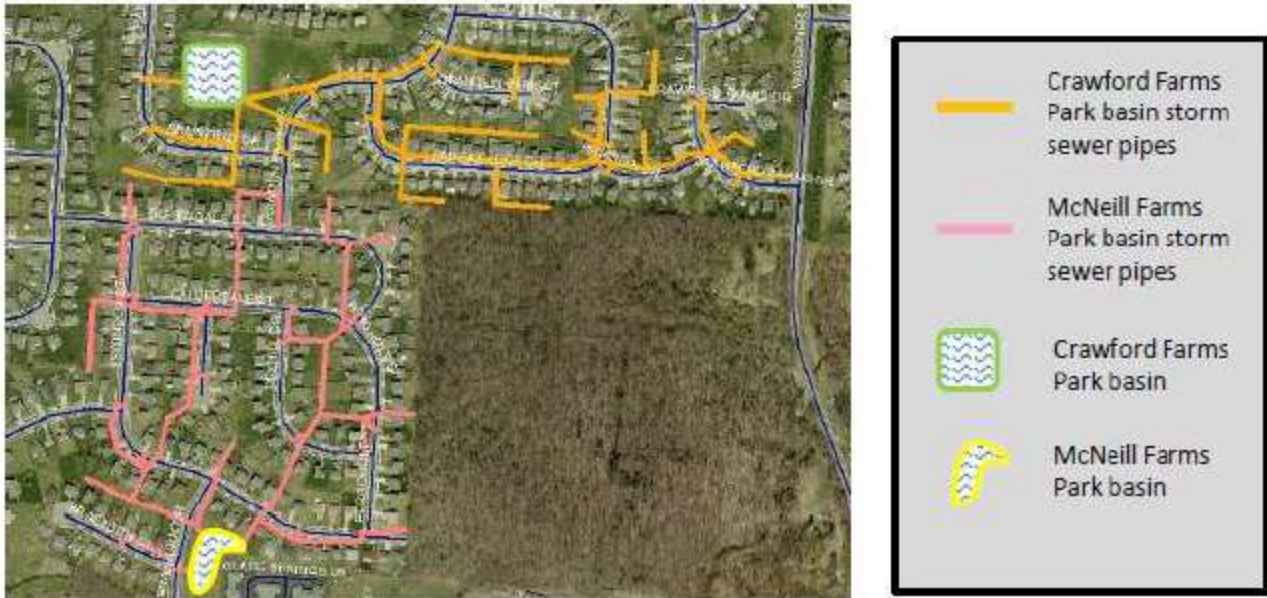
Figure 13: Crawford Farms and McNeill Farms storm sewer systems and stormwater basins

The impact of this basin is compounded, since its outflow is connected to a second stormwater basin in McNeill Farms, the subdivision to the south of Crawford Farms. The McNeill Farms stormwater feature receives the runoff from a total area of approximately 40 acres, which combines with the outflow from the Crawford Farms basin (Figure 13). In effect, the McNeill Farms basin collects the stormwater from over 70 acres of subdivision and becomes a creek more than a basin during most rain events (Figure 14).

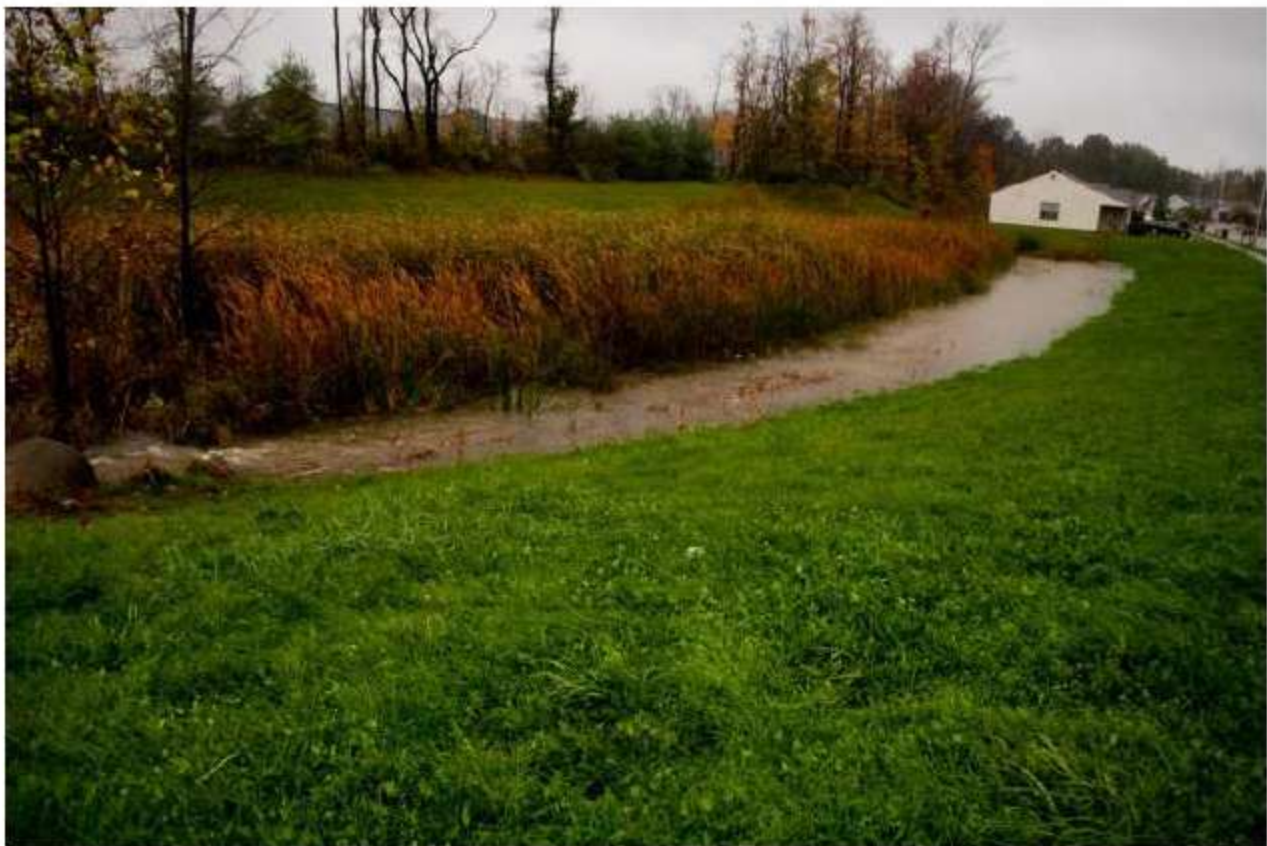
Figure 14: McNeill Farms basin at 5:00 PM October 20, 2011 after 4.95" of rain over 40 hours

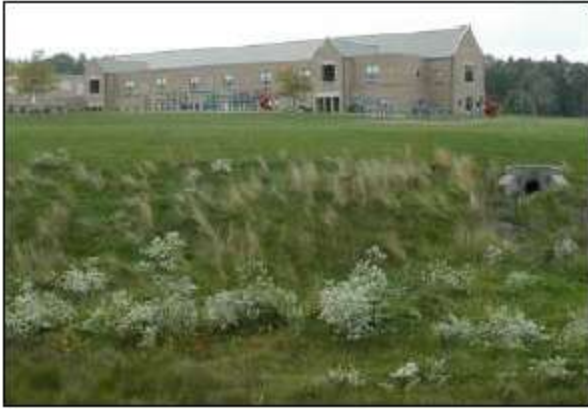
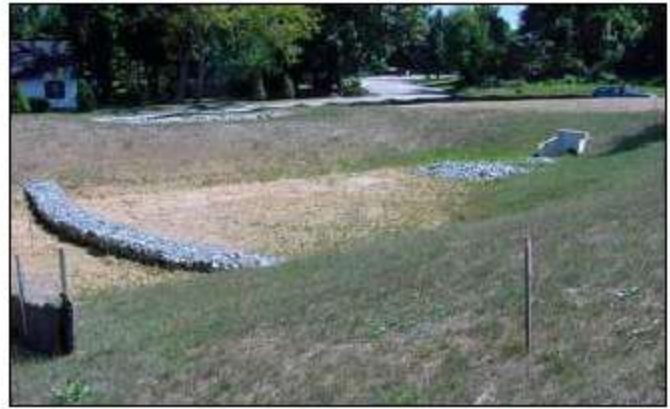
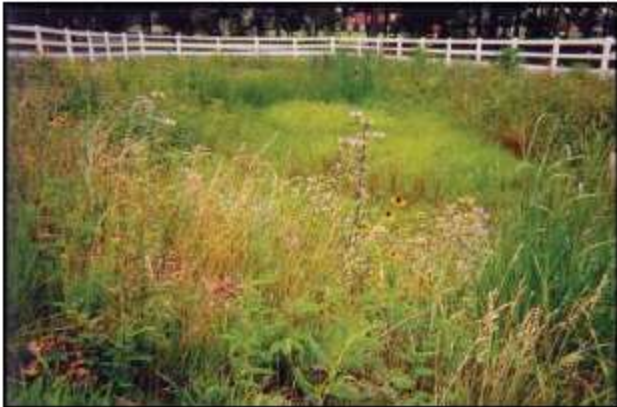
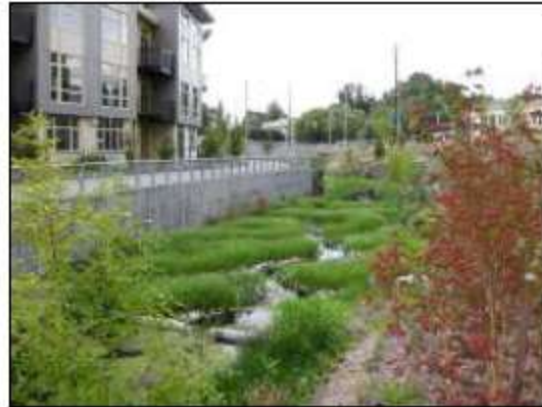
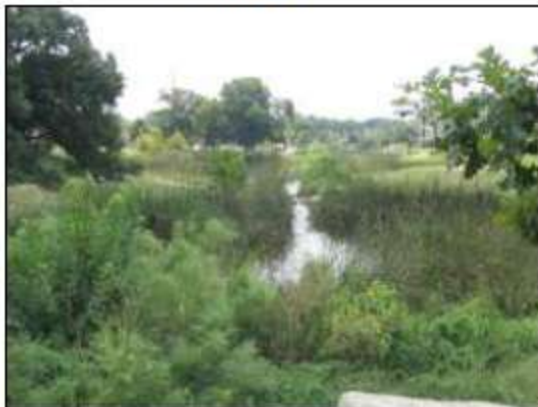
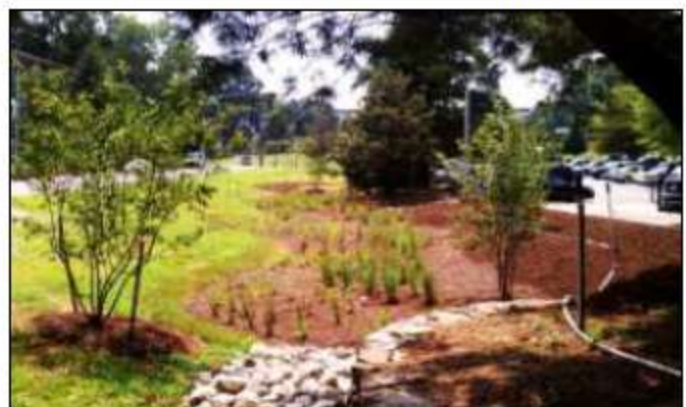
Figure 15: Possible design components

Vegetated Infiltration Area

Forebay

Vegetated Infiltration Area with Wet Meadow

Wet Channel

Wetland Pool

Dry Channel (at bottom of image)
